REVIEW OF AERONAUTICAL FATIGUE INVESTIGATIONS IN POLAND (2013-2014)

This review was presented on the 34 Conference of the International Committee on Aeronautical Fatigue and Structural Integrity, Helsinki, Finland, June 1-2, 2015. It contains description of main works and investigations in fatigue of aircraft structures performed in Poland during the years 2013 and 2014.

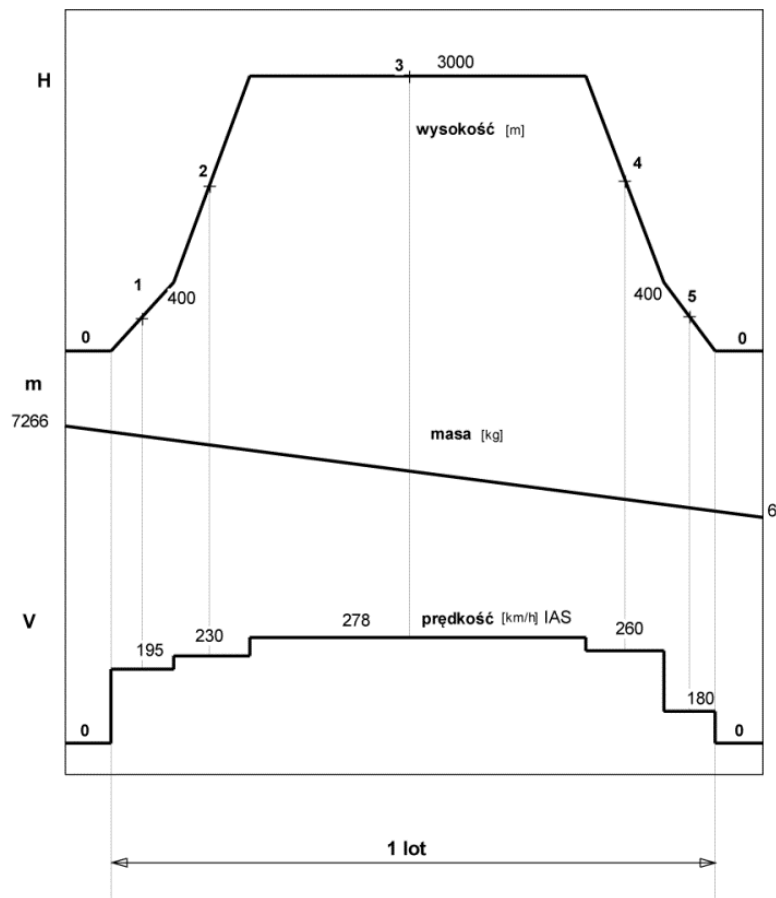
Fig. 1. A typical flight profile of the PZL M28 05. Airspeed, flight altitude and aircraft weight are shown. Assumed flight duration is one hour. Mission consists of:
 0 – taxiing, ground roll before take-off and after landing,
 1 – take-off and initial climb to 400m above airfield altitude,
 2 – climb to cruise altitude,
 3 – cruise,
 4 – descend to 400m above airfield altitude,
 5 – go-around and landing.

A typical flight profile, i.e. basic flight parameters, of the PZL M28 05 in one-hour flight is shown in Fig. 1.

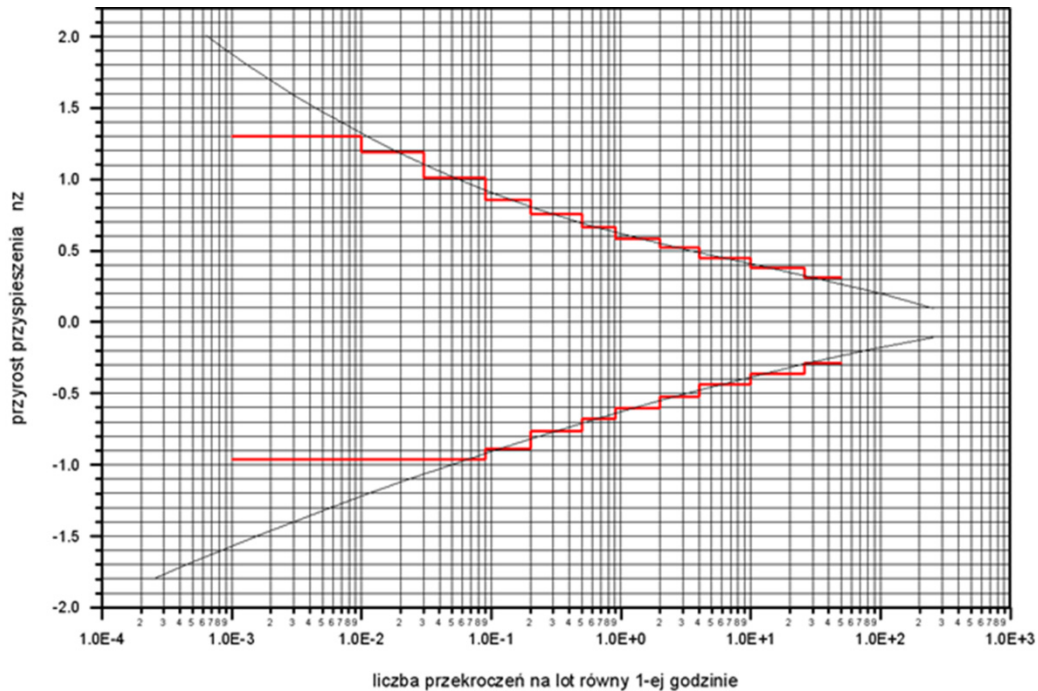
**Fig. 2. Discretised load spectrum applied in fatigue test (red line).
Base continuous load spectrum is also shown.**

The fatigue analysis showed that about 25% of the wing's fatigue damage was GAG result. So, in the fatigue tests of wing and wing loads carry-through structure the ground loads were also taken into account. The selection of load levels for fatigue tests was done by iteration for different load levels sets while preserving the basic assumptions. The final result was 11 load levels with loads occurring at 100 flights considered as shown in Fig. 2. Of course, total fatigue damage for test load spectrum was the same as for the continuous load spectrum.

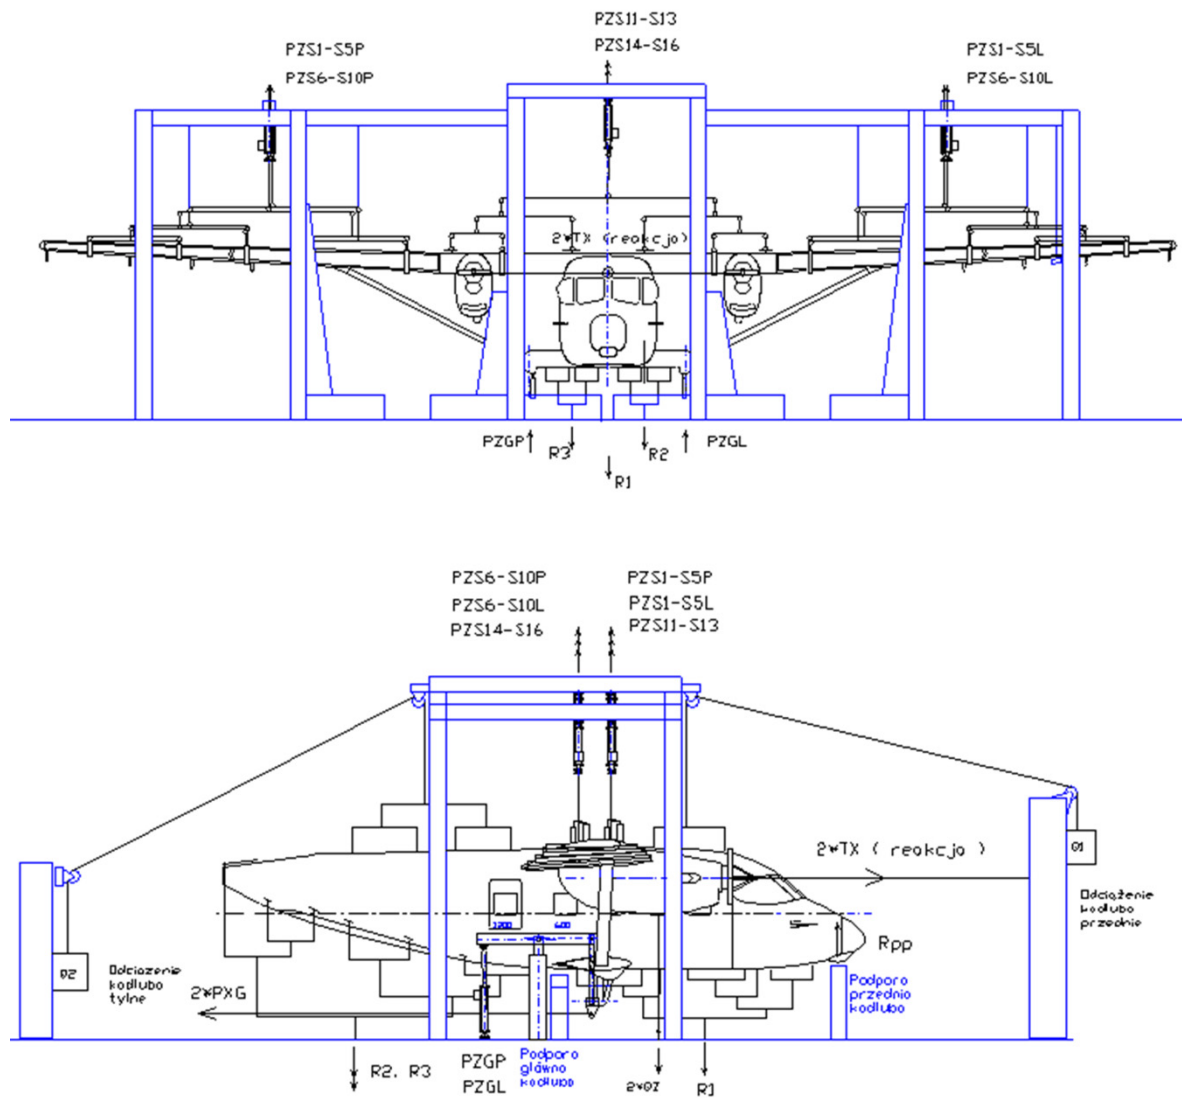
Fig. 3. The PZL M28 05 wing and wing load carry-through structure fatigue test scheme.

Figure 3 presents the PZL M28's wing and wing load carry-through structure fatigue test scheme. There were 12 actuators of the MTS Aero system used. Active forces were applied to the wing (6 actuators), main landing gear (2 actuators for vertical forces and one actuator for horizontal force) and the engines frames (2 actuators for applying torque from each engine separately and one actuator for applying the power plant vertical load, LH and RH).

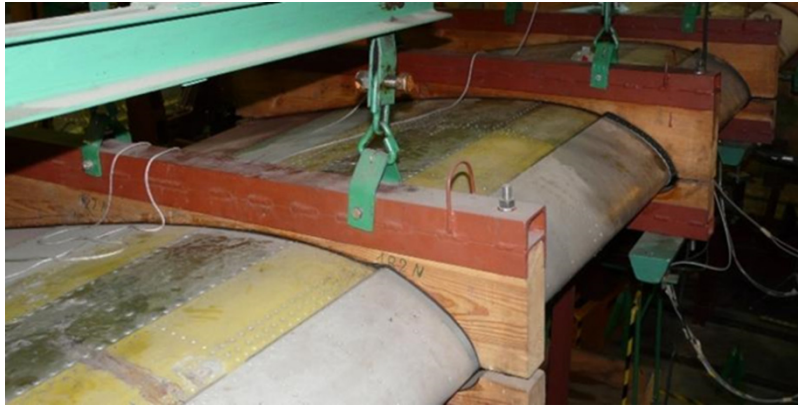
Fig. 4. PZL M28 05's wing and wing load carry-through structure fatigue test fixture. Clamps introducing loads to the wing are shown.

Balancing reactions were applied to the fuselage, nose landing gear fitting and engine frames (horizontal force balanced by the engines' thrust). Wing loads were usually applied through clamps – see Fig. 4.

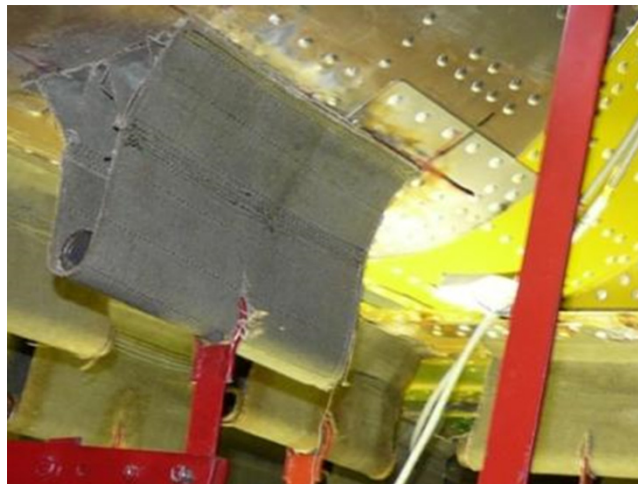
Fig. 5. PZL M28 05's wing and wing load carry-through structure fatigue test fixture. Sample tapes glued on the fuselage are shown.

There were 12 clamps in total applied to introduce loads at 12 spanwise stations. At 4 wing stations, loads were applied by glued tapes. Fuselage loads were applied through glued tapes – see Fig. 5.

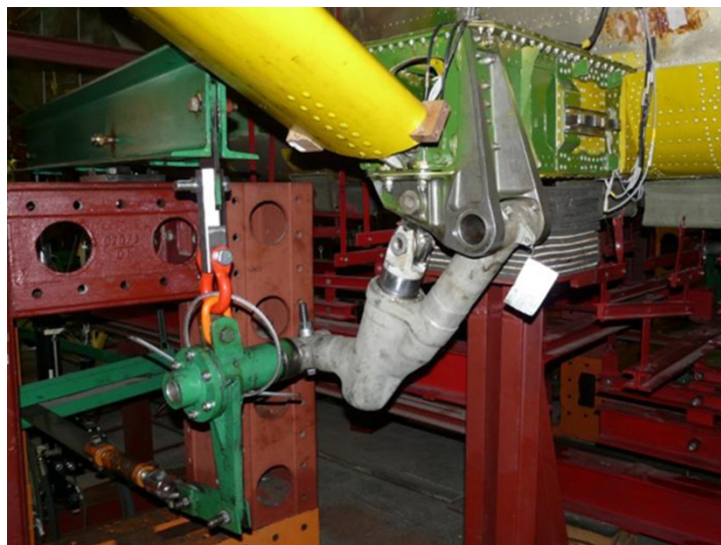
Fig. 6. PZL M28 05's wing and wing load carry-through structure fatigue test fixture.

Tapes were arranged in a way which helps avoid excessive load concentration, nonexistent in reality, and likely to introduce damage to the thin-walled fuselage structure. This rule was applied to all the loads introduced. The main landing gear leg is a convenient element to introduce ground loads, of significant effect on the fatigue damage of the airframe. Vertical and horizontal loads were applied to each leg – see Fig. 6.

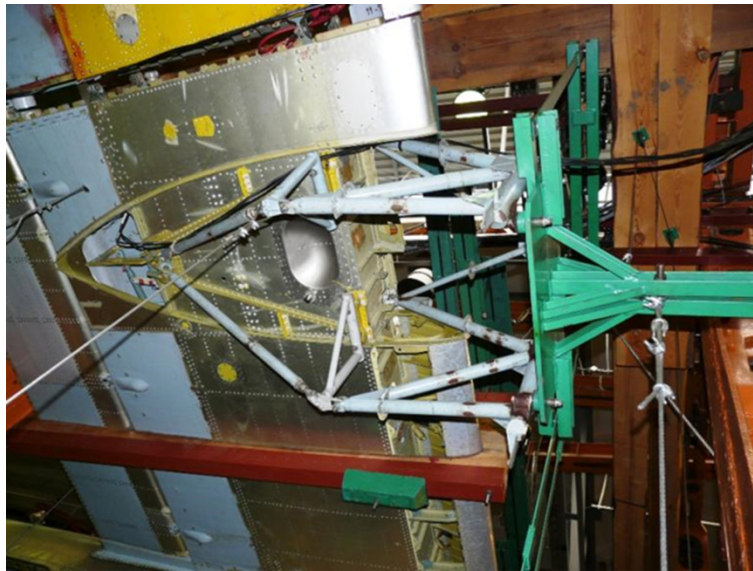
Fig. 7. PZL M28 05 wing and wing load carry-through structure fatigue test fixture. The engine frame is loaded by vertical power plant inertia force, engine torque and balancing prop thrust force.

Note that horizontal force is shifted from the wheel axle in order to simulate the wheel braking effect. The engine frame was a convenient element to introduce engine torque, the vertical force resulting from power plant inertia, and prop thrust force – see Fig. 7.

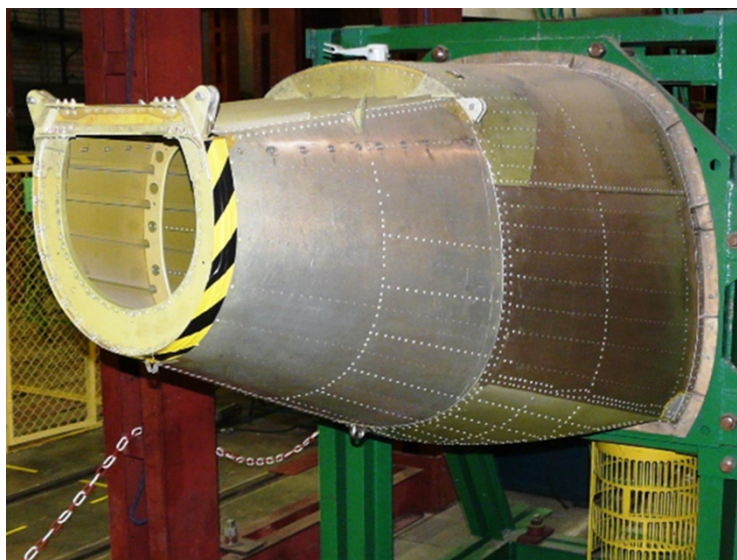
Fig. 8. PZL M28 05's empennage fatigue test fixture. In the picture there is a fuselage part used in test (empennage is dismantled).

In the case of the empennage, the tested item was the empennage and fuselage attached structure. The question arose what part of the fuselage should be in the test fixture. After performing structural analysis, it was decided to cut the fuselage at station two frames before forward stabilizer fittings – see Fig. 8.

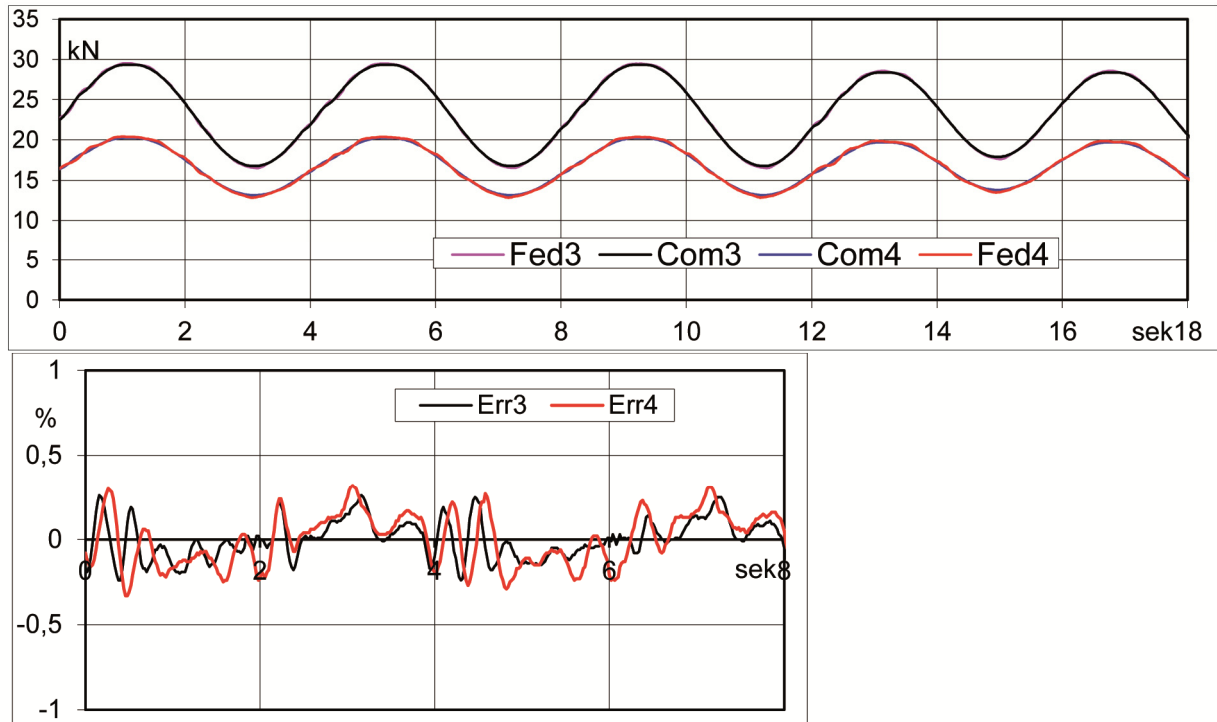
Fig. 9. Fatigue test of the PZL M28 05's wing and wing load carry-through structure. Illustration of command (in blue) and feedback (in red) forces registered for several seconds of the test in channels 3 and 4. Force errors in these channels as difference between command and feedback forces, expressed in percentage of maximum force in the load transducers, are also shown.

During fatigue tests of the wing and wing load carry-through structure, the accuracy of applied loads was kept within an error margin of 2%. This margin relates to the maximum force in a given channel in the test. An example of the command and feedback force course in the channels is shown in Fig. 9.

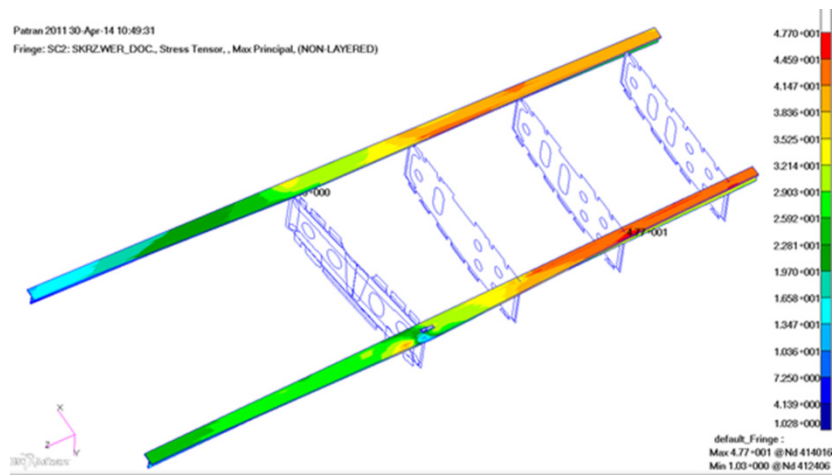
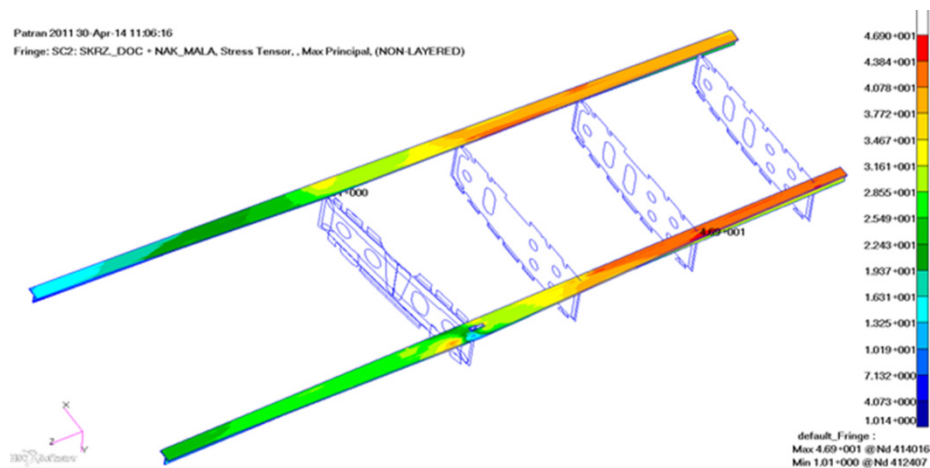
Fig. 12. The FEM analysis of a crack in the PZL M28 wing area of rib 17 during fatigue testing:

- a) Sketch of the cracked area of the skin between ribs 17 and 18 with a strap.
- b) Stresses in the wing spars' lower caps for level flight ($n_z = 1$ g) load before the repair.
- c) Stresses in the wing spars' lower caps for level flight ($n_z = 1$ g) load after the repair.

Another crack in the wing was observed at rib 17. The crack was in the wing skin only, so it was assessed as not critical. As it is the area of the integral fuel tank, a crack occurrence is signalized by a fuel leakage. Repair on the airplane in operation is possible, so such repair was made in the tested wing. The FEM stress analysis was performed in order to check the effect of the repair on the stress level in the wing spars – see Fig. 12.

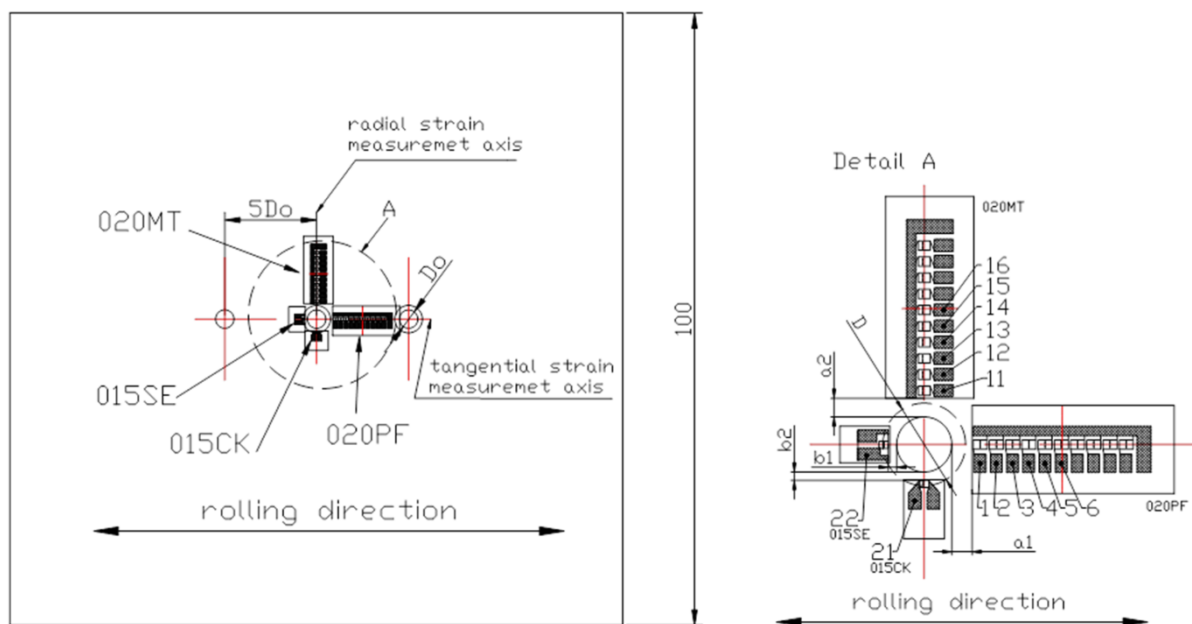
Fig. 13. Specimen geometry

The experiment with strain gauge measurements during the riveting process was designed and performed to investigate the strain state induced during the riveting process for several rivet types. The specimens used are presented in Fig. 13.

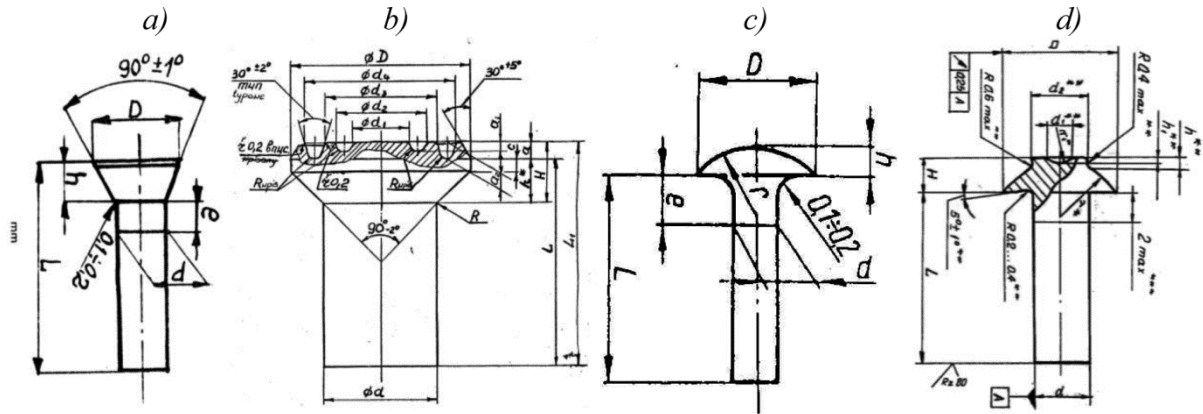
Fig. 14. Rivets used in the experiment

- typical 90° countersunk rivet (according to Polish aerospace standard BN-70/1121-04),
- 90° countersunk rivet with a compensator (according to Russian aerospace standard ANU 301)
- typical brazier rivet (according to Polish aerospace standard BN-70/1121-06)
- brazier rivet with a compensator (according to Russian aerospace standard OST 1 34040 79).

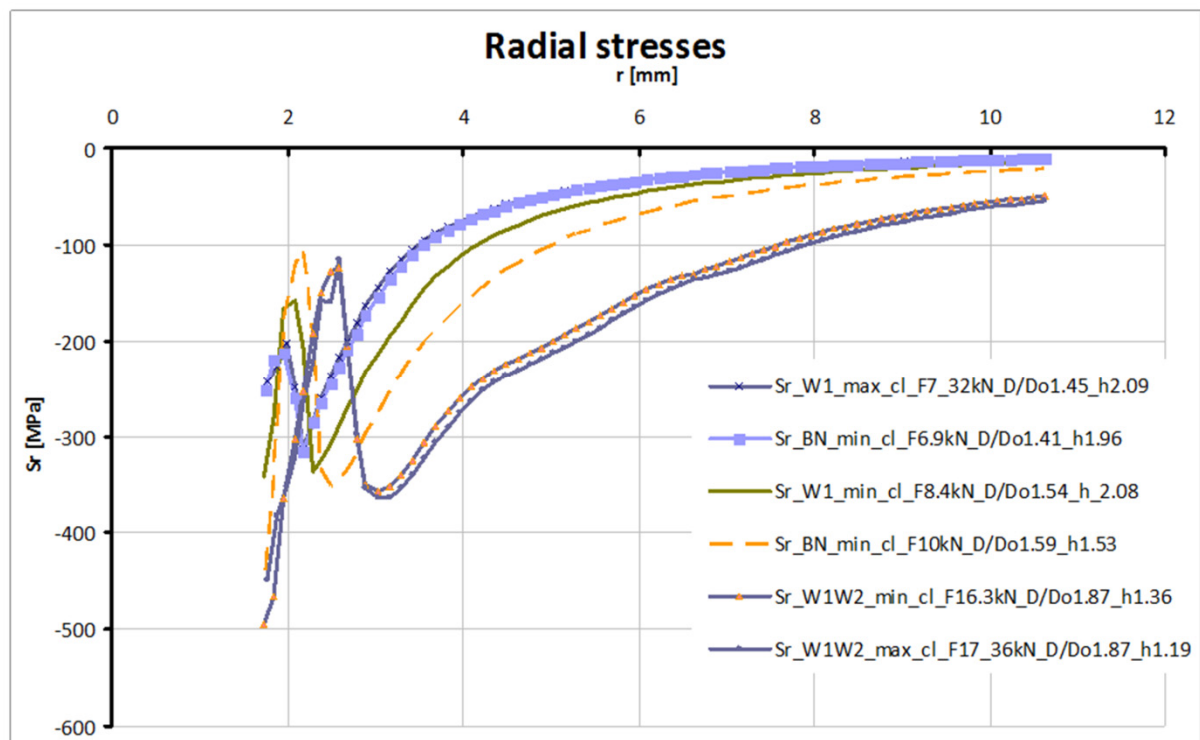
Fig. 17. Radial stresses on the sheet surface near the driven head – clearance and force influence

The radial (S_r) and tangential (S_t) stresses on the sheet surface near the driven head for the cases of clearance and driven head dimensions influence analysis are presented in Fig. 17-18.

The results show that residual stresses around the rivet can vary significantly within allowable riveting parameters defined in the investigated standards and instructions. This has a strong impact on the fatigue life of a joint. It is particularly visible in the case of tangential stresses since the area where the tangential stresses are compressive and the place of maximum value depend on the riveting parameters. The most affective factor is the squeezing force level. Stress courses in the case of maximal and minimal clearance are similar if the squeezing force level is approximately the same. Some differences exist for low forces while in the case of high forces stress courses are almost the same.

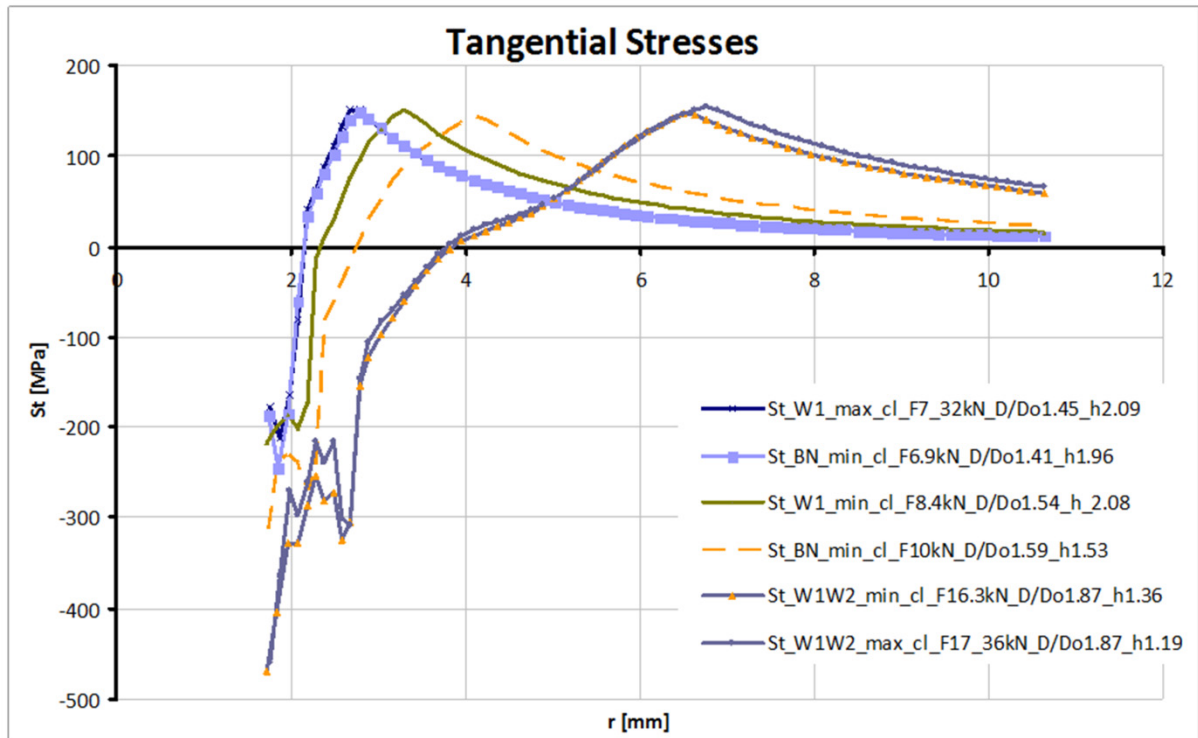
Fig. 18. Tangential stresses on the sheet surface near the driven head – clearance and force influence

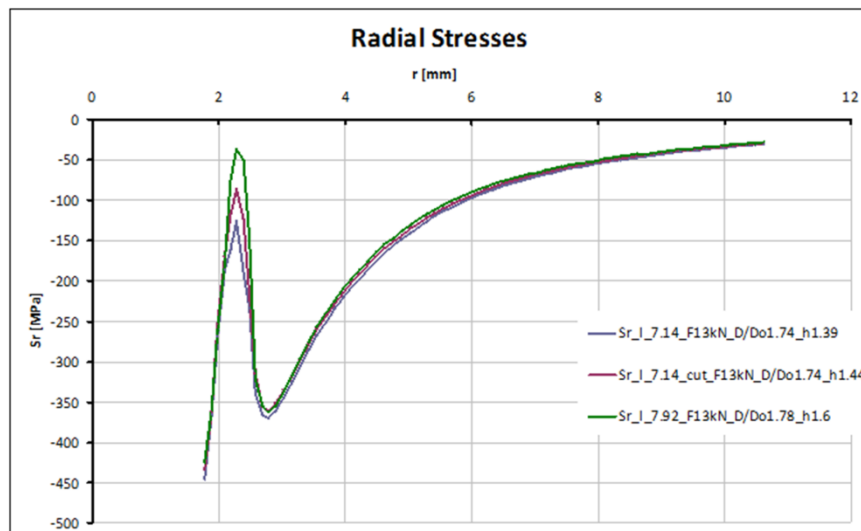
Fig. 19. The influence of radial stresses on the sheet surface near the driven head-rivet length

Figs. 19-20 present radial and tangential stress courses on the sheet surface near the driven head for the cases of the length influence analysis. For the same squeezing force, neither the difference of one length interval nor the shape of the shank end, have any significant influence on the residual stresses. The biggest difference is in the local maximum stress level near the rivet.

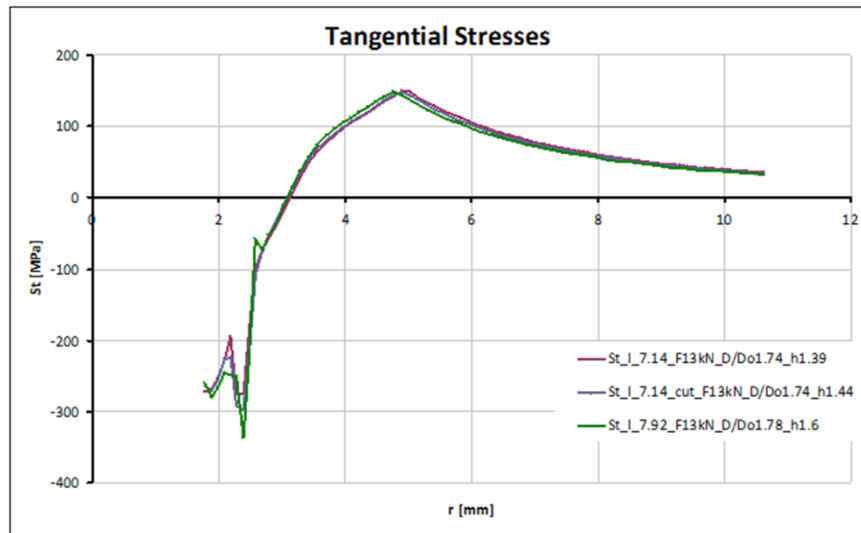
Fig. 20. The influence of tangential stresses on the sheet surface near the driven head-rivet length

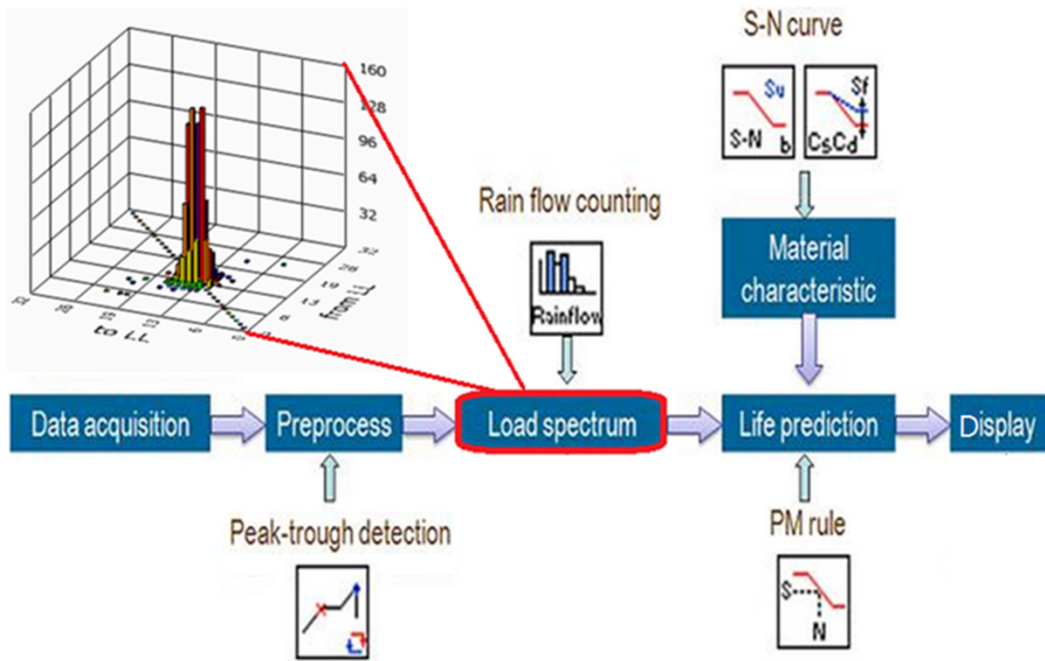
Fig. 21. A scheme for calculating fatigue life

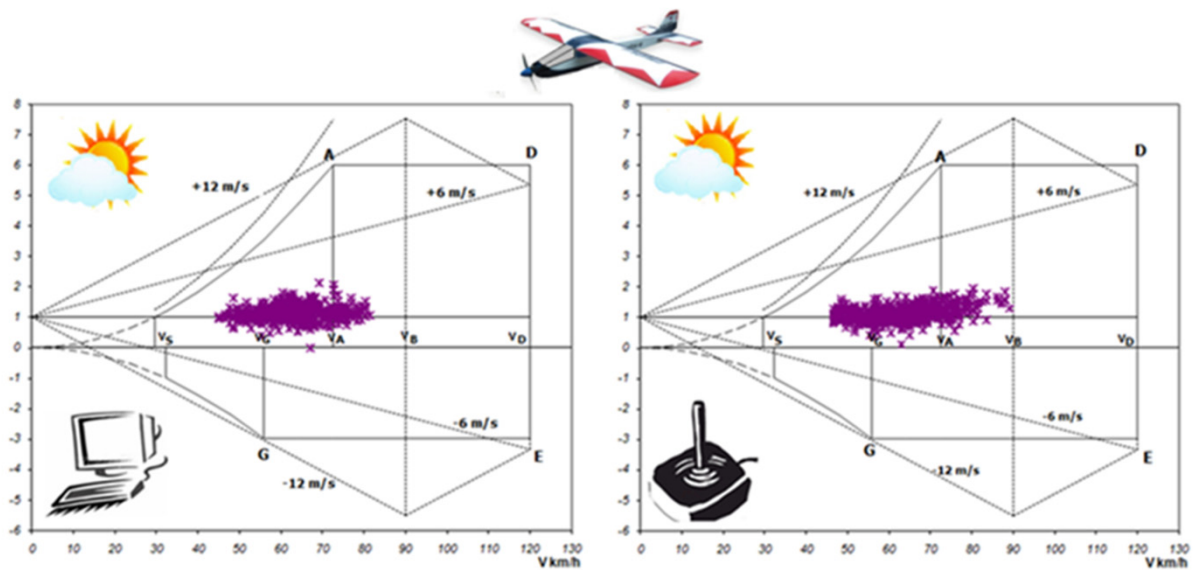
Fig. 23. Loads of a "WorldStar" UAV in different control conditions

The investigations have been carried out to test the loads of UAVs in different weather conditions and different operating modes. The qualitative nature of the loads in the manual and automatic control mode is shown in Figures 22 and 23.

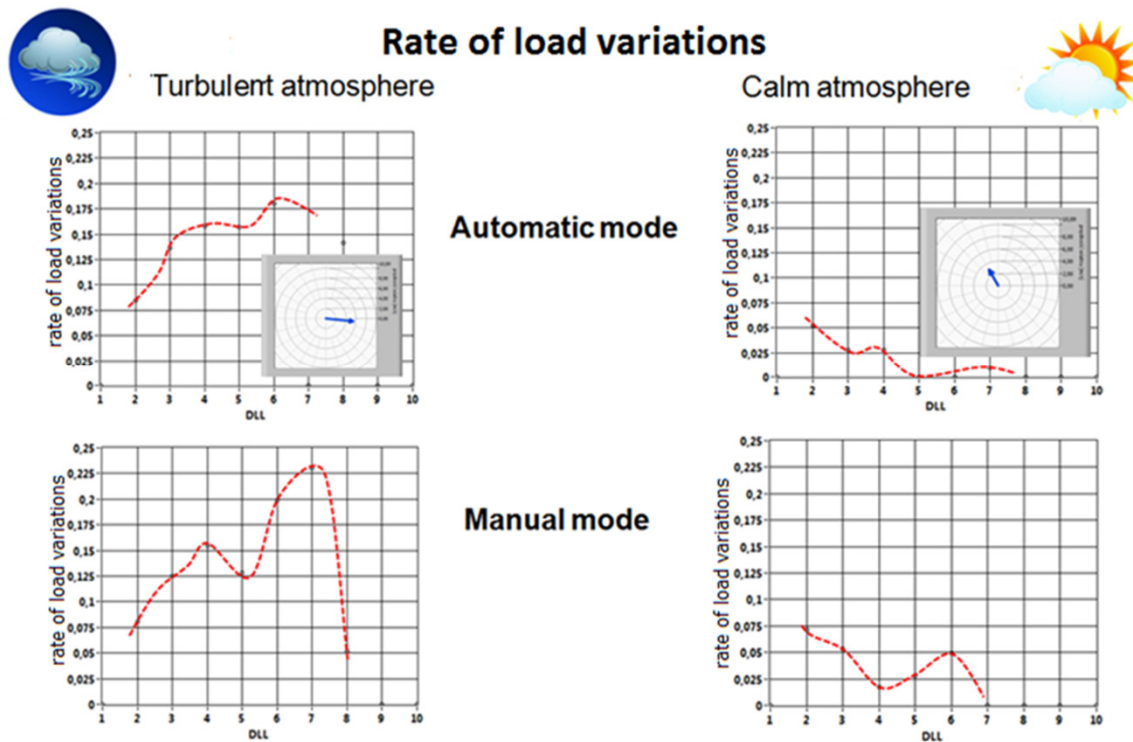
Fig. 26. Rate of load variations recorded during flight tests of the WorldStar

The results of calculations for different conditions in which the WorldStar aircraft was tested are shown in Figure 26. It was observed that in the case of high turbulence, greater load values correspond to an increase in the rate of load variations, which might possibly be an important factor in reducing the fatigue life. However, in calm weather conditions, the load increase was accompanied by a decrease in the rate of load variations.

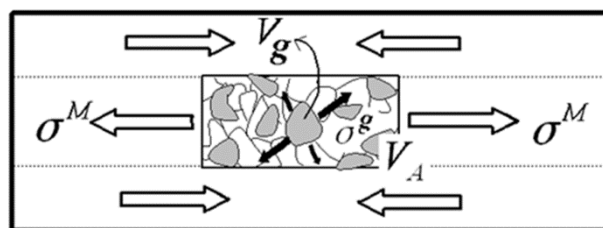
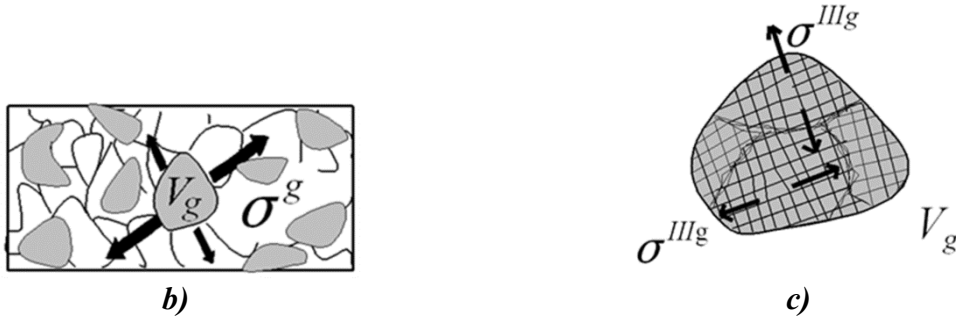
Fig. 27. Stress classification: a) first order stresses, b) second order stresses, c) third order stresses

- Second Order Stresses: they vary from grain to grain. Second Order Stresses can be observed in a rolled specimen, too. They originate from different plastic deformations of an individual grain. Average in the whole volume of the specimen for stresses of this type is zero (Fig. 27b).

- Third Order Stresses: their values vary inside every individual grain. They describe the stress field originating from dislocations or grain boundaries. The average value of Third Order Stresses in the whole volume of the grain is zero (Fig. 27c).

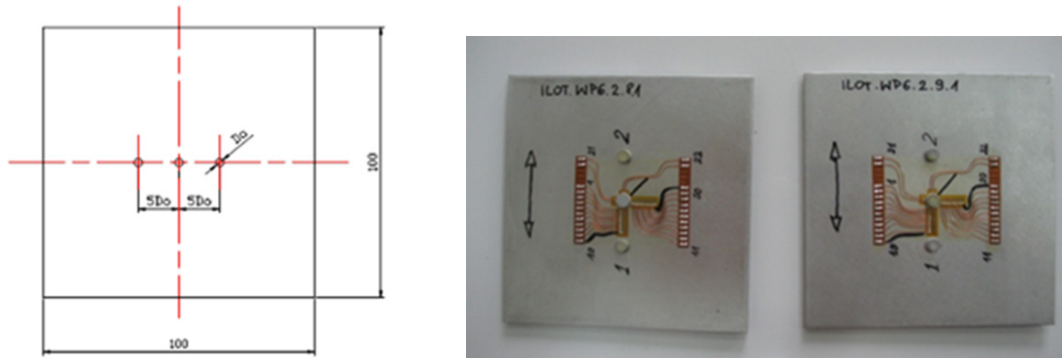
Fig. 33. Geometry of specimen for residual stress gradient measurements

The specimen geometry is presented in Fig. 33. The specimen consisted of two sheets of PA7 aluminum alloy, which is the Polish equivalent of 2024T3 alloy, riveted with a press. The sheets were 1.27 mm thick and without any protective layer such as cladding or an anodized layer (except for a thin layer of technological cladding approximately several micrometers thick).

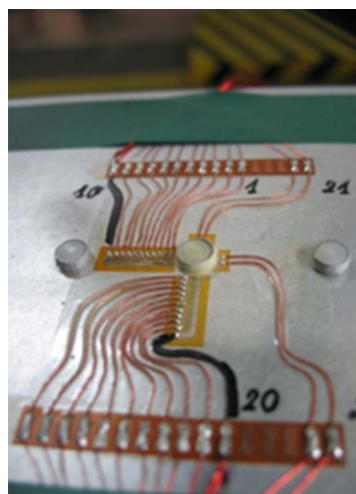
Fig. 34. Riveted specimen with strain gauges

The strain gauges experiment was performed with the strip gauge patterns. Two different strain gauges were used – one of them measured tangential stresses while the other radial stresses. The measurement was performed during the riveting process with the riveting force controlled. The central rivets were riveted with a force giving the ratio between the driven rivet head and the rivet shank equal to 1.55. The riveted sample with strain gauges mounted is shown in Fig. 34, and the example of strain measurement during riveting is presented in Fig. 35. Two types of gauges were used: strip and micro gauges. Strip miniature gauges contained ten gauges, each with a length of 0.51mm, and were located outside the driven head. They worked during the whole riveting process. Additionally, two micro strain gauges with a length of 0.38 mm were applied very close to the rivet hole, in the area under the driven head after the riveting process. The gauges recorded strains until they were destroyed by the driven head.

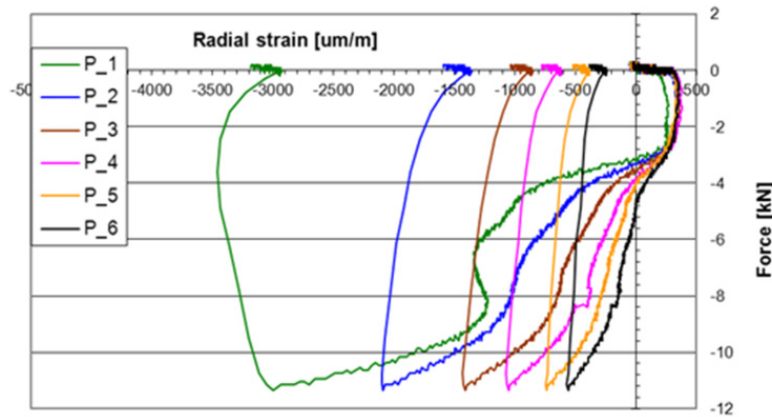
Fig. 35. Example of strain gauges measurement results during the riveting process

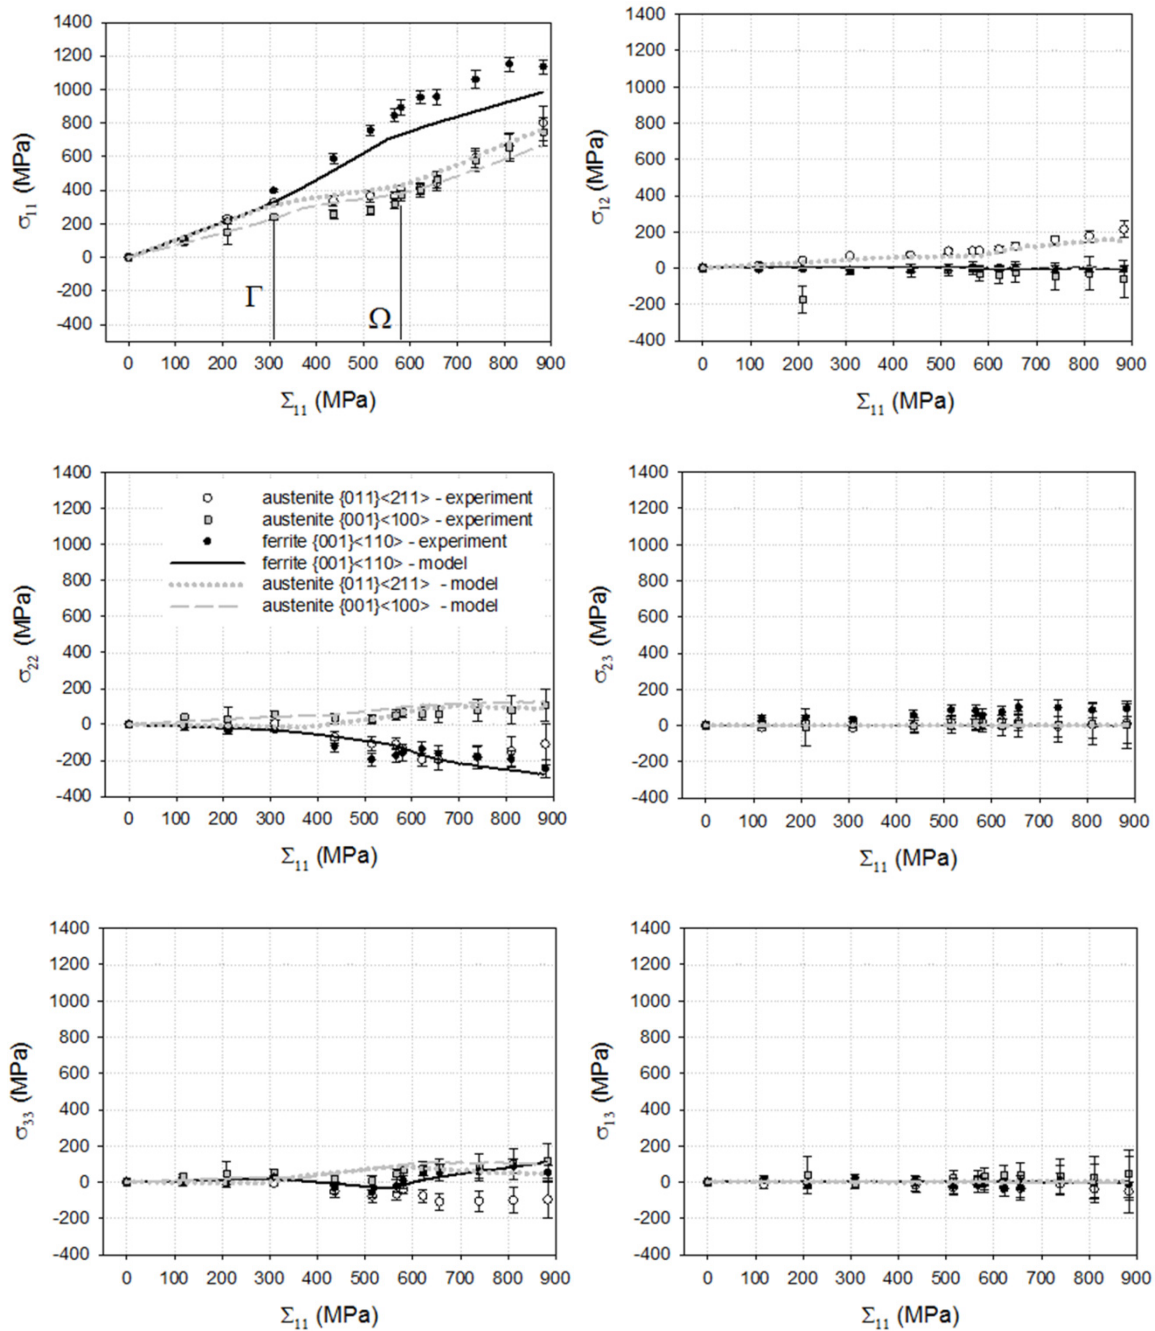
Fig. 37. Components of stress tensor localised on the group of grains having the three studied texture orientations vs. applied macrostress. Experimental results obtained using the crystalline group method (points) are juxtaposed with the self-consistent prediction (lines)

The dependence of six stress components determined according to eq. (1) for three studied orientations is shown in Fig. 37 alongside the prediction of the elastoplastic model. The theoretical result was adjusted to the experimental data and the plastic parameters were found for both phases of the studied steel. The Voce law describing the hardening process at the grain scale was used and the plastic parameters were defined for each phase of the steel separately, i.e.:

Analysing the plots presented in Fig. 37 it can be seen that there is a significant difference in the stresses localised in different phases. The evolution of the stress component parallel to the applied load (reflects the behaviour of the phases. The ranges in which both phases are elastic and both phases are plastic can be easily distinguished. The positions of the thresholds precisely determine yield stresses for each phase, which can be easily read from the presented plots. These thresholds are used to adjust the parameters of the Voce law. It can be noted that, in the purely elastic range, all the components of the stresses are predicted very accurately by the model.

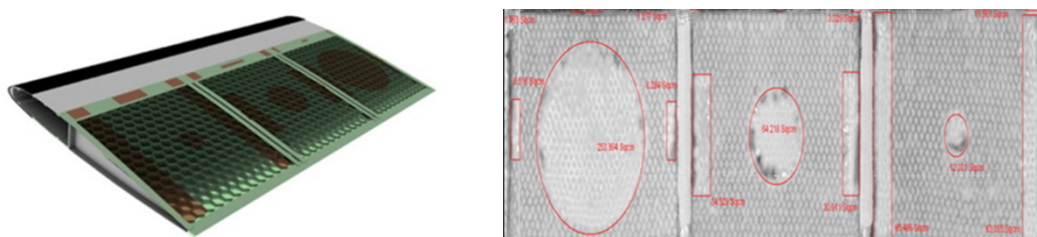
Fig. 2. Calibration specimen design (left) and MIA (right) inspection results of the disbonds

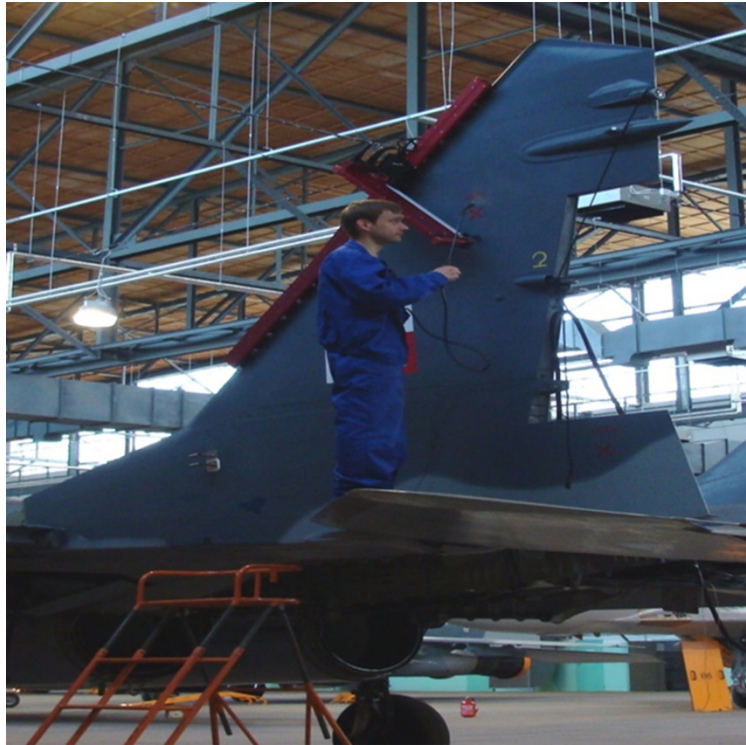
Fig. 3. Composite Vertical Stabilizer Inspection

automated scanning procedure was applied. The MAUS[®]V system was used. The MAUS[®] system (Mobile AUtomed System) is a hybrid construction enabling inspection with the following techniques: ultrasound, eddy current, MIA, Pitch-Catch, Resonance and with the Phased Array module for ultrasound. The system is fully portable and enables inspection on horizontal and vertical inverted surfaces thanks to a flexible track system equipped with a special handle. Figure 3 presents the inspection of the vertical stabilizer composite skin of the MiG-29.

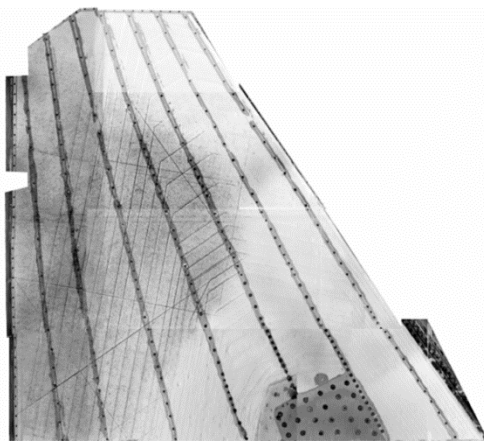
Fig. 4. Amplitude C-scan of F-16's horizontal stabilizer

The resonance and the ultrasonic inspections with the MAUS system are both quantitative methods. The results obtained are presented in the C-scans mode. The system's embedded interface enables the amplitude and ToF (Time Of Flight) C-Scan data presentation. Figure 4 below presents the amplitude C-scan of the F-16 horizontal stabilizer while Figure 5 shows the ToF C-scan of the MiG – 29 vertical stabilizer. On the amplitude data different colours are associated with different signal attenuation. The amplitude mode is useful for determination of the damage location.

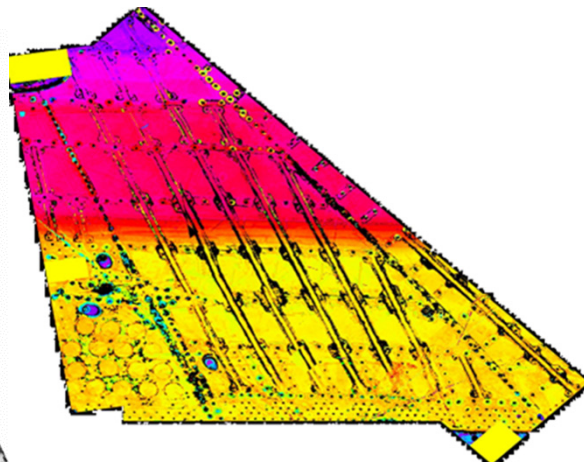
Fig. 5. TOF C-scan of MiG-29's vertical stabilizer

Colours used in the representation of the TOF data refer to different composite skin thicknesses and to different depths of delamination location. This system of data presentation helps describe damage and quickly find its location. The damage location distribution relative to the side of the vertical tail (internal/external, left/right) was found to be relatively normal. Some inspection results of interest are presented below.

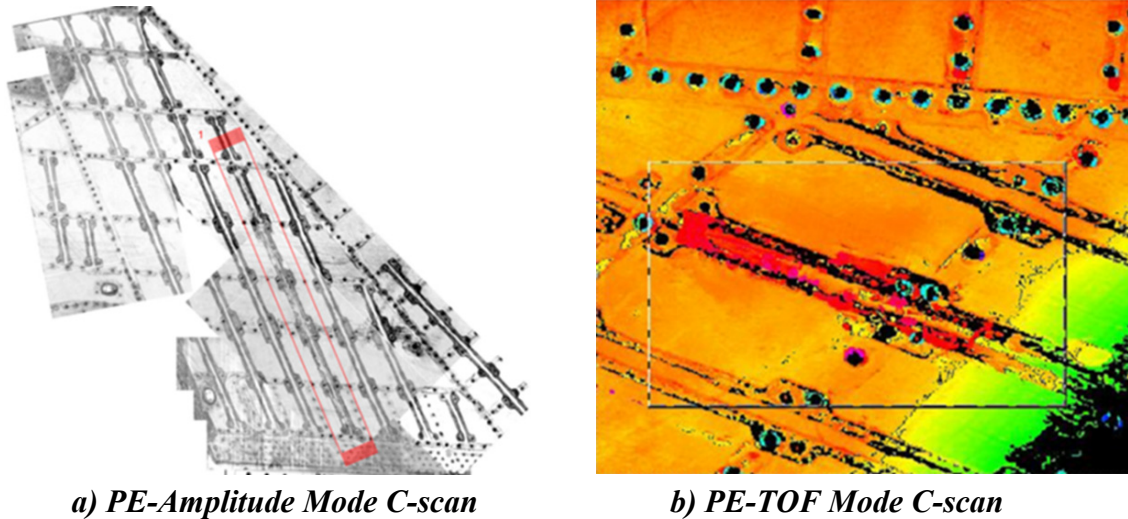
Fig. 6. Large delamination along the longeron of MiG-29's vertical fin

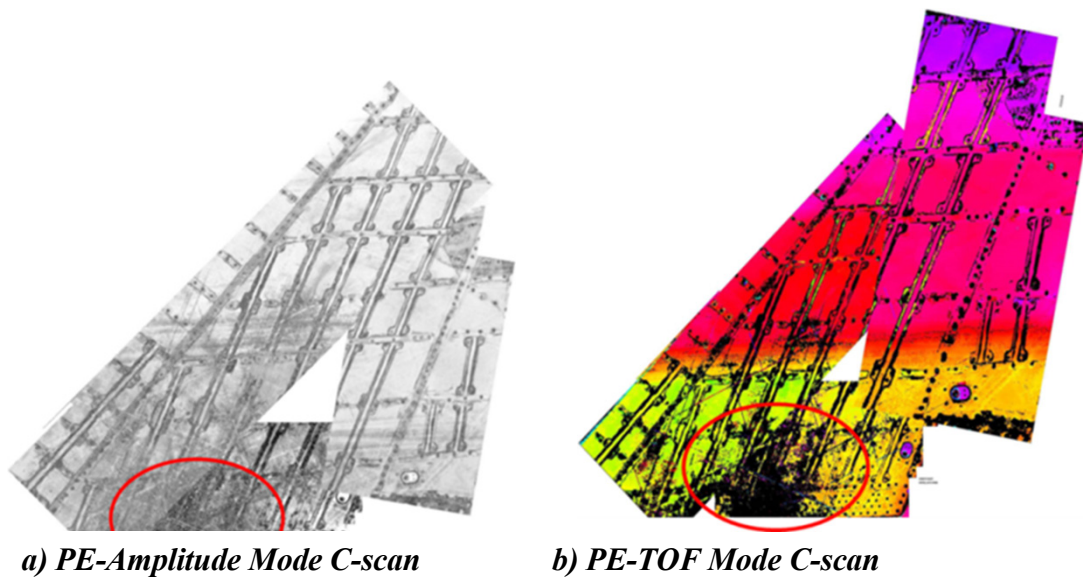
Fig. 7. Porosity location in MiG-29's vertical fin

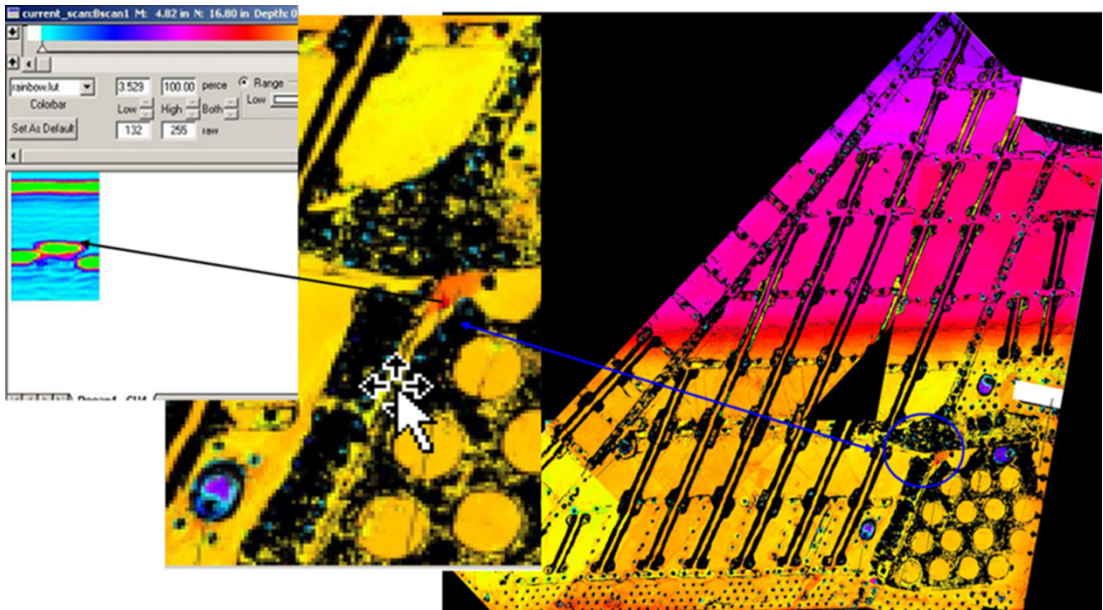
Fig. 8. Foreign object inclusion (embedded) in MiG-29's vertical fin
