REVIEW OF AERONAUTICAL FATIGUE INVESTIGATIONS IN POLAND (2013-2014)

This review was presented on the 34 Conference of the International Committee on Aeronautical Fatigue and Structural Integrity, Helsinki, Finland, June 1-2, 2015. It contains description of main works and investigations in fatigue of aircraft structures performed in Poland during the years 2013 and 2014.

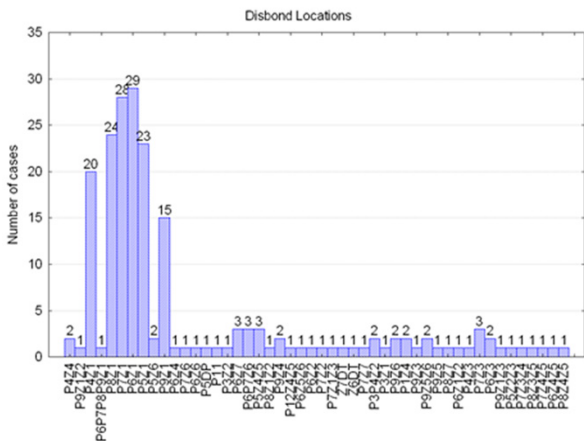
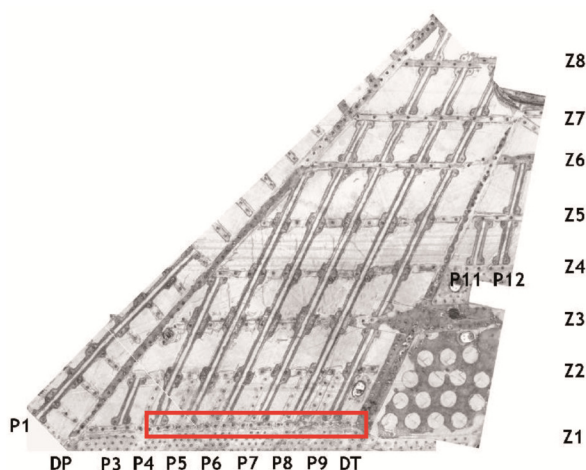
Fig. 9. Distribution of disbands in the MiG-29's vertical stabilizer

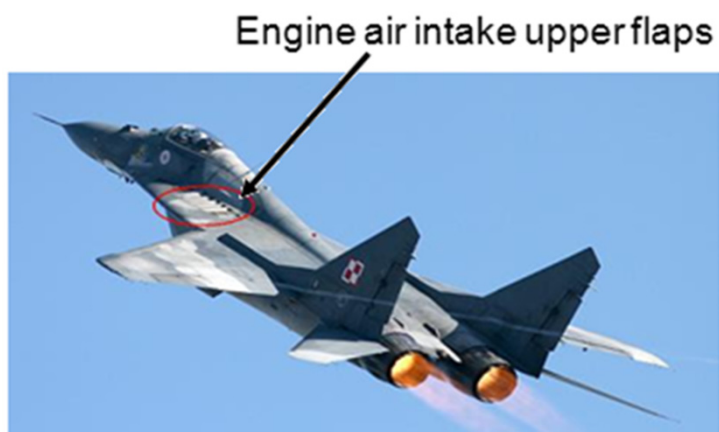
Fig. 10. Location of the engine air intake upper flaps

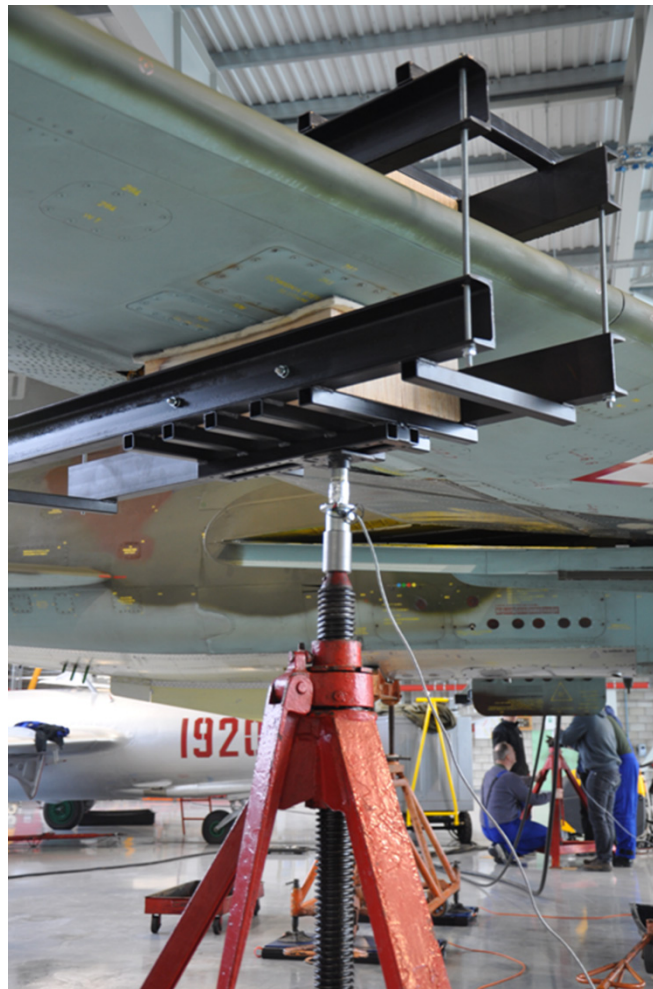
Fig. 12. Scaling of strain gauges – loading of the wing

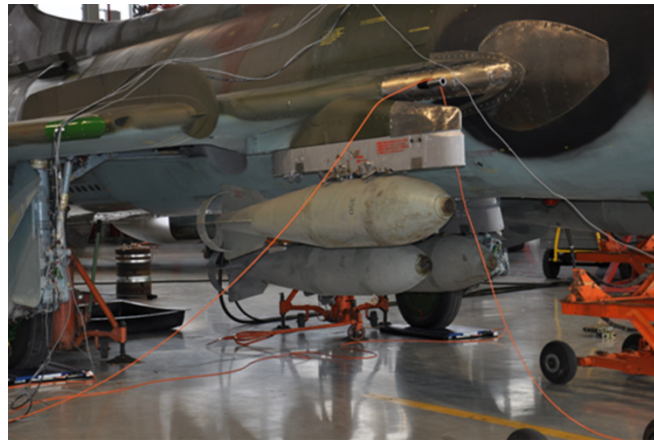
Fig. 13. Scaling of strain gauges – loading of the fuselage

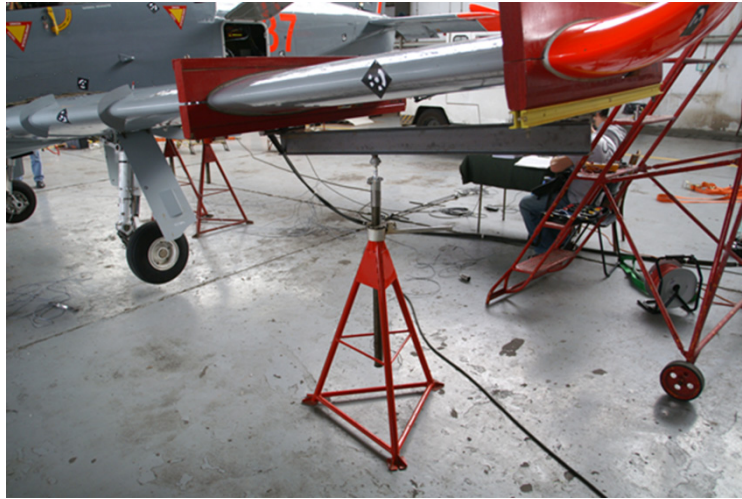
Fig. 15. Calibration of strain gages – loading of the wing

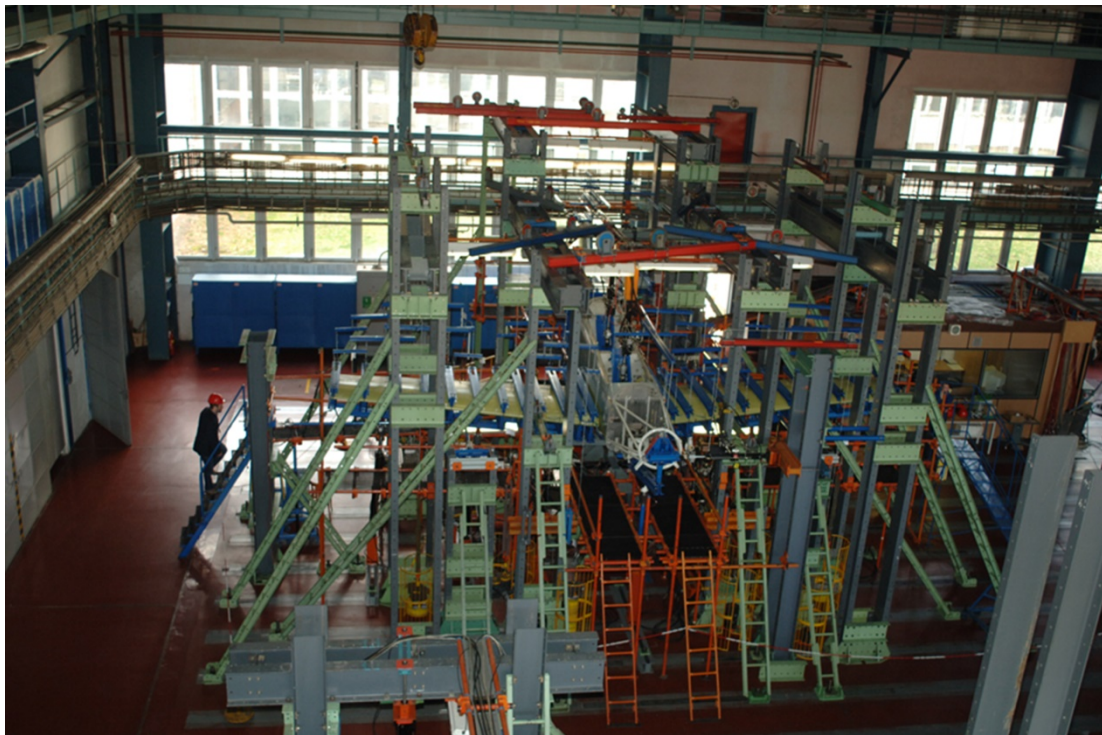
Fig. 16 Full Scale Fatigue Test Bed

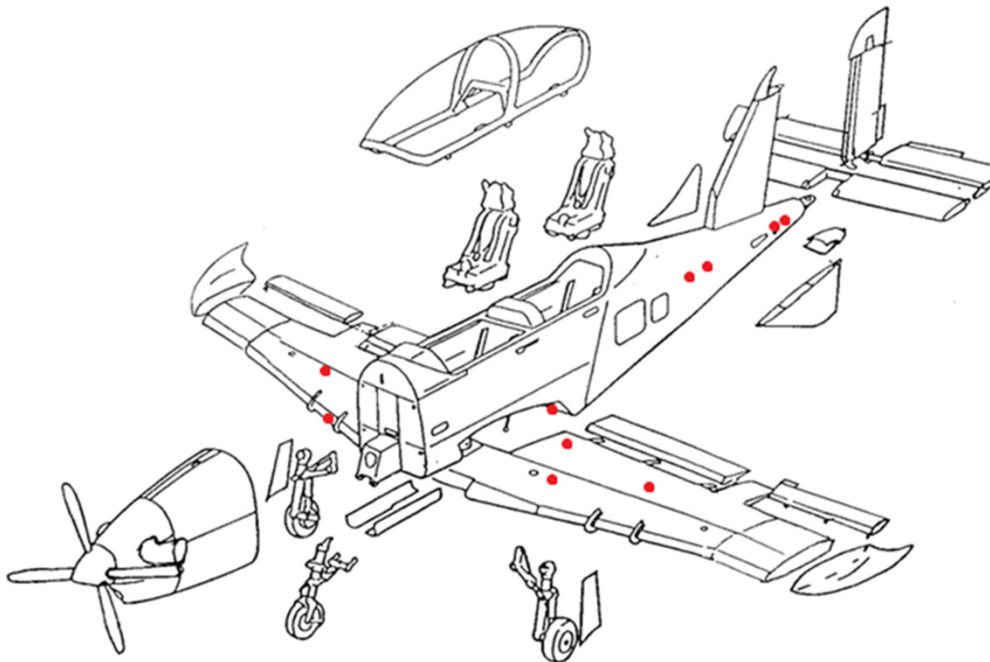
Fig. 18. Selected hot-spots on the aircraft structure

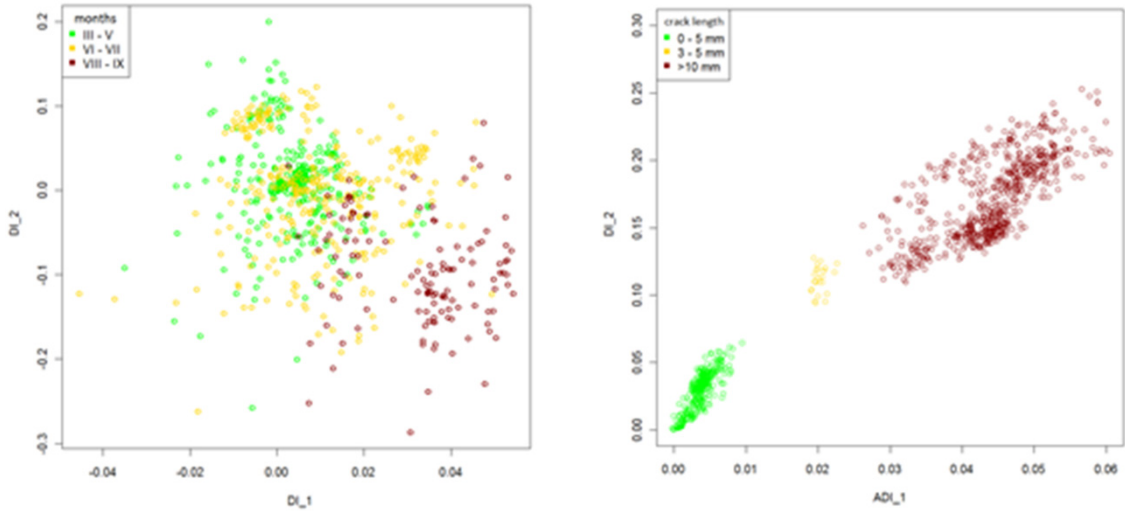
a) Unchanged hot-spot location

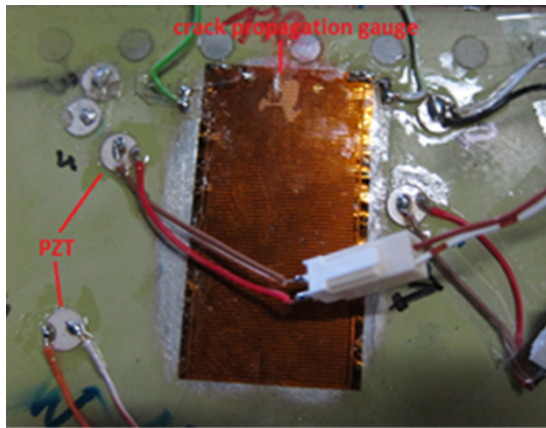
a) Damage non developing after PZTs placement

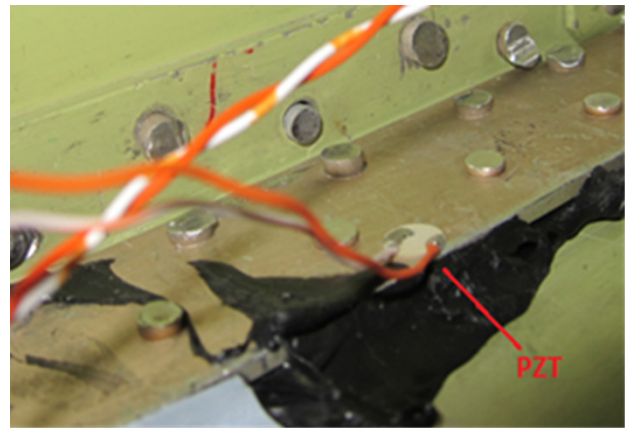
b) Damage developing after PZTs placement
