## EVALUATION OF SHEAR CAPACITY FOR BRICK MASONRY WALLS

**KEY WORDS:** Masonry Walls, Ceramic Block With Hollows, Cyclic In-Plane Loads

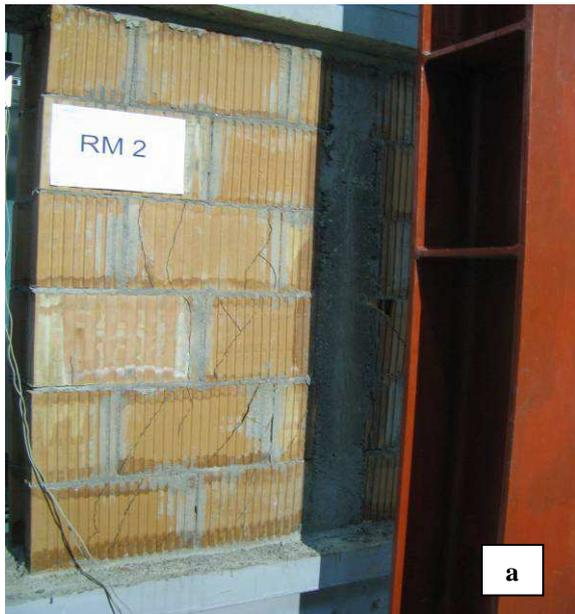
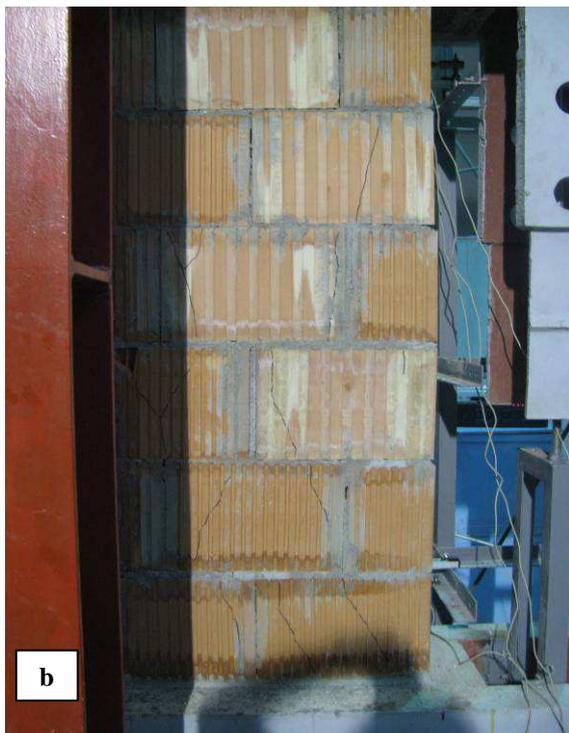
For the RM2 specimen with one concrete column in the middle, the failure mode was also in diagonals, but this time mostly in the ceramic blocks as seen in Figure 11.

Figure 11. Failure mode for RM2 specimens  
 (a. RM2, b. RM2-1)

This type of wall configuration was the most efficient, with substantially increased shear capacity, in comparison with the other two wall type specimens.
