ENERGY EFFICIENT SCHOOL BUILDING HVAC SYSTEMS MONITORING PLAN

I. Boros^{a, *}, D. Stoian^a, V. Stoian^a, T. Nagy-Gyorgy^a

The paper presents aspects regarding the component of the HVAC system and their monitoring system of a school building, which use both energy efficient concepts and renewable energy solutions.

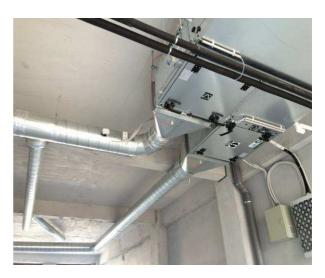
Figure 13. Ventilation unit sensors

The ventilation system is fitted with 5 temperature sensors on each unit. Sensors (Figure 12 and 13) are placed before and after the heat exchanger, both on the discharge circuit as on the suction circuit, respectively a sensor after the heating and cooling battery. This measuring system indicates the suction and discharge temperature to exterior and interior, recovered energy by the exchanger and the contribution of the batteries. Also to determine the losses on the ventilation circuit, sensors are placed on the farthest discharge ports of each system (Figure 15). The installation of the sensors in the air treatment systems is done the perforating the equipment metal sheet and their further sealing but using airtight closing.

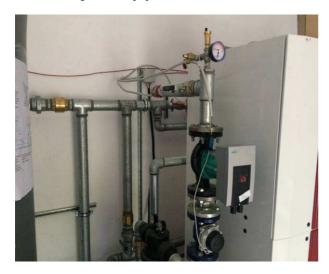
Figure 17. Equipment room flow meters

A number of 7 flow meters (Figure 16 and 17) were installed on the tour circuits of the heat and hot water sources: between drill holes and pumps, between pumps and buffer tank, between pumps and boiler, respectively gas station and distributor. Also, another 2 flow meters were placed on the tour circuit of the cold water supply and on the retour circuit of the hot water. The flow meters provide relevant information (Sarbu, 2016) about the contribution and the energy produced by the boreholes, heat pumps and gas stations for assuring the heat, cooling and hot water demand.
