**FUNCTION OF AGRICULTURAL TERRACES
IN MEDITERRANEAN CONDITIONS – SELECTED
EXAMPLES FROM THE ISLAND OF IKARIA
(THE SOUTHERN SPORADES, GREECE)***

Abstract: The aim of the research was to define the influence of agricultural terraces on slope erosion. There have been selected three plots located on the Greek island Ikaria. On the plots detailed geomorphological mapping was done, spatial relief models were created based on the measurements taken using GPS RTK, georadar profiles were made using RAMAC/GPR and the extent of destruction of terrace resistance walls was evaluated.

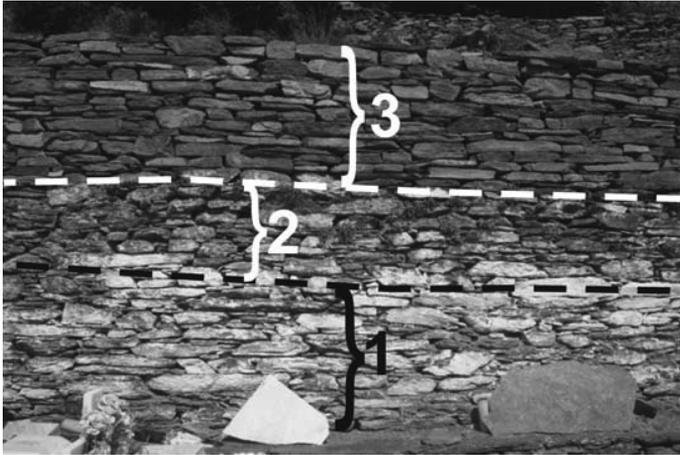
Fig. 7. Stages in the construction of a wall supporting a terrace

fragments used are diverse (from a few up to 50 cm) and they depend solely on local possibilities to obtain building material. The thickness of the walls (20-40 cm) was determined by the size of the stones used, which were put with their longer axis along the wall, the shorter one – crosswise and the shortest one vertically. The thickness of the wall was proportional to the width of the biggest stones. The wall structure proves that terraces were built in stages (Fig. 7), up to gaining a terrace of complex width, which would be a function of the slope gradient and the wall height ensuring its stability, determined probably on the basis of the local builders' experience. The beginning of each terrace system was the lowest terrace. It confirms the conclusions of other authors researching similar forms in the other parts of the world (e.g. Spencer, Hale, 1961, Treacy, 1987, Treacy, Denevan, 1994). On Ikaria this technique is also currently used.
