Full-scale Test of an Unreinforced Concrete Dome Plug for the Spent Nuclear Fuel Repository

In the planned Swedish repository for spent nuclear fuel, plugs are designed to close the deposition tunnels. The outer part of these plugs consists of a concrete dome made with self-compacting-concrete, designed to have low pH to reduce negative effects on the bentonite clay buffer. A full-scale test has been performed to evaluate the performance of the plug, to test the installation and to verify underlying design assumptions. In this paper, the behaviour of the concrete dome is evaluated based on measurements, from casting the concrete until it was subjected to 4 MPa hydrostatic water pressure.

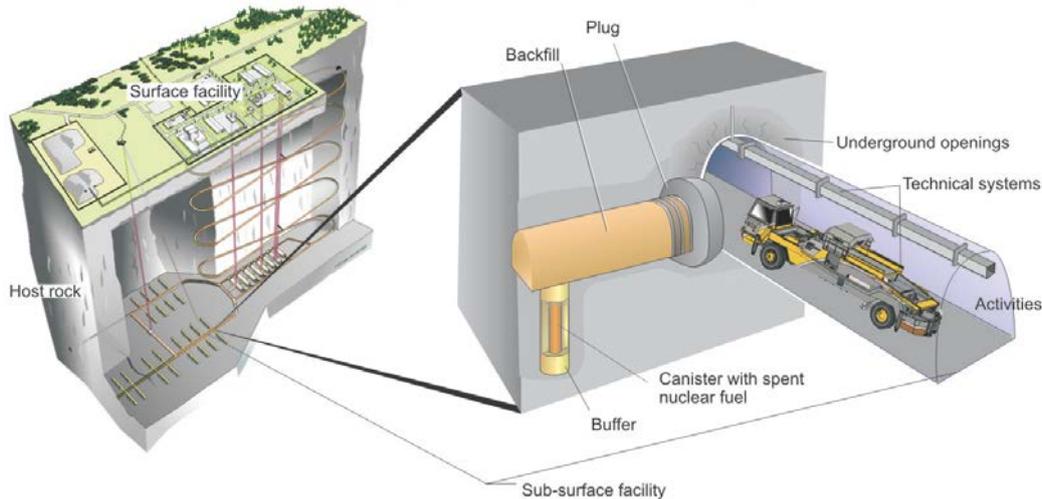
Figure 1 – Illustration of the KBS-3 repository, from [1].

seen in Figure 1. In total, about 100 deposition tunnels are planned to be built in the repository. The designed life-span of these plugs is only during the operation period of the repository, i.e. maximum of 100 years. When all deposition tunnels are backfilled and plugged, the adjacent main tunnel will also be filled with bentonite clay and in the end, all tunnels and shafts will be filled all the way up to the ground level, [1].

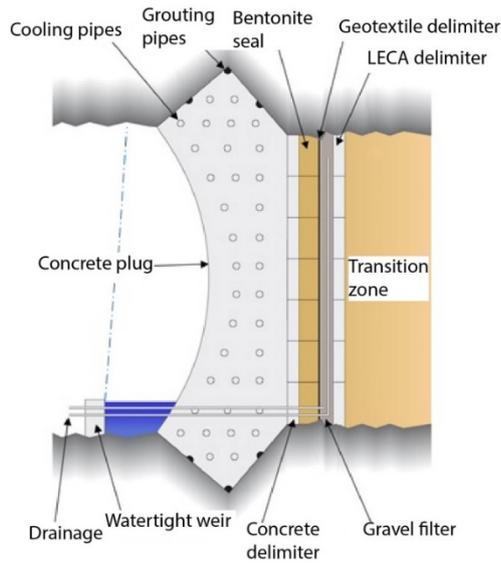
Figure 2 – Illustration of the reference design of plugs for the KBS-3 repository, from [1].

The plug used to seal the deposition tunnels consists of several material layers, each with its specific purpose, see Figure 2. The main parts of the plug are; filter, bentonite seal and a concrete dome. The filter is needed to control ground water inflow during casting and hardening of the concrete dome through drainage pipes. The bentonite seal is intended to be the water-tight seal of the plug and should thereby prevent that leakages occur from the backfilled deposition tunnel to the adjacent main tunnel. The concrete dome constitutes the mechanical resistance intended to transfer the loads from swelling pressure of bentonite and the hydrostatic water pressure to the surrounding rock. The concrete dome has an octagonal shape with a concave downstream surface, and thereby carrying the horizontal pressure loads as a dome. The concrete dome is unreinforced and built with a specially developed concrete mix that is intended to have a lower pH than conventional concrete. The low pH-concrete is described further in detail in the following section. Between these material layers, different delimiters are installed only to separate the materials. The delimiter closest to the concrete dome consists of concrete beams.

In the wire sawn slot, grouting pipes were installed as shown previously in Figure 2. The purpose of the grouting tubes was to ensure water tightness of the dome. In addition, the thermal pre-stress of the dome will minimize the risk of cracking and thereby lead to reduced leakage. After about three months, contact grouting was performed. The purpose of the contact grouting was to seal gaps that had occurred between the concrete dome plug and the surrounding rock. Due to the high amount of shrinkage during the first 90 days according to the experiments and the thermal cooling of the concrete dome plug, it was intended to create a gap between the rock and concrete plug. According to [3], the estimated gap due to shrinkage at the time of grouting would be about 3.7 mm in the top of the dome plug, under the assumption that the plug has released from the rock. In addition, since cooling was performed prior to contact grouting, the gap between concrete and rock was planned to increase even further up to 4.2 mm. First the inner tube on the upstream side was grouted and after this the outer tube, i.e. on the downstream side. Both were performed on the same day, June 11th, 2013. In the first stage, a total of 105 litres were used and the pressure was stable and ended at 10 bars. During the second stage, i.e. grouting of the outer tube, when about 42 litres of grout had been used, a small area with leakage of grouting could be detected near the top of the dome. The total amount of grout was about 93 litres where the final pressure was 10.7 bar. The third and final grouting stage was performed about one week after the first two. In the third grouting stage, the centre tube was grouted with a total of 406 litres, ending up with a final pressure of 61 bar, i.e. 6 MPa, with a pressure increase of 10 bar/min. During the grouting of the last tube, no leakage was detected by

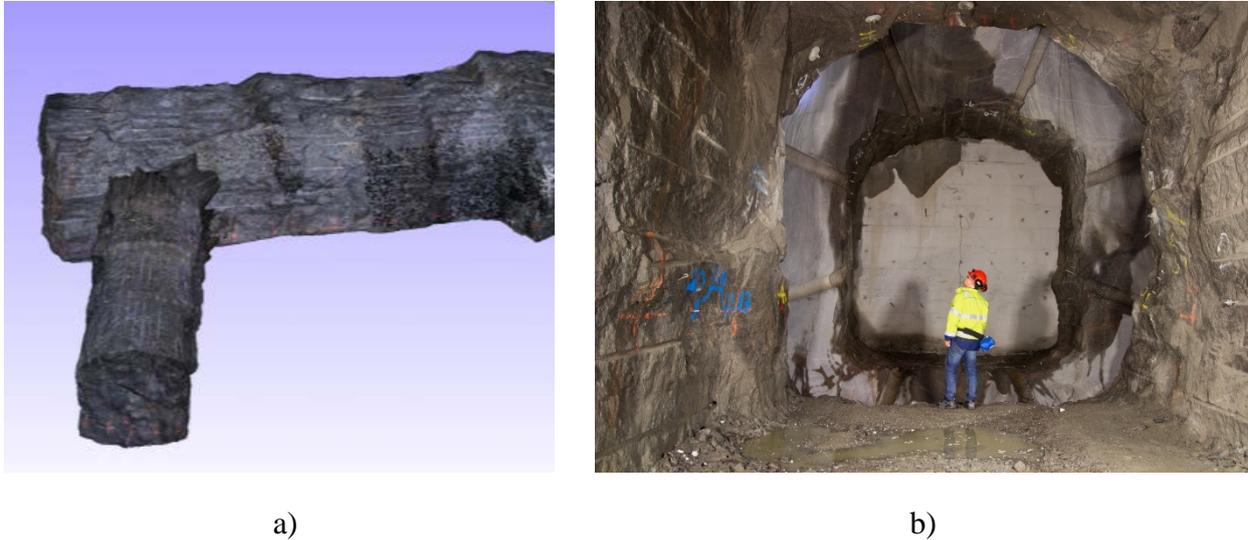
Figure 3 – a) Illustration of the excavated test tunnel based on laser scanning, b) Photo of the excavated slot, in the photo the project leader Pär Grahm (SKB) is shown.

drilling eight 250 mm cores from the downstream side and eight 250 mm holes from the upstream side that intersected the previously drilled holes. The holes were inclined to form an octagonal shape after this wire-sawing with a pushing cut was made to create the slot, see Figure 3 b).

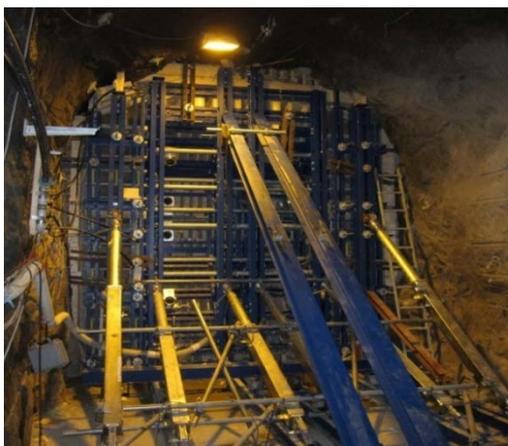
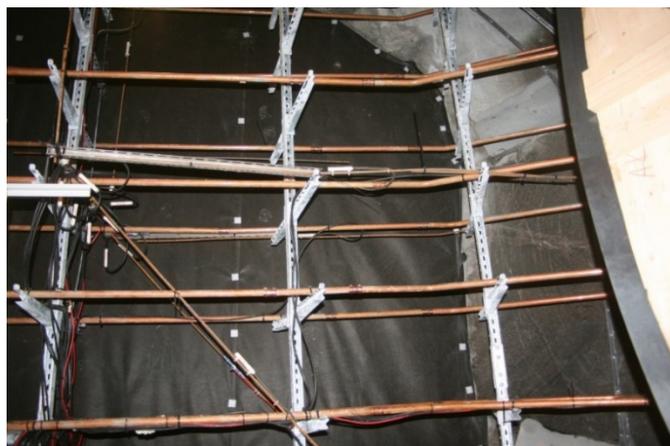
Figure 4 – Photos from construction of the dome plug, a) formwork, b) cooling pipes and their scaffolding.

The concave downstream shape of the dome and the use of self-compacting concrete resulted in a rather complex formwork designed to carry the full hydrostatic pressure, as seen in Figure 4 a). On the upstream side, the concrete beams act as formwork and a geotextile had been installed to prevent bond between the concrete dome and the concrete beams, as seen in Figure 4 b).

Cooling pipes were installed for cooling of the concrete dome. The cooling pipes were made of copper with a diameter of $\phi 25$ mm, and consisted of three separate sections where each section had a length of 80 m. Since there was no reinforcement in the concrete dome, a supporting steel scaffolding was installed to carry the self-weight of the cooling pipes, as seen in Figure 4 b). A design criterion for the steel frame was that it should not be attached to the rock in both the top and bottom, i.e. so that it could cause restraint forces in the concrete dome due to shrinkage. One cooling machine of at least 20 kW was needed for the cooling. However, since the cooling was vital for the construction, a redundant (backup) cooling machine was also placed on site, if the first one would fail for some reason. The flow of the cooling media was controlled by temperature where the allowed difference between inlet and outlet temperature was defined as 2 °C.

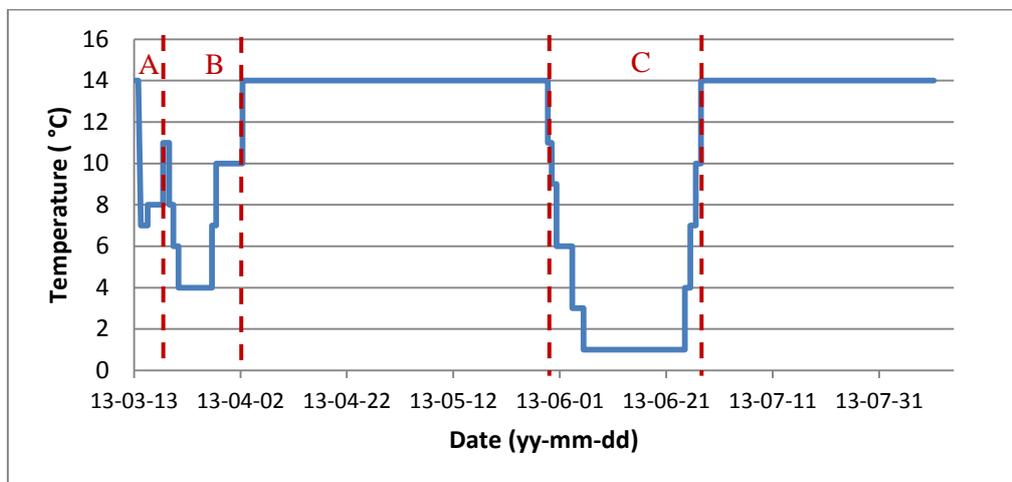
Figure 5 – Illustration of inlet temperature in the cooling pipes during the cooling procedure, with the three stages (A) cooling during hydration, (B) cooling to force the dome release from the rock and (C) cooling during contact grouting plug used in the full-scale test.

Considering that the concrete dome is unreinforced the intention was to allow for free shrinkage during the first three months. This would be achieved by an advanced cooling procedure, where the concrete was cooled during hardening (stage A) and when sufficient strength has been developed, the intention was to cool the concrete significantly to break the bond between concrete and rock (stage B). This procedure would thereby allow for free shrinkage and after about three months the concrete dome would be cooled once again (stage C) to make it shrink as much as possible to allow for contact grouting between the dome and the rock surface. The cooling during contact grouting would also result in thermal pre-stressing of the dome when the cooling was ended. The temperature in the tunnels was about 14 °C and the temperature in the inlet of the cooling pipes was at most reduced to 1 °C. The temperature in the concrete varied and was naturally higher than this, as later presented in Section 4.2. The cooling procedure of the dome is illustrated in Figure 5, where the three stages A, B and C are illustrated.

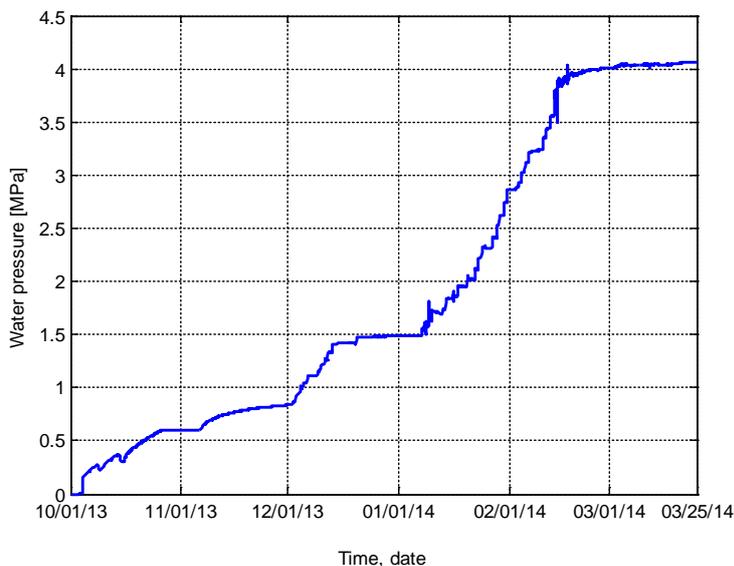
Figure 6 – Pressurization sequence of the plug, where the pressure was increased to 4 MPa.

The pressurization of the plug started initially with only natural inflow of water. After about 0.8 MPa of water pressure was reached in December 2013, the pumps started which continuously increased the water pressure until 4 MPa, i.e. a hydraulic head of 400 m, was reached. The intention was to increase the water pressure up to 7 MPa, however due to the conditions of the surrounding rock at the experimental site it was not possible. After the water pressure had been increased to about 3 MPa, a significant leakage in the rock occurred in the adjacent tunnel, about 15 m from the plug. Water leakage through rock fractures had been recognized as one major project risk since the rock at Äspö HRL is significantly fractured in general. Due to the encountered rock fracture, by-passing the plug, it was decided to limit the water pressure in the plug to 4 MPa and perform continuous measurements of the observed leakages at this level. This pressure could successfully be maintained by the water pressurization system for about three years. The pressurization curve from the full-scale test is shown in Figure 6.

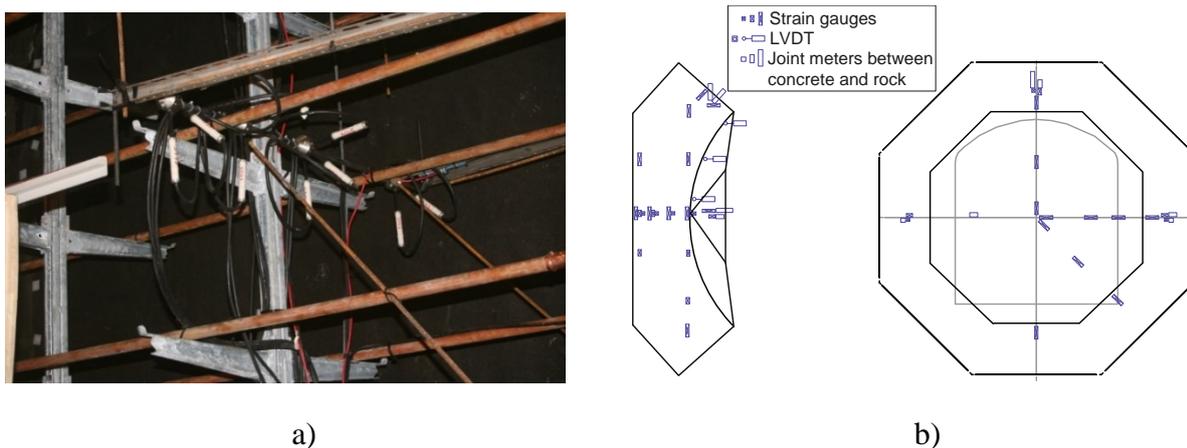
Figure 7 – Installed sensors, a) strain gauges in the centre, b) placement of sensors.

In this paper, the focus is on evaluating the early age behaviour and the response during initial pressurization. Therefore, all results from this full-scale test will not be presented in this paper. In Figure 7, a photo of installed strain gauges and cooling pipes is shown in addition to a sketch illustrating the placement of sensors.

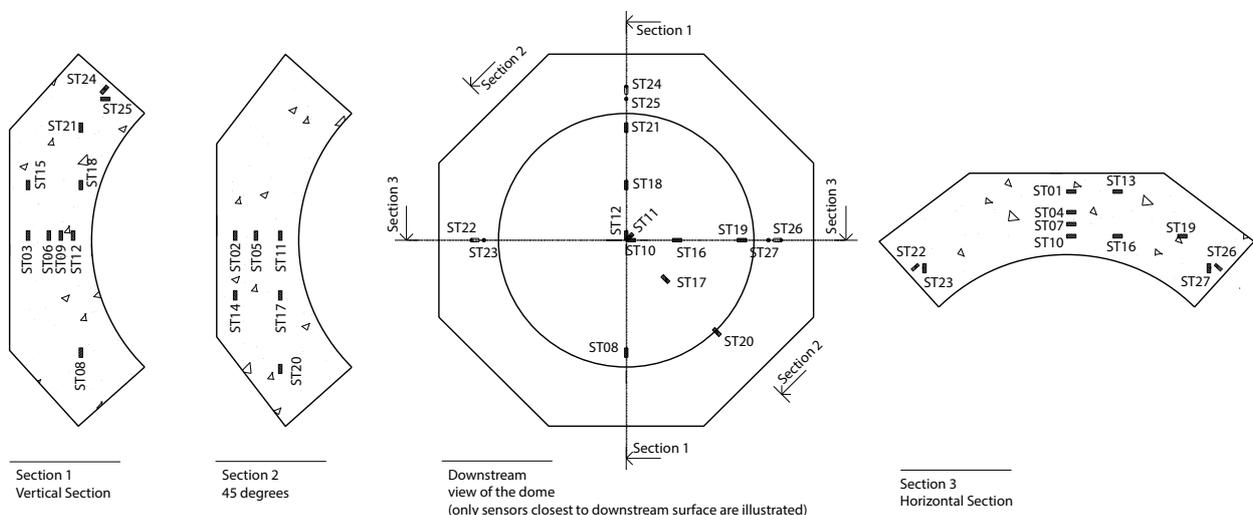
Figure 8 – Placement of installed strain gauges.

In total, 28 strain gauges were embedded in the concrete dome with the intention to capture its behaviour from hardening until the test was ended. The placement of all embedded strain gauges is illustrated in Figure 8. Sensors were placed at four depths in the centre of the dome and in three directions to capture the distribution of strain. In addition, several strain gauges were placed close to the interface between concrete and rock. Almost all strain gauges were placed on shorter reinforcement bars that were mounted on the cooling pipes, except for the strain gauges closest to the rock. In this case it was not possible to attach these to the cooling system, so instead reinforcement bars were installed in the rock on which the strain gauges were attached. The concrete cover was at least 400 mm for the sensors closest to the surfaces to minimize the risk of the sensors being subjected to high water pressure.

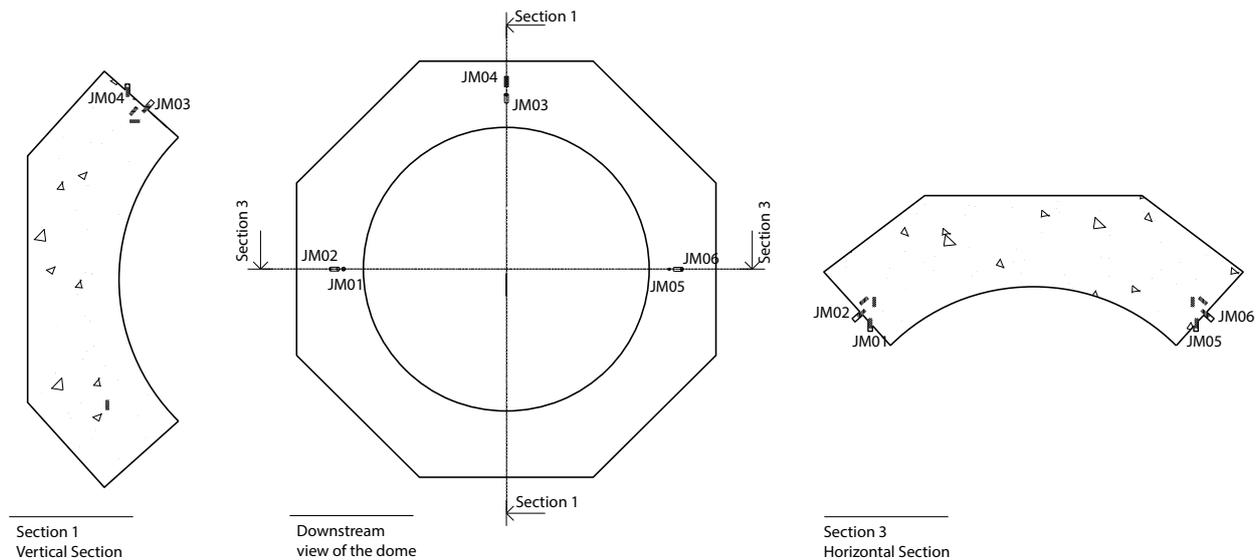
Figure 9 – Placement of installed joint meters gauges.

Joint meters were installed to measure the relative displacement between the concrete dome and the rock. In total, 6 joint meters were installed; two sensors each at the left- and right-hand side and two in the top. All these sensors were drilled into the rock at the downstream side of the slot, where one was placed perpendicular to the rock surface and the other one was placed vertically (in the top) or in the tunnel axis direction (left- and right-hand side). The intention of these sensors was to observe if the concrete dome released from the rock. It was expected that the concrete dome would release from the rock during the second cooling stage (B), and that the downstream side would be compressed when the dome was subjected the water pressure.

The joint meters measured the relative displacement between concrete and rock at six locations, as previously shown in Figure 9. The results up to the point after contact grouting is shown in Figure 12. As can be seen in Figure 12, the joint meters show small relative movement between concrete and rock which indicates no direct crack opening during the first stages. The maximum relative displacement is 0.1 mm during cooling prior to grouting (stage C). If the concrete dome had released from the rock, a relative displacement of about 4.2 mm had occurred according to [3]. This shows that the concrete dome did not release from the rock on the downstream side of the slot, at least not at these locations. The relative displacements are in general so small, and most likely corresponds to elastic strains in the concrete. However, all joint meters show a slightly larger value after grouting than before, which indicates that at least some parts of the slot have been grouted. The largest difference before and after grouting is seen on JM05 which measures the relative displacement in the tunnel axis and is located on the right-hand side (viewed from the downstream side).

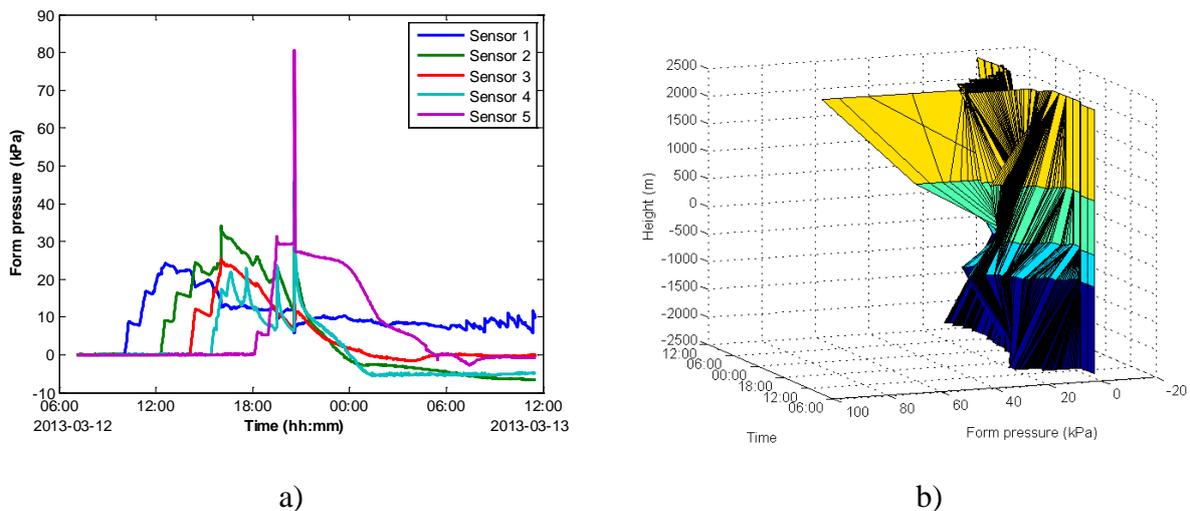
Figure 10 – Recorded pressure on the formwork.

The pressure on the formwork was measured at five locations over the height of the form/dome. The sensors were numbered from 1 to 5 based on their height above the ground, meaning sensor no 1 was at the bottom and sensor no 5 was close to the top. In Figure 10 a), the pressure is shown as a function of time, measured at each sensor and in Figure 10 b) the same result is

presented in a 3D plot (height, pressure and time). As can be seen, the maximum pressure at each location of the sensors occurs a few hours after the level of concrete reached that position. This means that the hardening of concrete in the bottom started before the whole plug was cast. Thereby, the maximum theoretical hydrostatic pressure of 160 kN/m^2 (at the bottom) never occurred. Instead the maximum pressure measured close to the bottom was approximately 25 kN/m^2 . The maximum form pressure was typically 35 kN/m^2 measured at all sensor positions. However, there was a significant increase measured at the sensor in the top where it increased from about 30 kN/m^2 to a maximum of approximately 80 kN/m^2 for a period of four minutes. This was however after casting was completed. According to the staff at site during casting, the contact grouting tubes were pressurized at the end of casting to cleanse the tubes. This pressure impulse, is likely a result of this action.

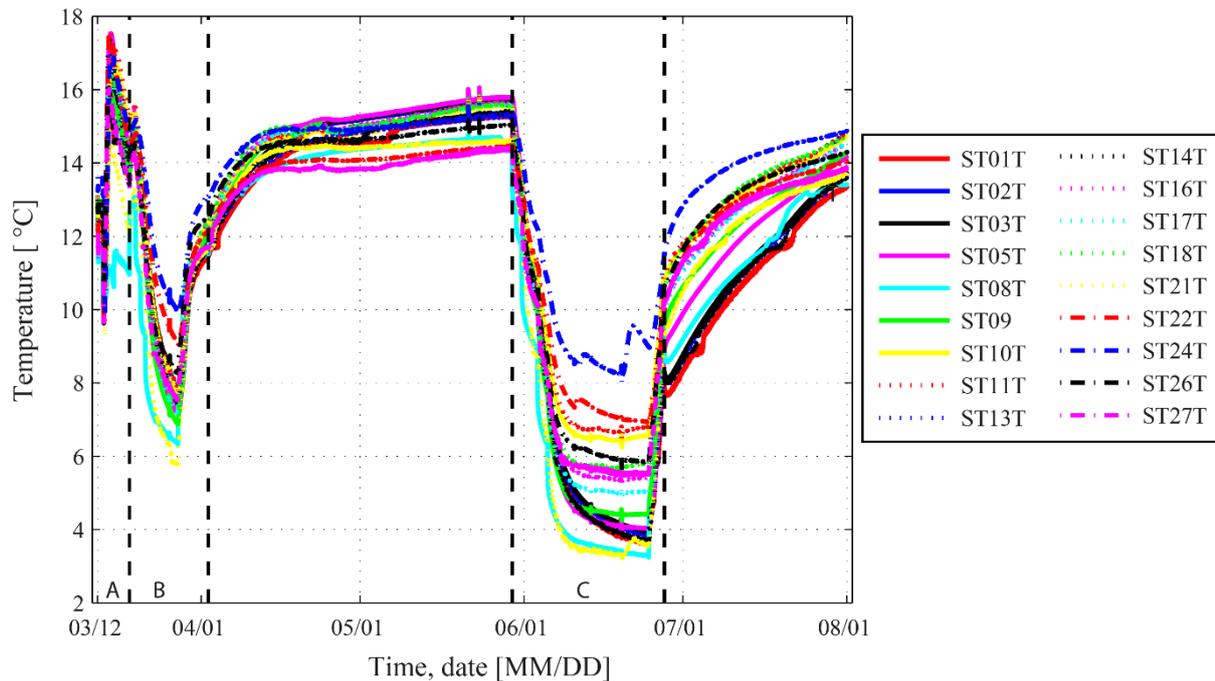
Figure 11 – Recorded temperatures in the concrete during the first five months.

Finally, after about three months, the cooling system was used once again to cool the concrete dome as much as possible to allow for effective contact grouting. During this cooling stage (C), the inlet temperature in the cooling pipe was reduced to $1 \text{ }^\circ\text{C}$ to create a large thermal pre-stressing of the concrete dome, i.e. to introduce compressive forces into the dome after the cooling was completed. The measured temperature during the cooling period prior to the contact

grouting (stage C), decreased to a minimum of 3 °C and was about 8 °C as maximum, as seen in Figure 11.

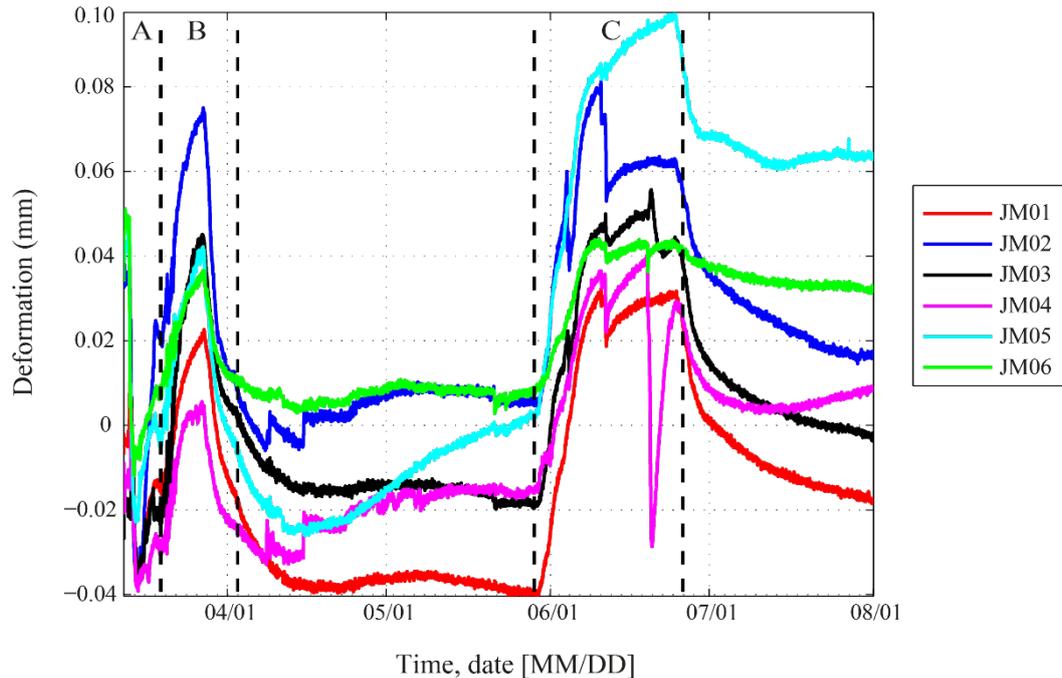
Figure 12 – Variation in relative displacement at the interface between concrete and rock.

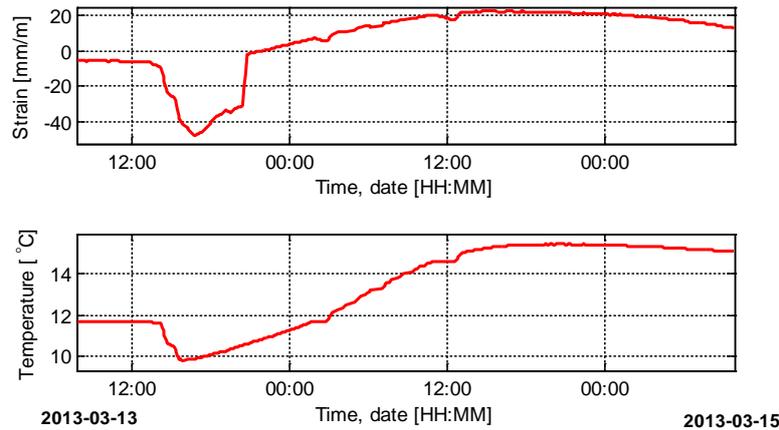
Figure 13 – Early strain/stress development in concrete. Measured strain development in the dome plug with a Geokon sensor (top), temperature development from the same Geokon sensor (bottom).

In the full-scale test, two different type of strain gauges were used. The strain gauges with larger flanges (Geokon 4200) at the ends, were significantly easier to evaluate regarding the early age behaviour since they quite early recorded reliable strains in the concrete. In Figure 13, the development of strain from one of these sensors is shown as an example for the early age strain development in the dome. In the figure, the corresponding measured temperature at this sensor is also presented. In the figure, the graph is presented from the start of casting (at 07:00 in the morning). The presented sensor is however located in the centre of the dome and hence was not embedded in concrete until about seven hours after casting begun.

For the other strain gauges, with smaller flanges it was much more difficult to capture the early behaviour since several sudden changes in strain occurred in these signals during the casting and early in the hydration process. Methods to find suitable zero-reference level for the strain gauges used in case have been presented by [3] and [6]. The determination of the zero-reference value is, however, only important for obtaining the absolute value of the strain and to predict induced stresses. In this case, it is more interesting to find the influence from the advanced cooling and to quantify the effect from the thermal pre-stress. Thereby, to achieve this only the relative difference of the strain before and after the third cooling stage (stage C) as shown in Figure 14 should be considered, which is described in Section 4.5.

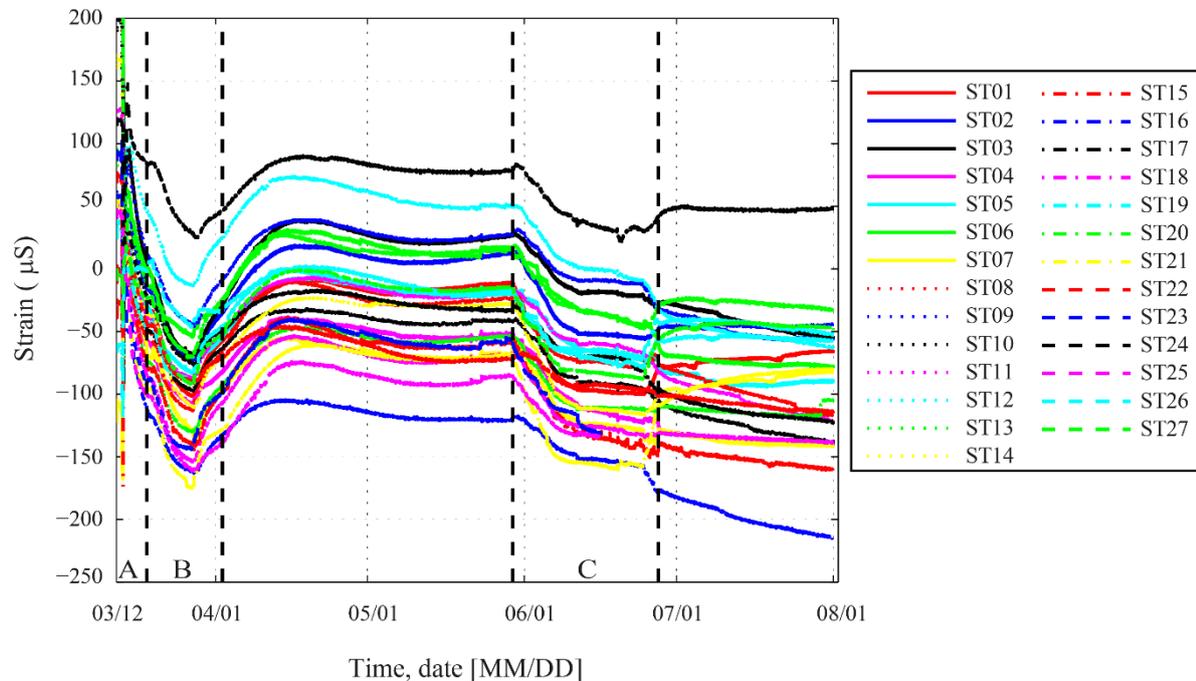
Figure 14 – Variation in measured strain based on all strain gauges.

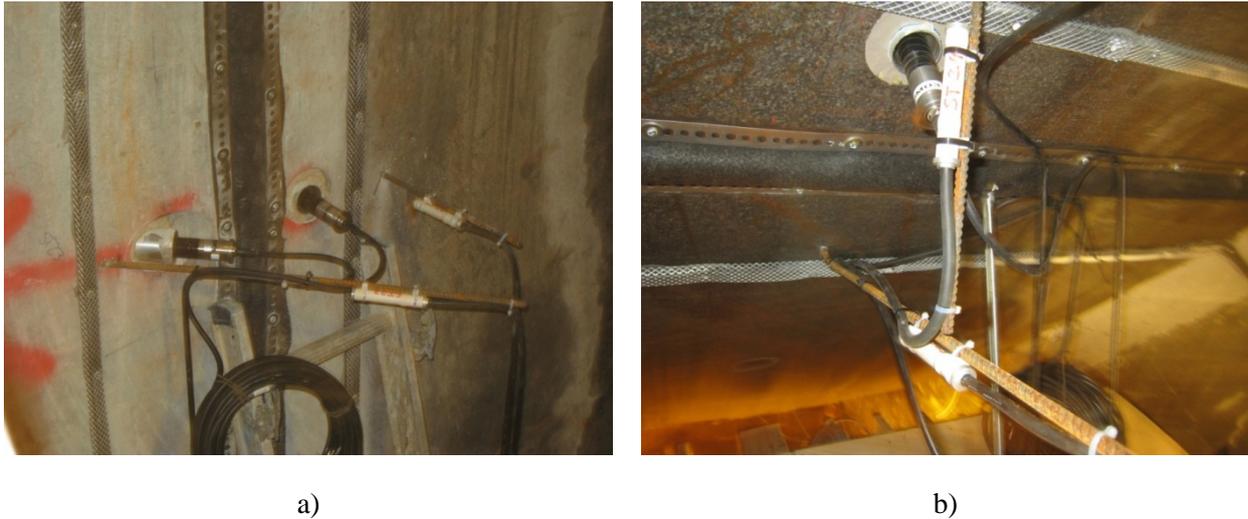
Figure 15 – Photos of strain gauges that failed during the third grouting, a) strain gauge ST23 and b) ST25. Also seen in the photo: the installed joint meters, a) JM01 and JM02 and b) JM03 and JM04.

Two of the strain gauges failed during the third and final grouting stage. The two strain gauges that failed (ST23 and ST25) were placed adjacent to the joint meters (JM01 and JM03). As it can be seen in Figure 15, these sensors were installed on reinforcement bars drilled in to the rock. However, these reinforcement bars were placed close to the centre tube that was grouted in the final grouting stage. It is therefore believed that the grout travelled along the reinforcement bar up to the strain gauges and the high grout pressure of 6 MPa destroyed these gauges.

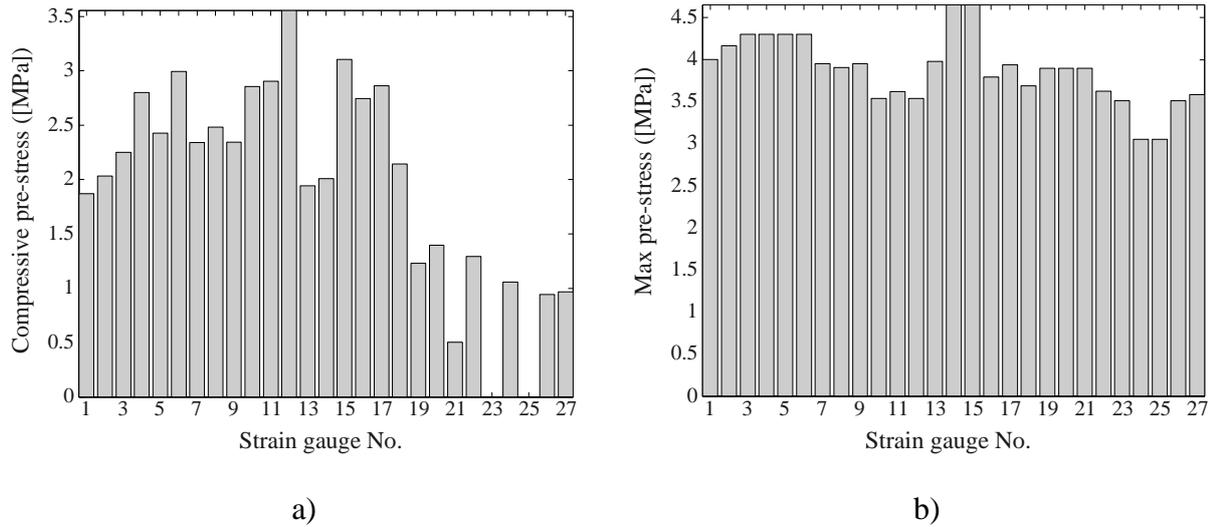
Figure 16 – Calculated effect from the thermal pre-stress during grouting, a) induced compressive strain based on the strain gauges, b) maximal stresses due to the variation in temperature.

To estimate the effect from the thermal pre-stress, the relative difference in strain before and after cooling stage C) was analysed for all strain gauges. The time points for the start and stop of the third cooling cycle was illustrated with two black lines in Figure 14. Here the strain difference has been multiplied with the elastic modulus of concrete (33.9 GPa according to [2]) to calculate the compressive pre-stress. The calculated compressive stresses induced due to grouting is presented in Figure 16 a). As seen in the figure, the thermal pre-stress (i.e. compressive) varies from about 0.5 MPa to 3.5 MPa in the concrete dome. It should be noted that the two strain gauges that failed during grouting are shown as zero stress in the figure.

If no grouting could be inserted between the concrete dome and the rock, then the strain would be identical before and after. For a case without bond between the concrete and rock, the full temperature reduction from cooling would result in thermal pre-stress. Here, the temperature difference is based on the difference in temperature for each sensor between maximum temperature during hydration (between 15 and 18 °C) and minimum temperature during cooling prior to contact grouting (between 3 and 8 °C). The maximum temperature during hydration is considered as the strain free temperature for the concrete. This is denoted as the maximum thermal pre-stress and is shown in Figure 16 b). Considering that the temperature varies in the concrete dome to some extent, this results in a variation in maximum theoretical thermal pre-stress between 3 and 4.5 MPa.

Finally, the ratio between the obtained strain difference before and after grouting (Figure 16 a) and the maximum thermal pre-stresses (Figure 16 b) indicates the degree of achieved pre-stress in the dome. By calculating the relative ratio of the induced pre-stress, the results are no longer dependent on the estimated elastic modulus of the concrete and is thereby only dependent on the measured quantities. It can be seen in Figure 17 that one sensor gives 100%, i.e. where the obtained pre-stress is equal the theoretical maximum. This sensor is denoted ST12 and is mounted in the centre of the dome, about 400 mm from the upstream surface and measures in the vertical direction. The two sensors close to this, ST10 and ST11 also show high utilization of pre-stress, about 80% of the maximum theoretical value. In common for the five sensors, that show highest achieved relative pre-stress, is that all are mounted on the upstream side of the dome. Most of the strain gauges show relatively low pre-stress compared to the theoretical maximum where the average utilization is 53%. Thereby, based on the calculated effect of thermal pre-stress it can be concluded that the dome plug had partially released from the rock and it is likely that the upstream side of the slot released to a greater extent than the downstream side (i.e. where the joint meters are located).

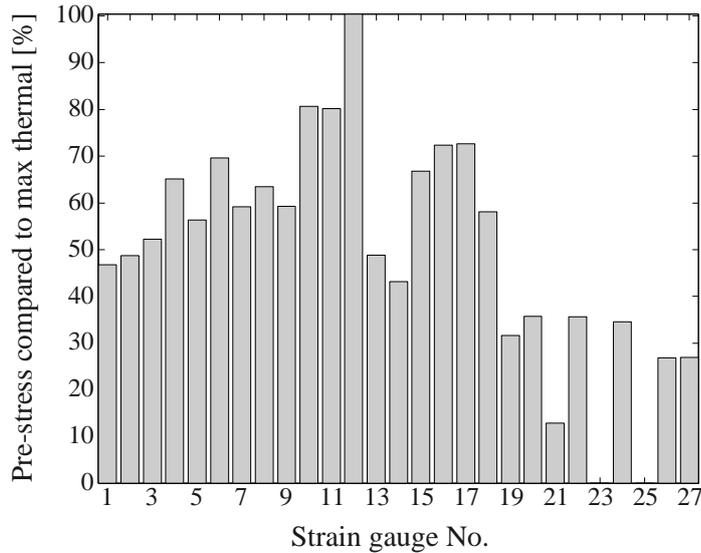
Figure 17 – Achieved pre-stress compared to maximum thermal stress.

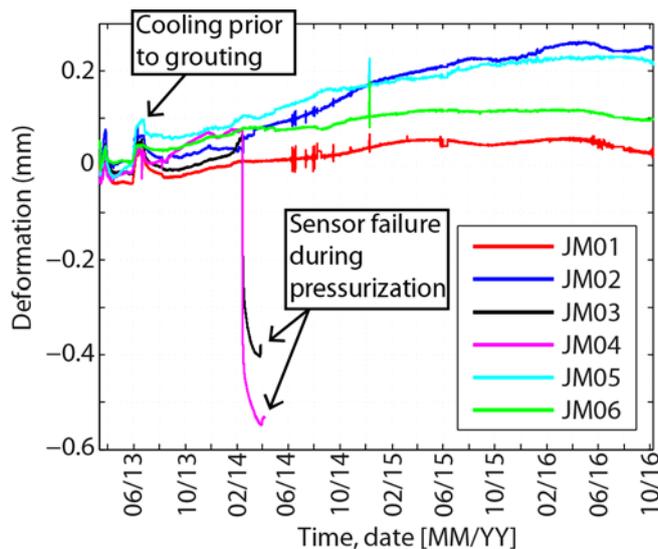
Figure 18 – Installed strain gauges.

As shown previously, the pressurization of the plug was performed to a water pressure of 4 MPa. When the water pressure reached about 3.5 MPa, a significant change for the two sensors in the top of the dome (JM03 & JM04) occurred as seen in Figure 18. This is likely caused by the dome releasing on the upstream side of the slot and thereby all loads are carried by to the downstream side of the slot in this region. Thereby, the joint meters were compressed and stopped recording reliable displacements when it was compressed beyond its measuring range. A water pressure sensor had been installed on the rock on the upstream side of the slot in this region. This sensor showed that water pressure increased in a similar manner as shown in Figure 6 before the sensor failed.

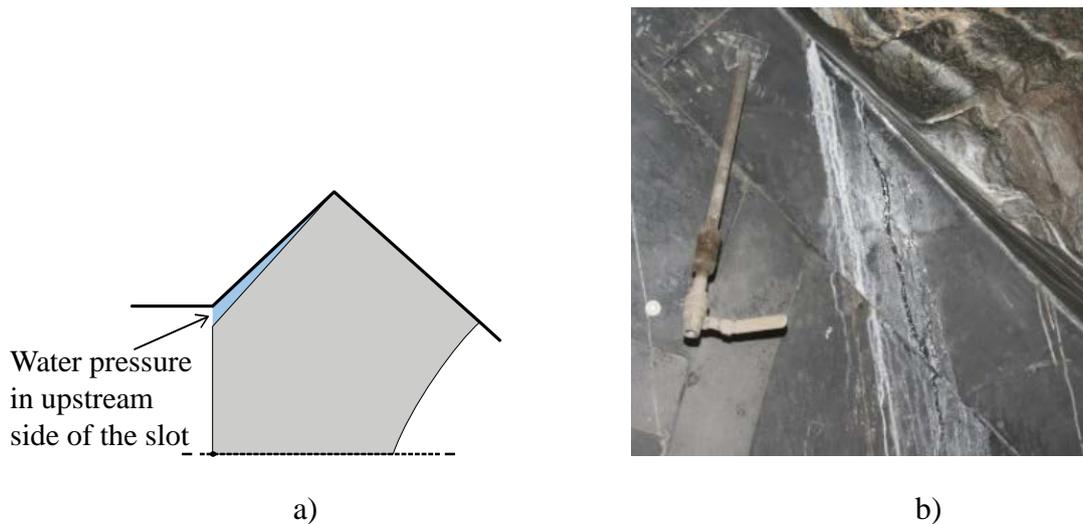
Figure 19 – a) Illustration of water pressure in upstream side of the slot, b) photo of small leakage near the top of the concrete dome.

Thereby, the concrete has most likely released on the upstream side of the slot in this region during the increasing water pressure, as illustrated in Figure 19 a). In addition, a small leakage

between concrete and rock was observed near the top of the concrete as seen in Figure 19 b). It should be noted that this is the same location where leakage of grout occurred during grouting. It is therefore likely that this location had not been sufficiently grouted which caused this leakage path. All leakage from the plug was gathered in a weir installed downstream of the concrete dome, see Figure 2. To prevent loss of water due to evaporation, a plastic sheet had been installed that enclosed the area upstream of the weir. From this weir, the leakage water was collected and measured automatically. The total leakage through the plug and the adjacent rock that was collected in the weir was 108 ml/min at this point and after this, the leakage at the top successively decreased and was 43 ml/min after 6 months, according to [1].
