Alkali-silica Reaction in Finnish Concrete Structures

Even though natural phenomena do not abide to borders, Finland has traditionally been considered an alkali-silica reaction (ASR) free country. This is due to exceptional quality of the mostly coarse crystalline igneous rocks. However, during the last few years dozens of cases of ASR have been reported. The scope of this study was to study the occurrence of ASR, and to find out the initiation time of the reaction in recent investigations of Finnish concrete structures. ASR is found occurring all over Finland. The reacting aggregates consist of rock types, which are considered relatively stable or low reacting in literature.

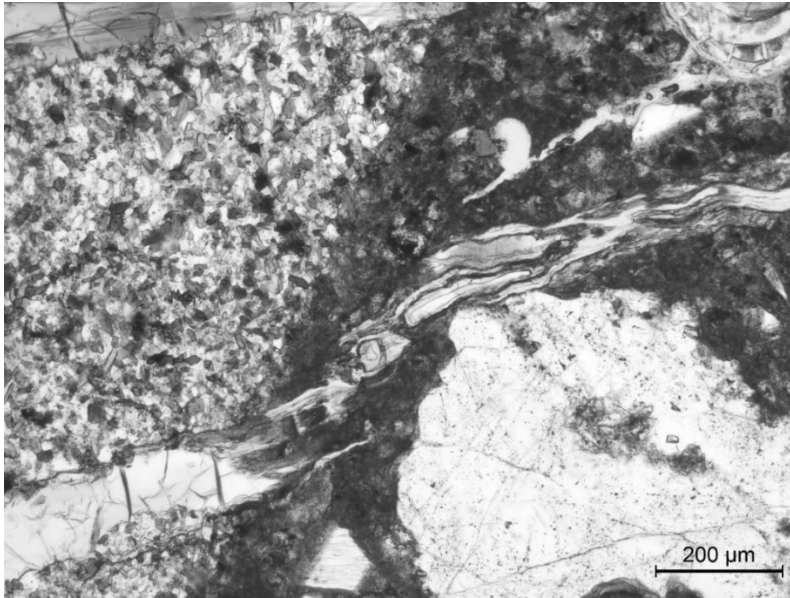
Figure 2 – Alkali-silica gel filling a crack propagating from the reacting aggregate the crack in concrete.

ASR is a heterogeneous chemical reaction, which takes place in the aggregate particles between the alkaline pore solution of the cement paste and reactive silica in the aggregate [10]. The pore water must contain sodium (NaOH) and potassium (KOH) hydroxides and the aggregate must contain minerals with low resistance to alkalinity [15]. The reaction forms alkali-silica gel, which has the property of absorbing lots of water from the surroundings, causing the volume of the gel to grow, which leads to internal pressure of aggregate and finally also in the pore system of concrete. When the internal pressure exceeds the tensile strength of concrete, cracks appear in the concrete structure allowing the relatively soft gel to extrude through them [15, 19], see fig. 2. Far advanced ASR can be detected by naked eye from cross section of concrete sample, see fig. 3.

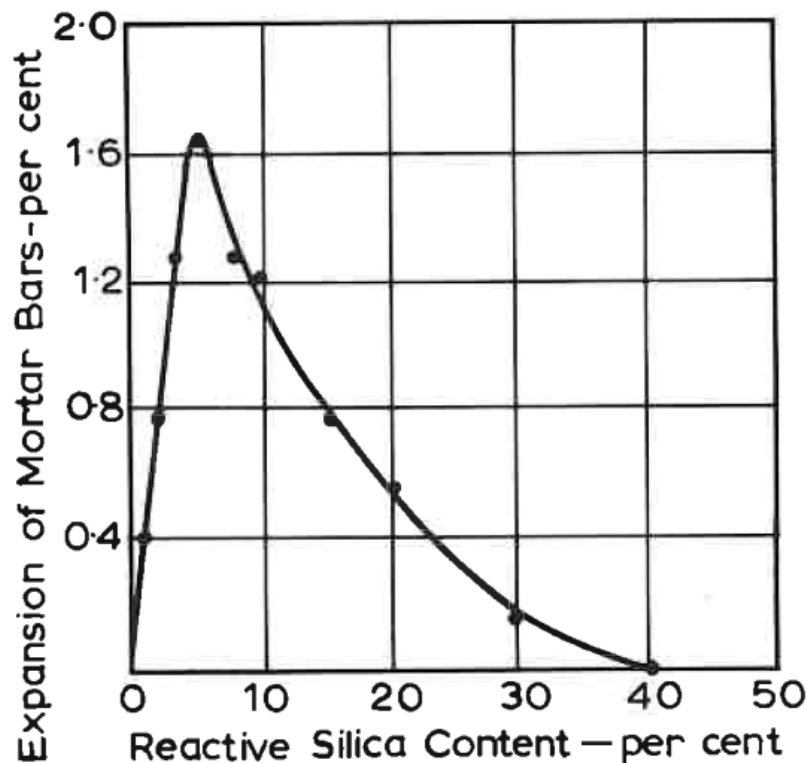
Figure 4 – Dependence of the expansion reaction in function of the silica content [15].

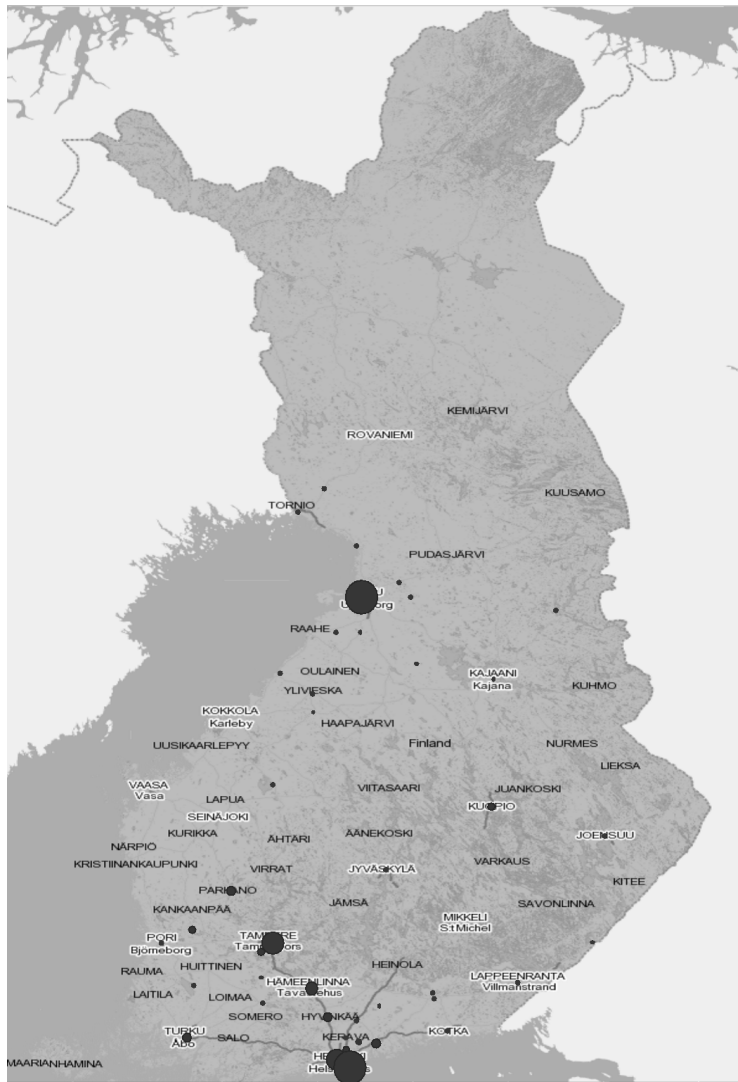
Figure 5 – The locations of detected ASR cases.

Of the 84 cases, in which ASR had been found, 16 were facades and balconies, 23 bridges, 6 swimming pools and 7 other concrete structures. Most of the cases were in Oulu (16), the capital area (15) and Tampere (5), see fig. 5. ASR cases are not concentrated in one geographical area, but spread across Finland. ASR is mostly detected in the areas where there is built environment. Therefore, in Lapland where there is less built environment and renovation activities, there has been no reported data on ASR.
