# PRODUCTION ENGINEERING ARCHIVES

## Irregular operation of autonomous vehicles

Accident reconstruction,  
Autonomous vehicle,  
self-drive  
crash  
Vehicle Movement Simulation

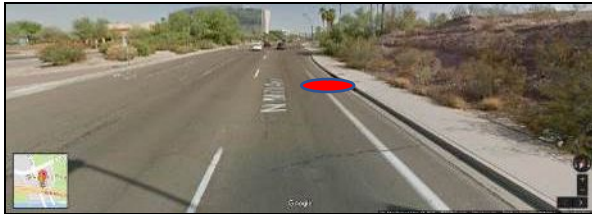
**Fig. 2.** The collision location (Google Earth)

Figure 2 shows the street view, where the location of the collision was specified.

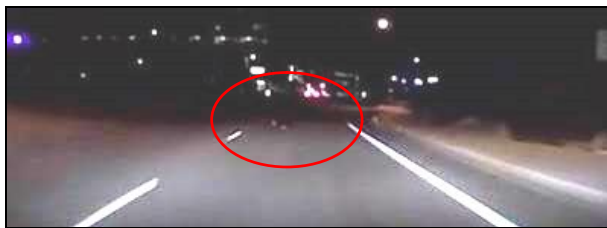
**Fig. 3.** The moment of pedestrian perception (Youtube, Abc Action News)

Figure 3 is a screenshot from the video when the pedestrian becomes visible to a driver.

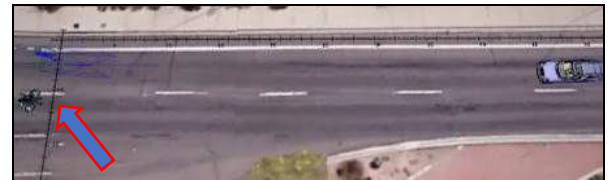
**Fig. 5.** The mutual position of the participant's T – 2,5 sec

Figure 5. shows the next situation when the pedestrian reached the lane along which the Volvo car was travelling. The vehicle is then approx. 43-47 meters, pedestrian approx. 4-5 meters from the point of hitting. In this case, a vehicle with an intensive brake manoeuvre can be stopped.

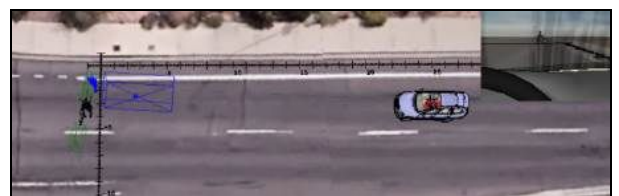
**Fig. 6.** The mutual position of the participant's T – 1,25 sec

Fig. 6 depicts a simulated moment corresponding to Fig. 5. The vehicle is then approx. 20 to 25 meters from the collision site. From this distance the vehicle with an emergency brake manoeuvre cannot be stopped before the pedestrian's travel path.

Based on this, it can be stated that the pedestrian became visible to the human driver within the braking distance. The collision was inevitable with normal operation.

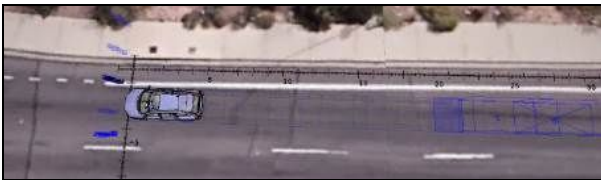
**Fig. 8.** The accident process in the case of adequate autonomous function

It can be calculated in case of 1,3 seconds before the occurrence, if, as a reaction point, the time when the pedestrian is seen on the video for the first time is chosen, or the self-drive system determined an emergency braking manoeuvre, and 0.1-0.3 seconds of self-drive system "reaction time" and the slowdown of emergency braking is taken into consideration, then Figure 8 depicts the simulated moment. In the case

under investigation, the pedestrian goes out of the path of the vehicle (time avoidance), but if the pedestrian had not even left the lane, then the speed of collision would have been one third of the real speed (about 18-25 km/h).

Based on the investigation of the avoidance of the accident, it can be stated that the detection and determining of the self-drive system was correct. According to own calculations, the Volvo could have been stopped before the pedestrian's travel path, 2.5 to 6 seconds prior to the accident.

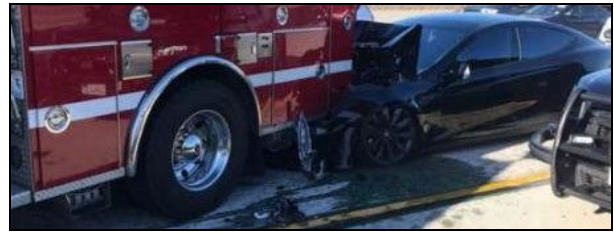
**Fig. 9.** The end position of the collision

In the case of the second accident, before the collision; the Tesla was travelling at 104 km/h. Based on the damage pictures, the collision speed can be estimated - approx. 40-45 km/h. It follows that the vehicle decelerated before the collision. There is no information available that the self-drive system or the human driver brake the vehicle.

Based on the speed of travel and collision, the Tesla started breaking at approx. 45 to 55 meters before the point of the impact. Figure 9 shows the end position of the collision.

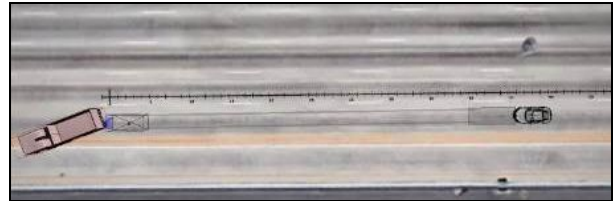
**Fig. 10.** The beginning of the car's braking  $T = -2,5$  sec

Figure 10 shows the start of braking.

Taking into account the reaction times, if the self-propelled system had started to brake, then the stationary car would have become recognizable 50-60 meters before the collision, if the human driver had recognized the emergency, then the reaction point would have been approx. 73 to 78 meters.

Following the breaking, the Tesla car collided with the left rear corner of the fire truck.

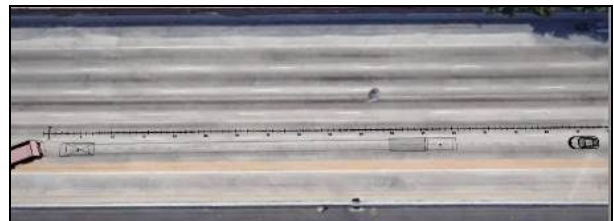
**Fig. 11.** The case of the safely standstill of the Tesla

In order for the Tesla car to stop safely behind the fire truck the self-drive system should have recognized the danger before the point of impact approx. from 62 to 67 meter, the human driver approx, from 82 to 87 meter. Figure 11. illustrates the breaking process with human reaction time.

It can be stated that the autonomous system detected the obstacle but approx. 15-20 meters, and approx. 1 to 1.5 seconds earlier would have been necessary to detect an emergency.
