# Geodetic monitoring of earth-filled flood embankment subjected to variable loads

Przemysław Kuras<sup>1\*</sup>, Łukasz Ortyl<sup>1</sup>, Tomasz Owerko<sup>1</sup> and Aleksandra Borecka<sup>2</sup>

## Abstract

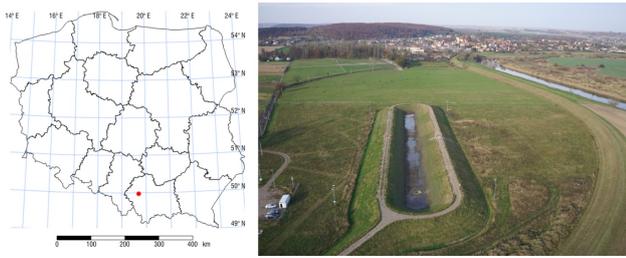
**Figure 1.** Experimental flood embankment – bird's-eye view (photo: S. Bazan)

In order to achieve the assumed goals, a temporary 4.5-metre experimental flood embankment was built on the terrace of the Vistula River, about 30 km from Kraków (Poland), consisting of two 180-metre parallel sections connected to each other in the form of a closed elongated ring (Fig. 1). The embankment formed a small reservoir that was filled periodically during the experiments in a way reflecting the passage of flood waves typical for the Upper Vistula basin. It had the form of a classic embankment (Tab. 1). All slopes were protected by a sod, and a temporary road made of hardened stone gravel was built on the embankment's crest.

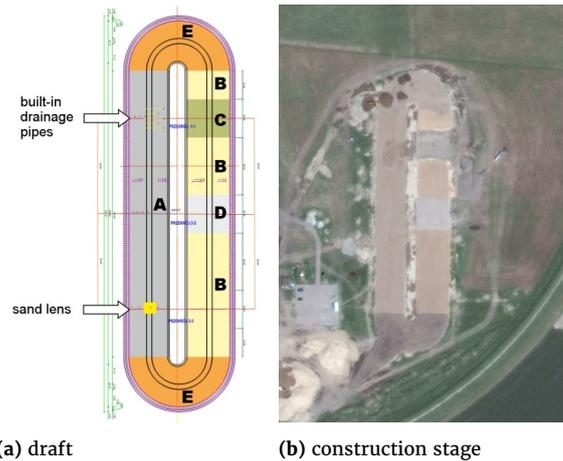
**Figure 2.** The distribution and type of material constituting the embankment (image source: Google Earth)

Various soil materials were used for the construction of the embankment (marked in Fig. 2 with the following symbols: A, B, C, D, E) originating from adjacent areas. They are characterized by variable granulometric composition from medium sand/silty sand (MSa/siSa) to loam (saclSi) and different coef-

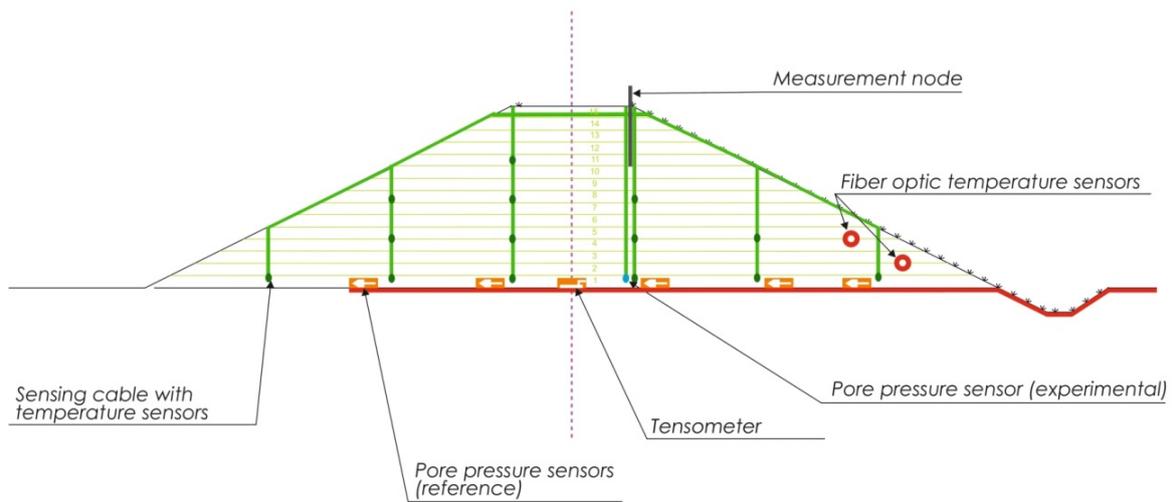
**Figure 3.** General location scheme of the sensors of experimental and reference measurement network placed in the experimental flood embankment (Sekula et al., 2017)

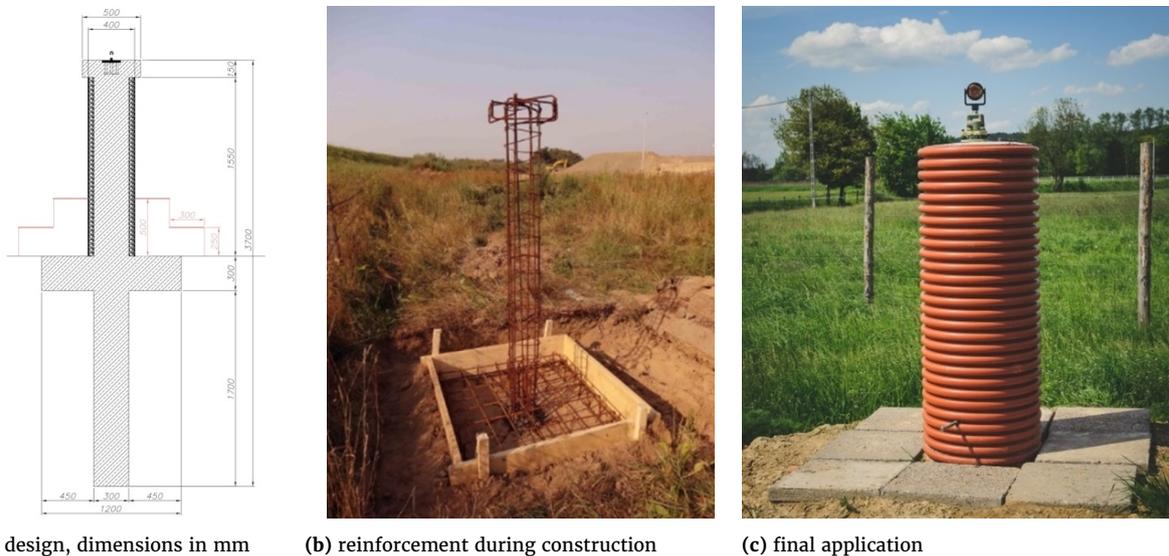
**Figure 4.** Observation pillar constituting a reference point

(a) design, dimensions in mm (b) reinforcement during construction (c) final application

which were designed as reinforced concrete pillars providing forced centering provided by a brass plate with a central screw. In addition, the benchmarks were installed on the pillars as reference points for height measurements, however the development of these measurements is not the subject of this publication. The aboveground part of the pillar was encased with a casing pipe, which was filled with thermally insulating material.

The basis of the network were reference points (Fig. 4),

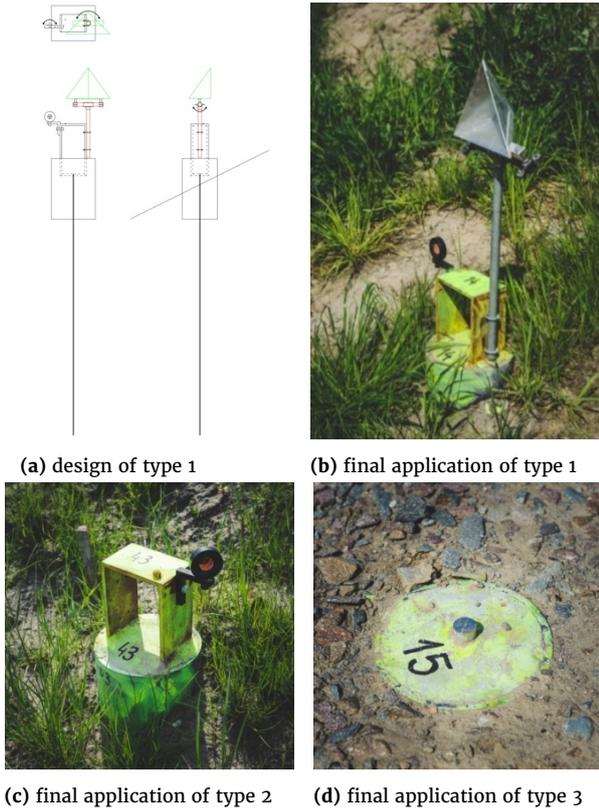
- type 1 (14 pieces) – for radar, tachymetric and levelling observations,
- type 2 (18 pieces) – for tachymetric and levelling observations, established on the embankment slope,
- type 3 (16 pieces) – for tachymetric and levelling observations, established on the embankment crest.

All types of markers consist of a steel rod with a length of 1.5 m set in the ground, finished at the top with a concrete stub. The type 3 marker has a pin embedded in a concrete stub, which acts as a benchmark, with a hole constituting the center. Determining the position of these points required temporary

Figure 5. Design and final application of observation markers on the structure

Three types of survey markers (Fig. 5) were designed and installed in the field:

centering using a tripod and plummet. Permanent stabilization was impossible, because the technological road ran along the embankment crest. For type 1 and 2 markers, it was planned to embed a steel profile in the concrete stub, allowing for permanent installation of the benchmark and both prism and radar reflectors, which can be rotated in any direction without changing the center's position. Type 1 and 2 markers were installed on slopes and foreground of the embankment. Type 1 markers were installed on the western levee, which was observed with an interferometric radar, however the development of these measurements is not the subject of this publication.

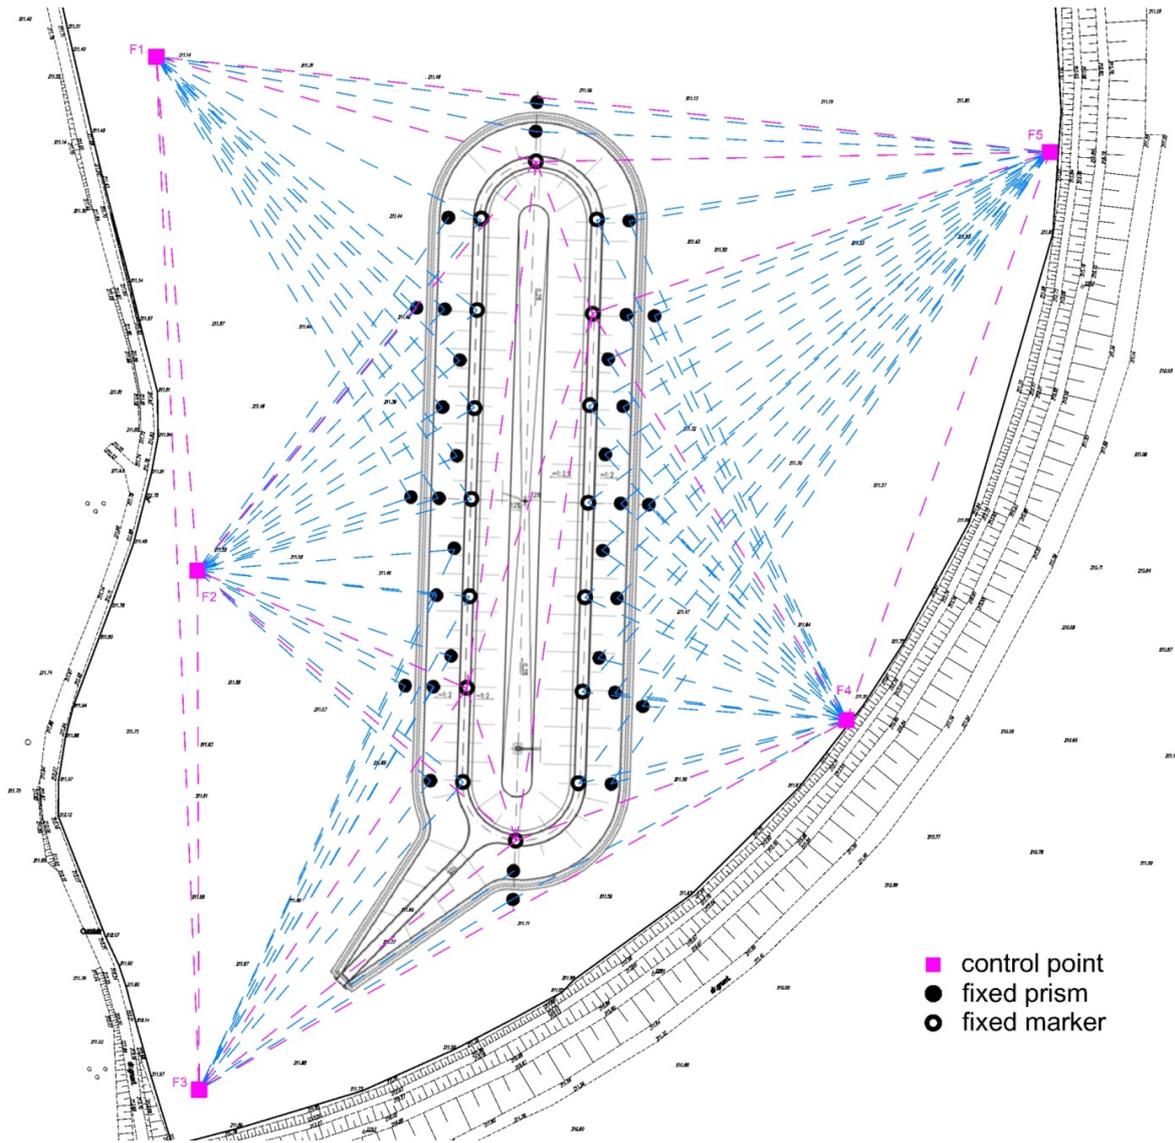
Figure 6. Observations in control network (violet lines – measurements between reference points, blue lines – measurements to the survey markers)

The designed and finally established angular-linear observation network consists of 5 observation pillars and 48 survey markers (types 1, 2 and 3). The distribution of points is shown in Fig. 6. Each periodic measurement included ca. 130 directions and 130 distances. With the exception of two survey markers, partially obscured by terrain obstacles, the position of remaining 46 survey markers were determined by redundant measurements. The surveying was performed with a robotic

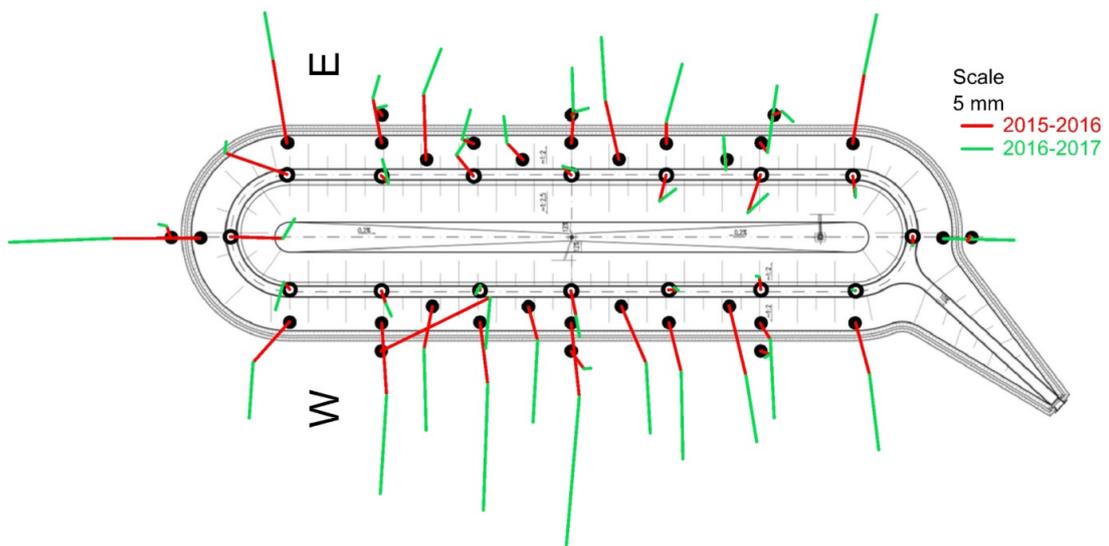
Fig. 7 shows the displacement values for both long-term intervals: 2015–2016 and 2016–2017. The results clearly indicate the dominance of displacements outside the reservoir for points located on the embankment. Points on the crest do not show significant movements (visible vectors may result from centering errors), like those on the foreground (except one, north-west point, which had been defectively established in the field).

Figure 7. Long-term displacements

The cause of the displacement may be the influence of atmospheric factors (e.g. soil freezing), vehicles moving on the embankment body or vestigial subsidence of the newly built embankment. Another explanation may be the frost heave of the soils used for the construction of the embankments causing swelling effect particularly in their upper part. In addition, points located on the western embankment show approx. 1.7 times larger displacements than on the eastern side, which may result from the diversification of soils forming the two embankments.

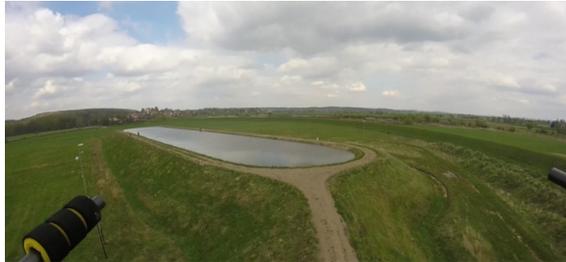
Figure 9. The reservoir filled with water – bird's-eye view (photo: S. Bazan)

During conducting a series of tests on flood embankment, the influence of the increase (Fig. 9) and decrease of the water level on the levee's behaviour was checked. As a result of numeri-

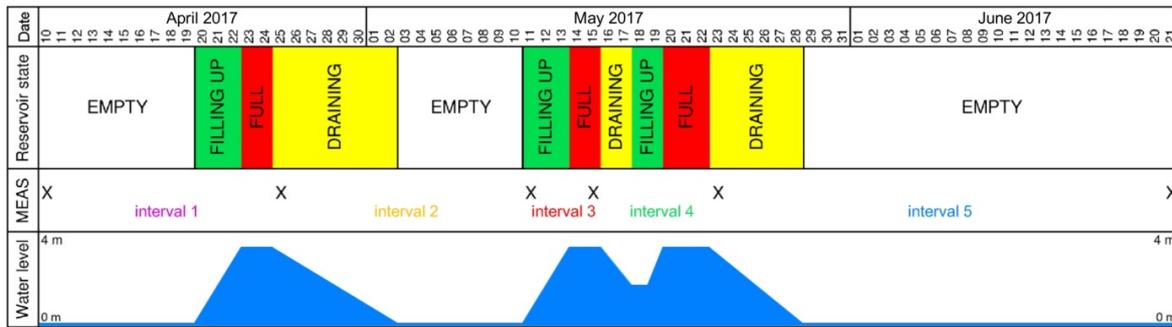
The course of the experiment simulating the flood wave is shown in Fig. 11. The periods of filling up and draining the reservoir are marked, as well as the water level. The "X" symbol indicates the days when the geodetic angular-linear network was measured in order to determine displacements of the embankment.

Figure 11. The course of the experiment with the marking of surveying measurements days

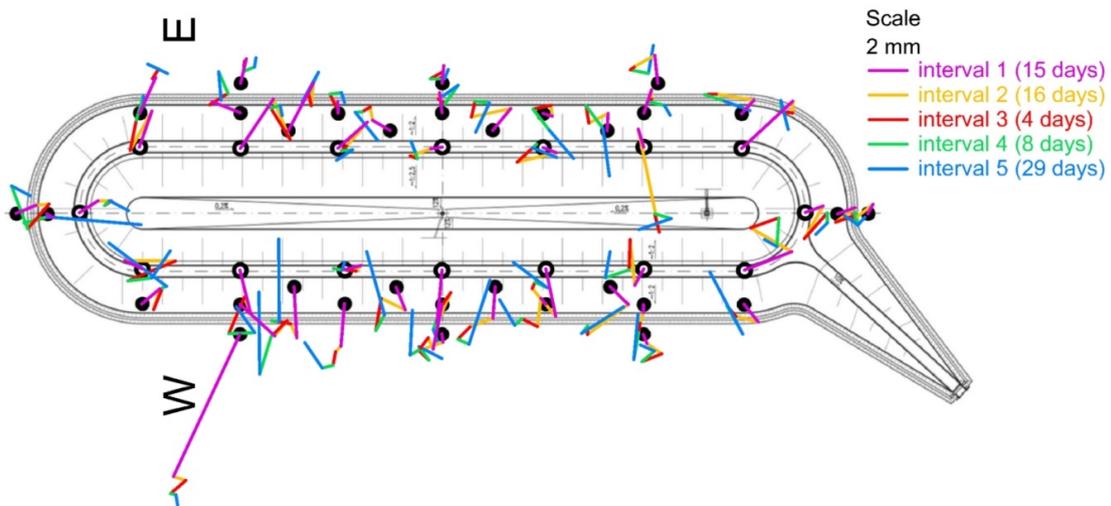
The method of determining displacements was analogous to the long-term monitoring, thanks to which the obtained measurement accuracy was equally high. The reference points F1–F5 invariably remained stable and served as the reference base for determining displacements of the remaining points. The results of displacement determination for all five time intervals are presented in Fig. 12.

Figure 12. Displacements determined during reservoir filling

Due to the low values of displacements, often at the level of their determination errors, the graph seems to be quite illegible. For this reason, only the E-W components of displacements were selected for further calculations, as they were expected in numerical analyses. In addition, points were divided into groups according to the height of their foundation, as in Chapter 4.1. Averaging the values of displacements (Tab. 7) allows to perceive some tendencies (Fig. 13).

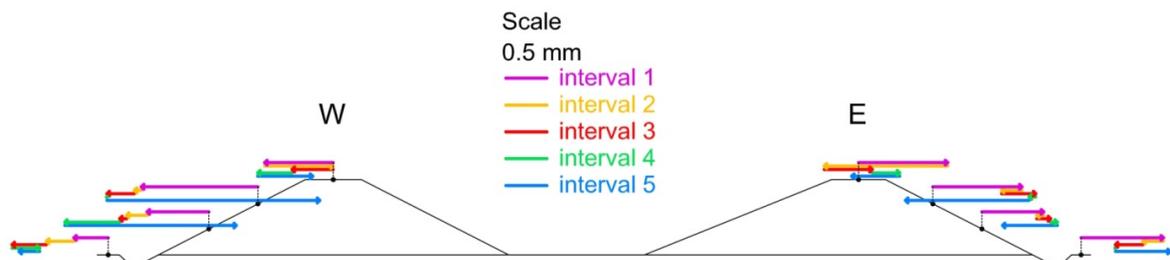
In the interval 1 the reservoir was filled with water and the embankment was soaking for a few days. All observed points then showed movement outside of the reservoir by an average of 1.2 mm. Then, in the interval 2, when the reservoir was emptied, the opposite tendency of points located on the crest was visible. The remaining points did not show significant (more than 0.5 mm) changes in location. In short intervals 3 and 4, when the reservoir was filled twice, the displacement val-

ues are small (0.3 mm on average), although there is a tendency of movement outside the reservoir for points located on the embankment. Finally, in a relatively long interval 5, when the levee could dry up, the points located on the embankment clearly moved inside of the reservoir (1.6 mm on average), returning more or less to their position before the filling experiments had started. It is illustrated by the values marked as  $\Sigma$  in Tab. 7, which are smaller than 0.5 mm in most cases. This return tendency is not shown by points on the foreground, for which a 1.0–1.5 mm displacement outside the reservoir can be found.

Figure 13. Average E-W displacements determined during reservoir filling for groups of points situated at the same height

On the basis of the above analysis, the relation between water reservoir soaking and the directions of embankment movement can be noticed. During periods of filling the reservoir and for some time after its draining, when the levee was still saturated with water, movements outside the reservoir were revealed. On the other hand, the following long period of drying caused movement in the opposite direction.
