MEASUREMENT OF DEFLECTION LINE ON BRIDGES

Rudolf Urban, Martin Štroner

Department of Special Geodesy
Czech Technical University in Prague
Faculty of Civil Engineering
Prague, Czech Republic

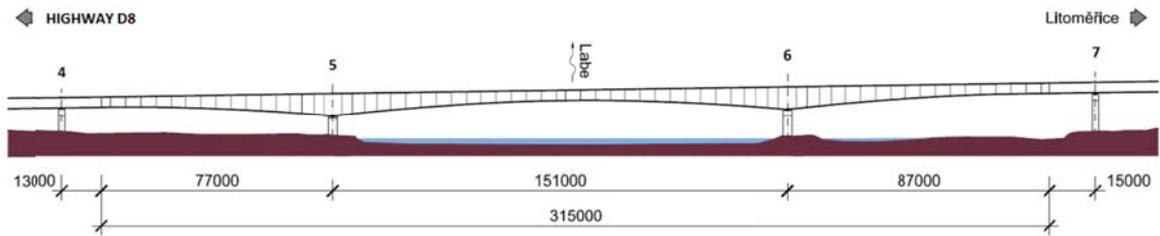
Fig. 1a. Longitudinal section of superstructure

The width of the bottom deck is 7.5 m; the width of the upper deck is 14.5. The main structure span (length 151 m) and neighbor spans (length 90 and 102 m) were constructed by balanced cantilevers method. These spans are made by two cantilevers with tapered cross section height (varies from 3.5 m in the middle of the span to 7.5 m above supports) and changing thick of the bottom slab (varies from 270 mm to 1200 mm) – see Fig. 1.

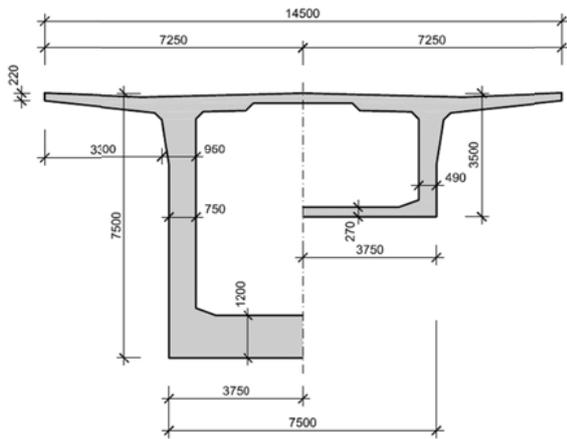
Fig. 1b. Cross section of superstructure

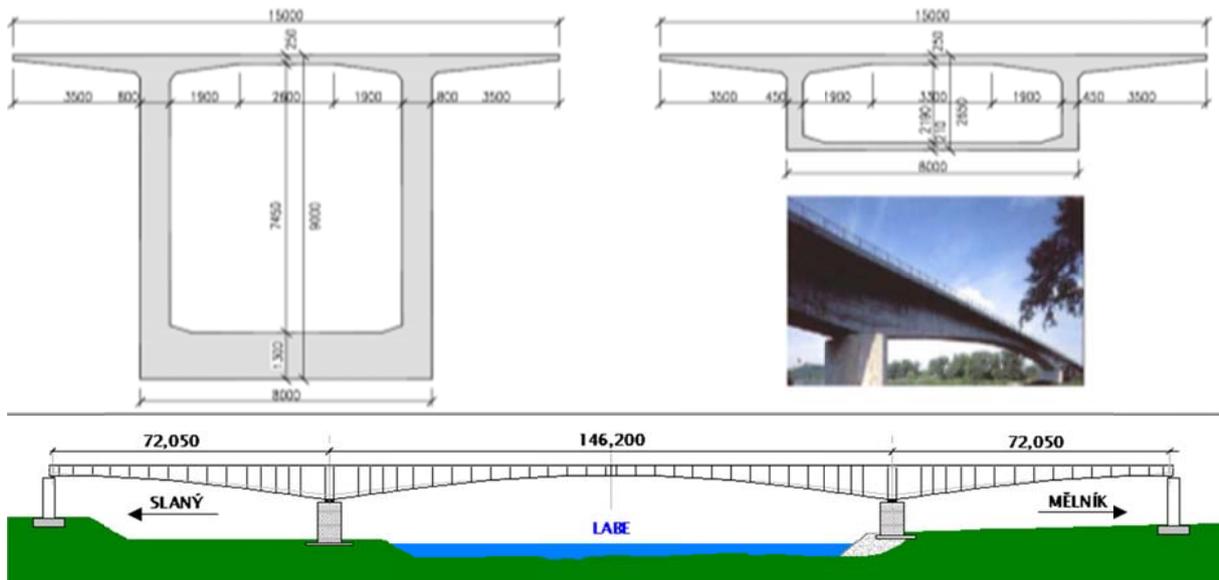
Fig. 2. The bridge near Mělník

Long span prestressed concrete bridge across the river Labe in Mělník (Fig. 2) is the main part of the bridging transferring the I/16 communication. It was designed as a through girder with span length 72.05 + 146.2 + 72.05 m. With the main span length 146.2 m it is still one of the biggest overhung concrete bridge in operation in Czech Republic.

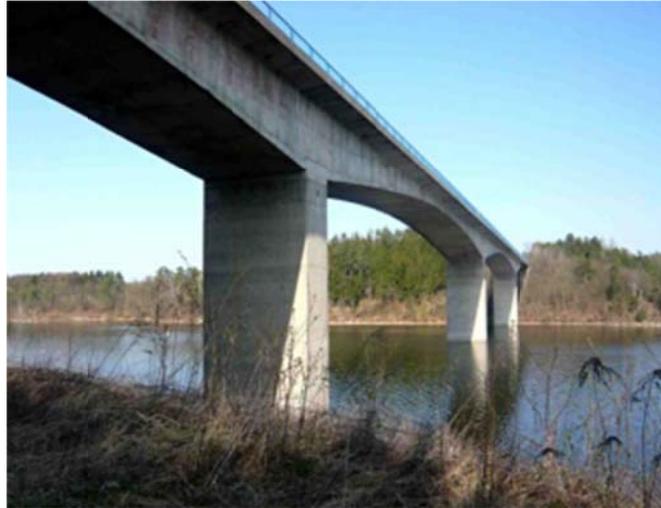
Fig. 3. The Bridge near Brzotice

The bridge over the river Želivka near Brzotice (Fig. 3) is the part of the road II/150 – connection between the valley of Sázava and D1 highway. The construction of bridge is designed as a concrete frame structure with four fields with inner joints in the 2nd and 3rd field. Length of bridge is 306 m, width 13 m and pillar are 65 m high.

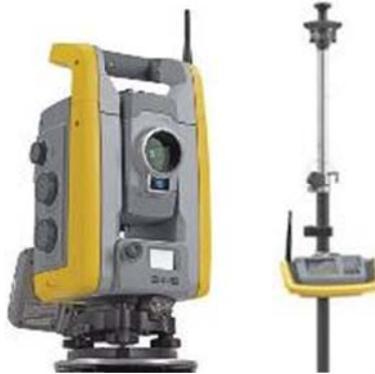
Fig. 4. Trimble S6 Robotic, a range pole with an omnidirectional prism

The Trimble S6 Robotic instrument ($\sigma_{\varphi} = 0.3$ mgon, $\sigma_D = 1$ mm + 1 ppm D) with a relevant omnidirectional reflection prism was used for the measuring (Fig. 4). It is a total station with automatic observation of an aim and spacing, which also enables automatic targeting on an omnidirectional reflection prism.

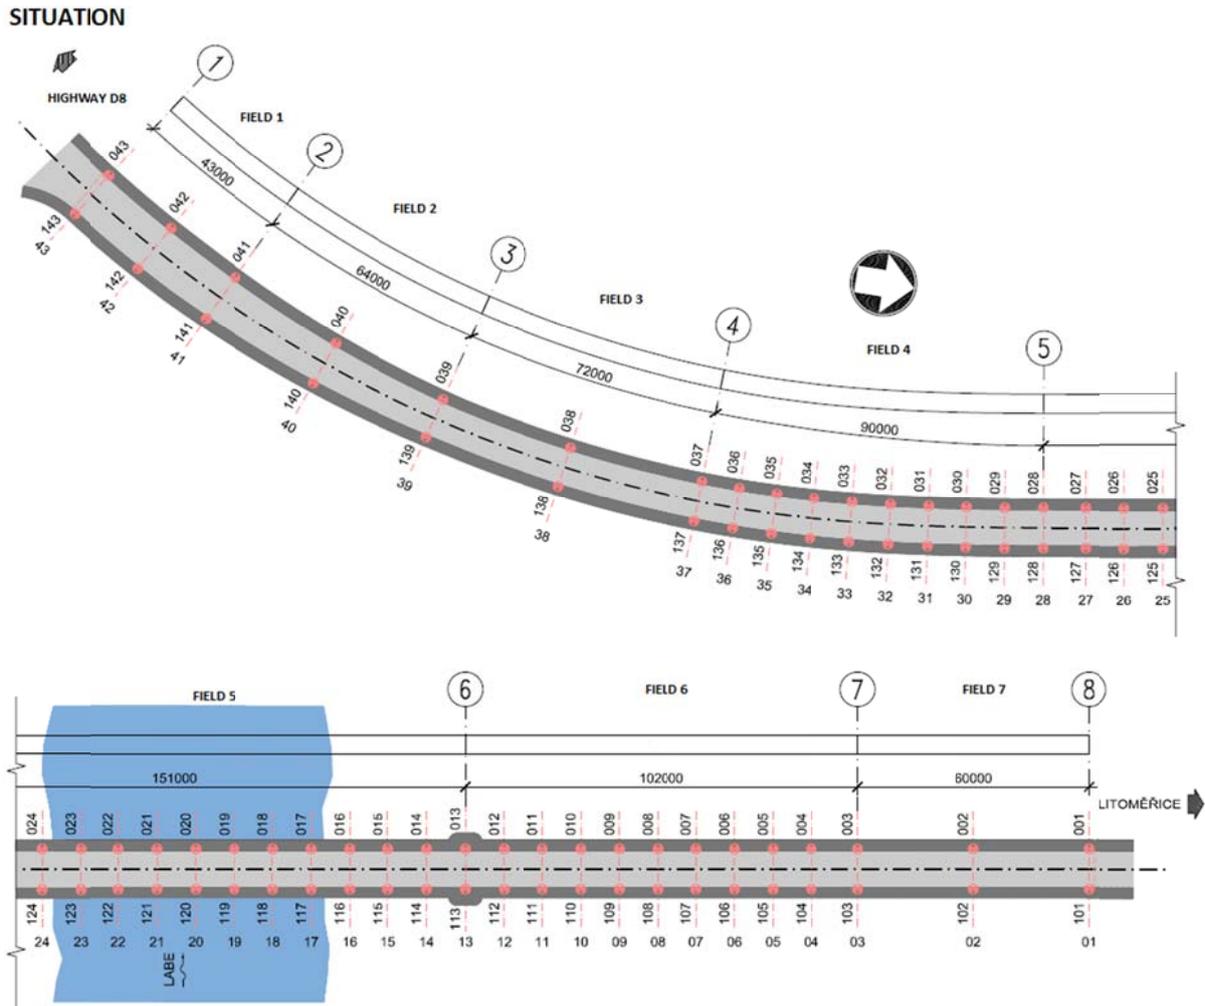
Fig. 5. Monitored points (Litoměřice)

The measuring configuration is shown in Fig. 5 for bridge near Litoměřice and in Fig. 6 for bridge near Mělník. Configuration of measuring on bridge near Brzotice was very simple. 88 points with exactly the same spacing were situated on the right side of the bridge. The bridge structure shape was changing in the course of measuring. When designing the configuration measuring the assumption was that the bridge temperature is stable (measuring was realized at night). In case of temperature instability, the „time sample method“ was used for correction.

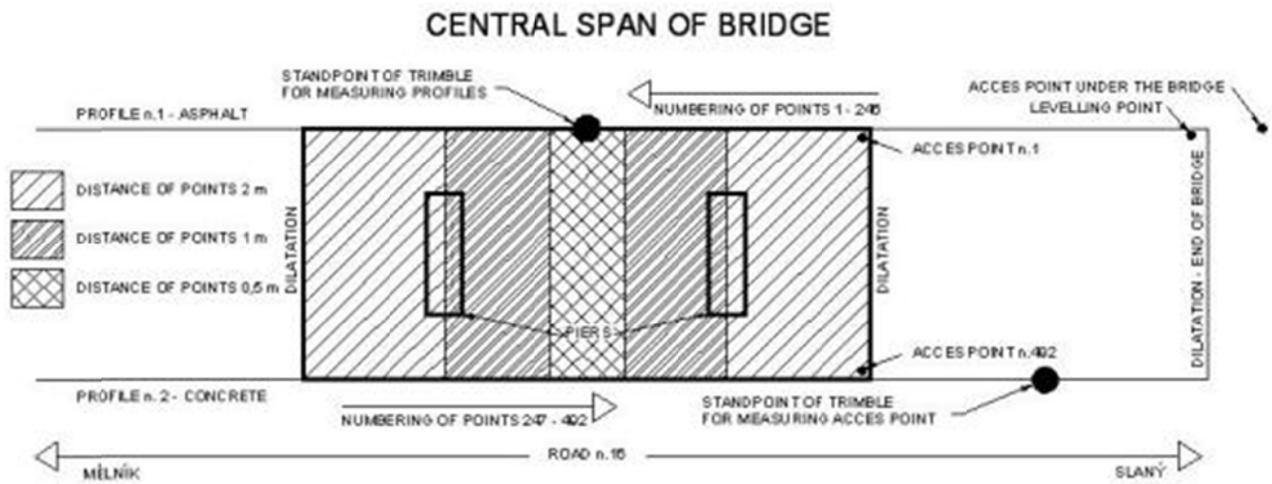
Fig. 6. Monitored points (Mělník)

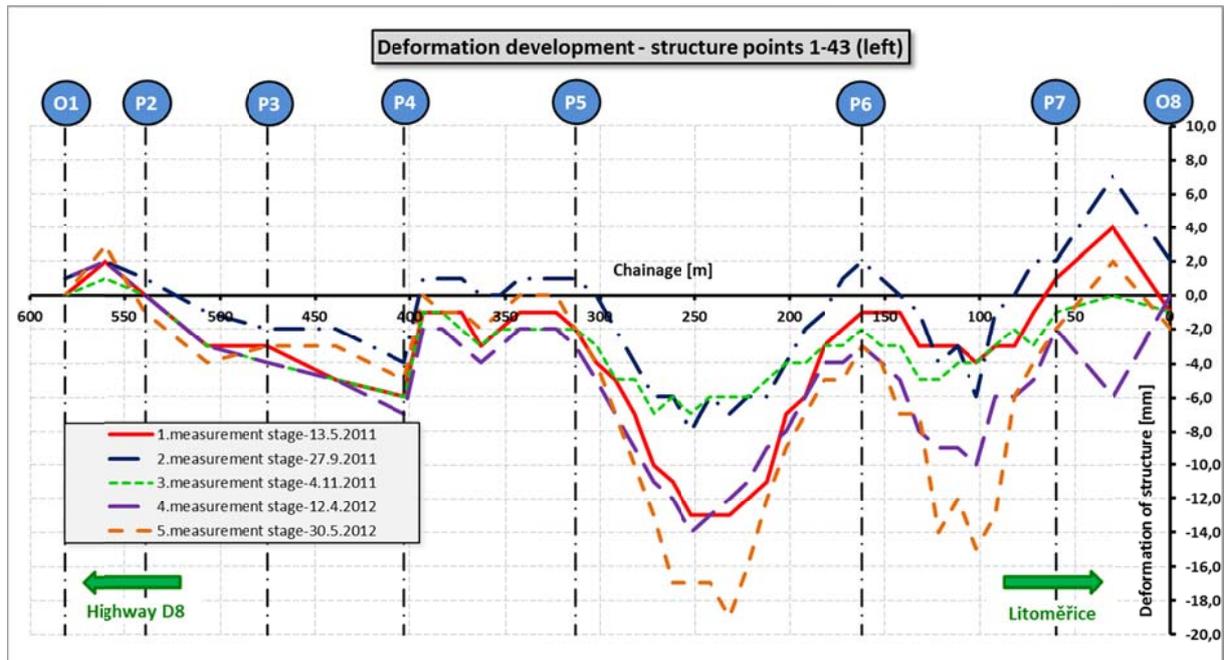
Fig. 7. Development of structure deformation compared 0th measurement stage (left)

Six measurements were determined by the relative heights of all monitored points from the reference geodetic connection point. Displacements (structure deformation) of each point relative to the base 0th stage are shown on Fig. 7 and Fig. 8. These pictures show significant decrease in the main field, which is situated above river.

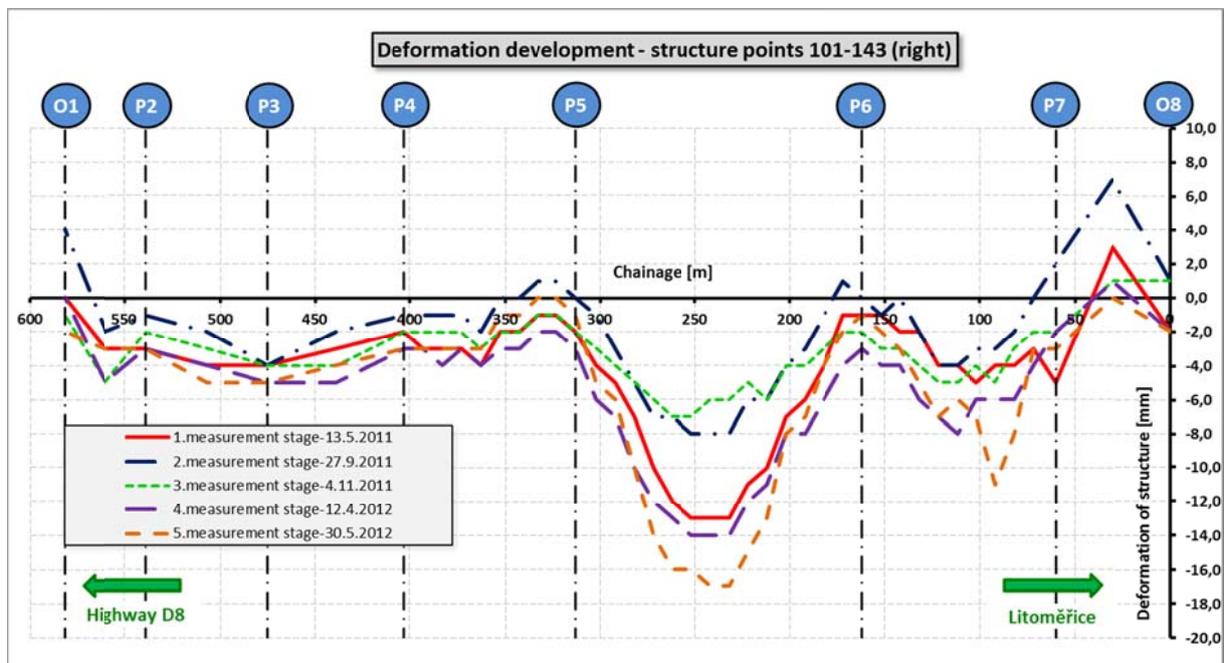
Fig. 8. Development of structure deformation compared 0th measurement stage (right)

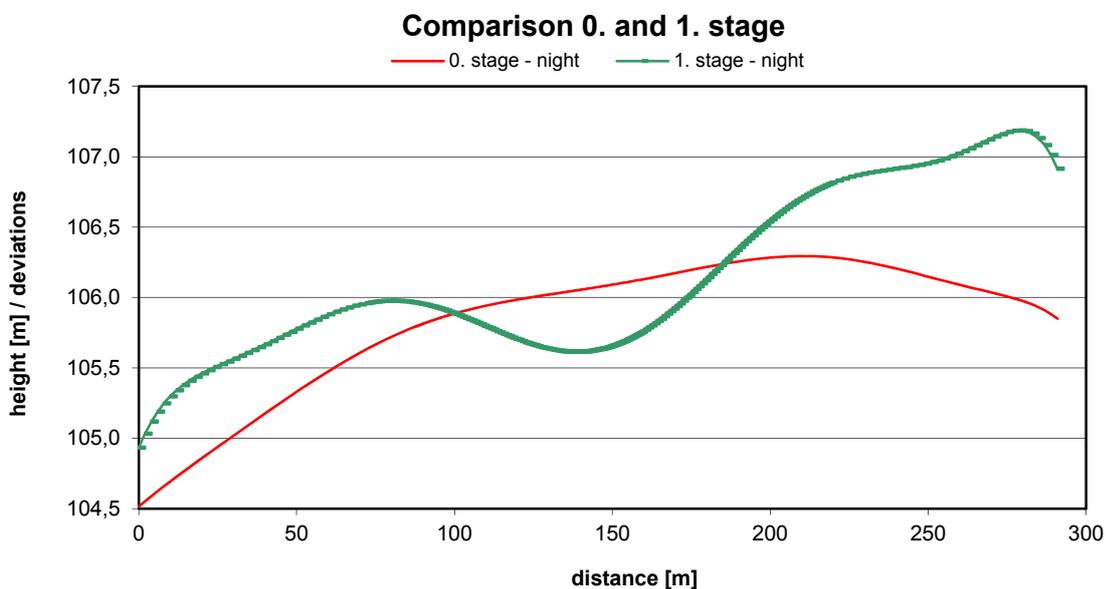
Fig. 9. Comparison 0th and 1st stage (night)

Three measurements were determined by the relative heights of all monitored points from the reference geodetic connection point. Displacements (structure deformation) of 1st stage to the base 0th stage are shown on Fig. 9. There is a comparison for study of development of construction in the longer term (3 months). On Fig. 10 are compared 2nd and 3rd stages for study of development due to temperature changes. Height of deformation (deviation) in figures was magnified a hundred times. The deformation in the main field is clearly visible.

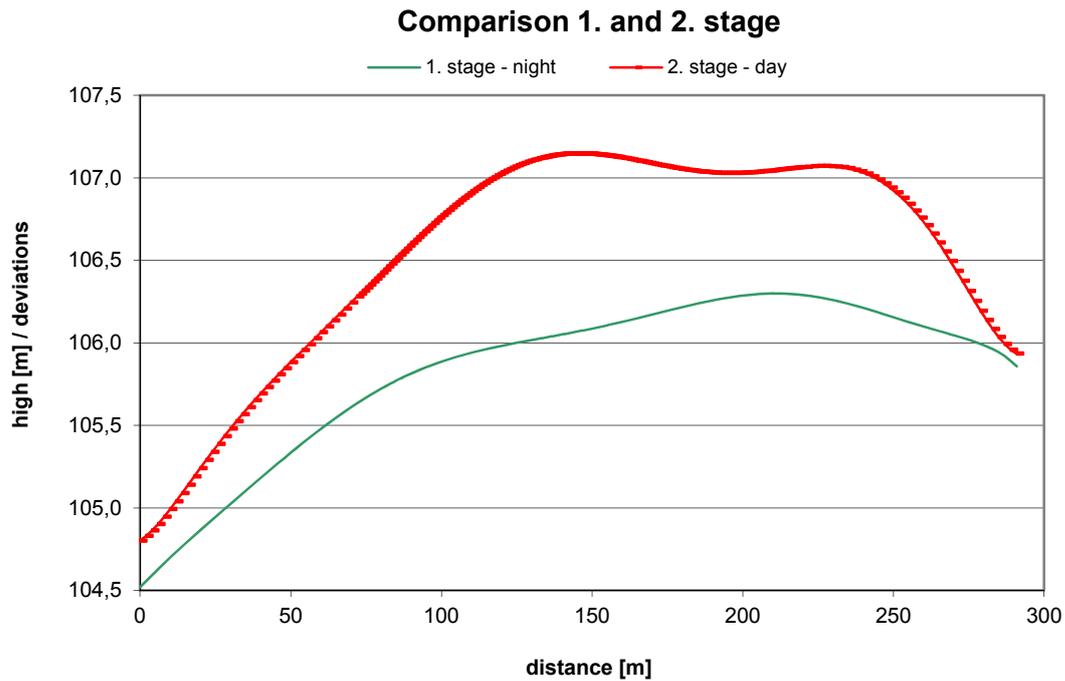
Fig. 10. Comparison 1st and 2nd stage (night – day)

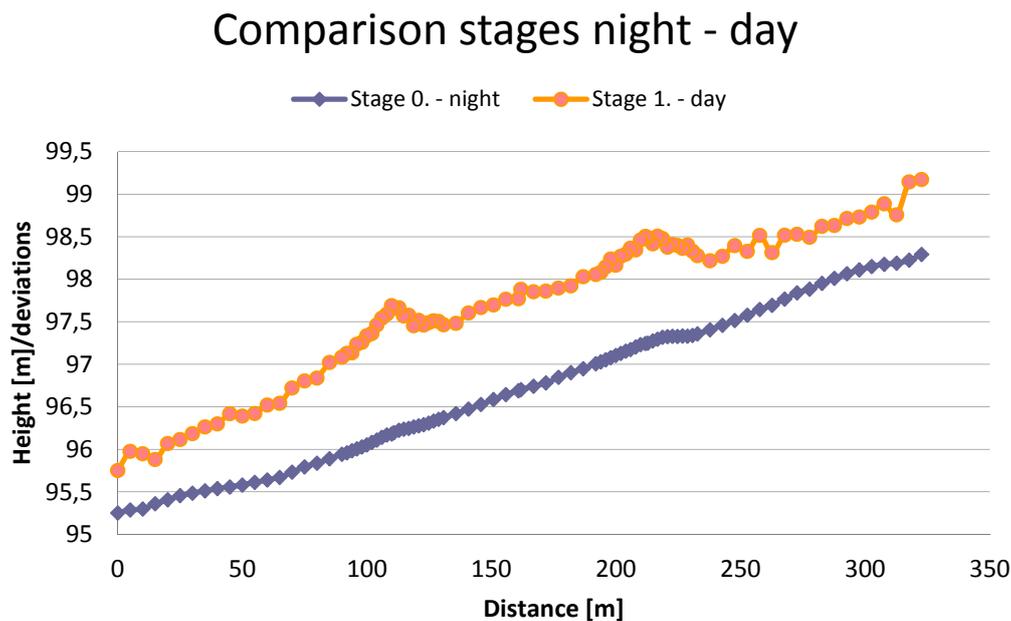
Fig. 11. Comparison 0th and 1st stage (night – day)

Two measurements were determined by the relative heights of all monitored points from the reference geodetic connection point. Displacements (structure deformation) of 1st stage to the base 0th stage are shown on Fig. 11. There is a comparison for study of development due to temperature changes. Height of deformation (deviation) in figure was magnified a hundred times. Two raised significant places in the picture correspond with inner joints of structure.
