## HORIZONTAL DRAINS AS EFFECTIVE MEASURE FOR LANDSLIDE REMEDIATION

MILOSLAV KOPECKÝ, MARTIN ONDRÁŠIK, DARINA ANTOLOVÁ

Faculty of Civil Engineering, Department of Geotechnics, Slovak University of Technology,  
Radlinského 11, 813 68 Bratislava, Slovakia.

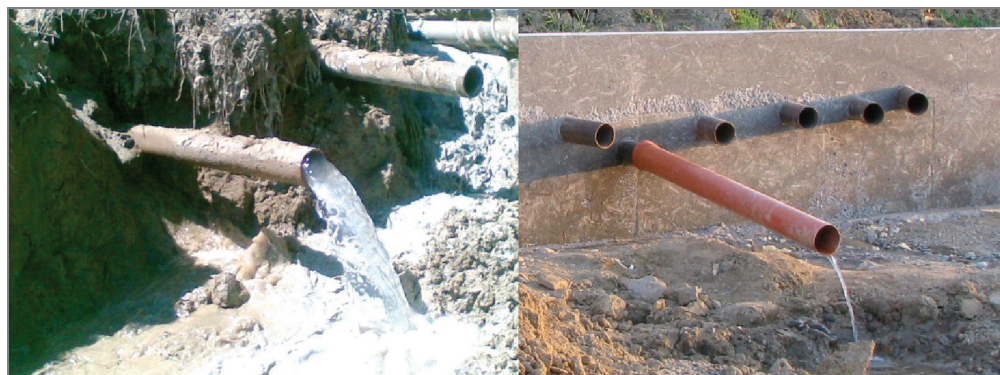
Fig. 3. HDB discharge during drilling and two months after

The largest discharge from HDB is achieved during drilling (max.  $300\text{ l}\cdot\text{min}^{-1}$ ), or shortly after, and then the discharge has declining trend (Fig. 3). The initial large discharge is mostly because of static groundwater reserves. Water from rainfalls is not a sufficient source to recharge larger dynamic resources. HDB discharge more water from the landslide than a volume of inflowing groundwater is recharging it. The further decrease of the discharge with time is also caused by the slow clogging of the casting perforations (Section 6).

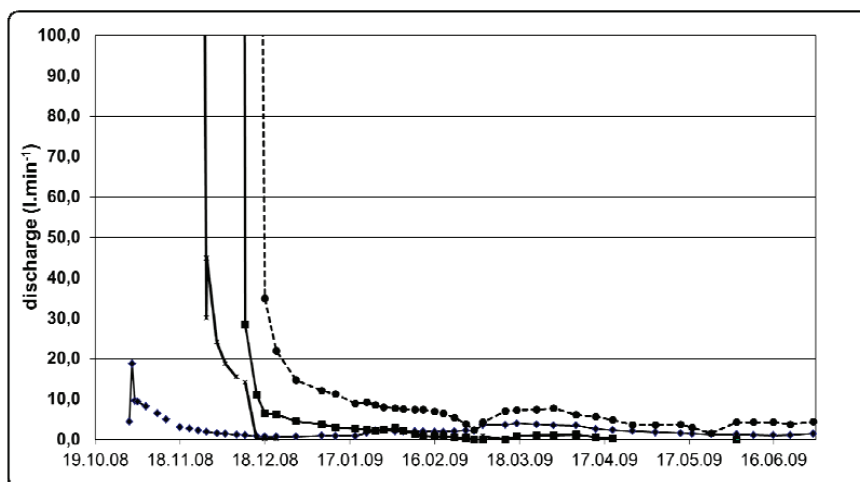
Fig. 4. Declining trend of HDB discharge in Považská Bystrica

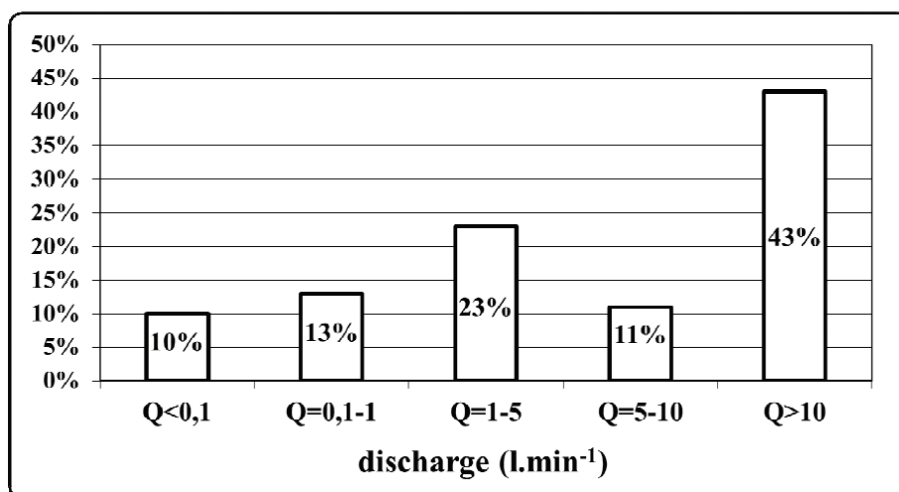
Fig. 6. Proportion of functional HDB based on their initial discharge

In Fig. 6, a division of HDB according to their initial discharge rate is illustrated.

The figure shows that up to 43% of the horizontal boreholes had initial discharge rate greater than  $10 \text{ l}\cdot\text{min}^{-1}$ . On the other hand, only 10% of the HDB had discharge less than  $0.1 \text{ l}\cdot\text{min}^{-1}$ .

In the conclusion of this Section we can say that there was observed only one factor that affects the functionality of HDB. It is the initial discharge rate of HDB (Fig. 6), because up to 43% of HDB functioning today had initial discharge rate greater than 10 l.min<sup>-1</sup> and 54% greater than 5 l.min<sup>-1</sup>.
