# WHAT WERE THE REASONS FOR THE RAPID LANDSLIDE OCCURRENCE IN “PIASECZNO” OPEN PIT? – ANALYSIS OF THE LANDSLIDE PROCESS

JOANNA JAKÓBCZYK, MAREK CAŁA, AGNIESZKA STOPKOWICZ

AGH University of Science and Technology, al. Mickiewicza 30, 30-059 Kraków, Poland,  
e-mail: jjakob@agh.edu.pl, cala@agh.edu.pl, agnieszka.stopkowicz@agh.edu.pl

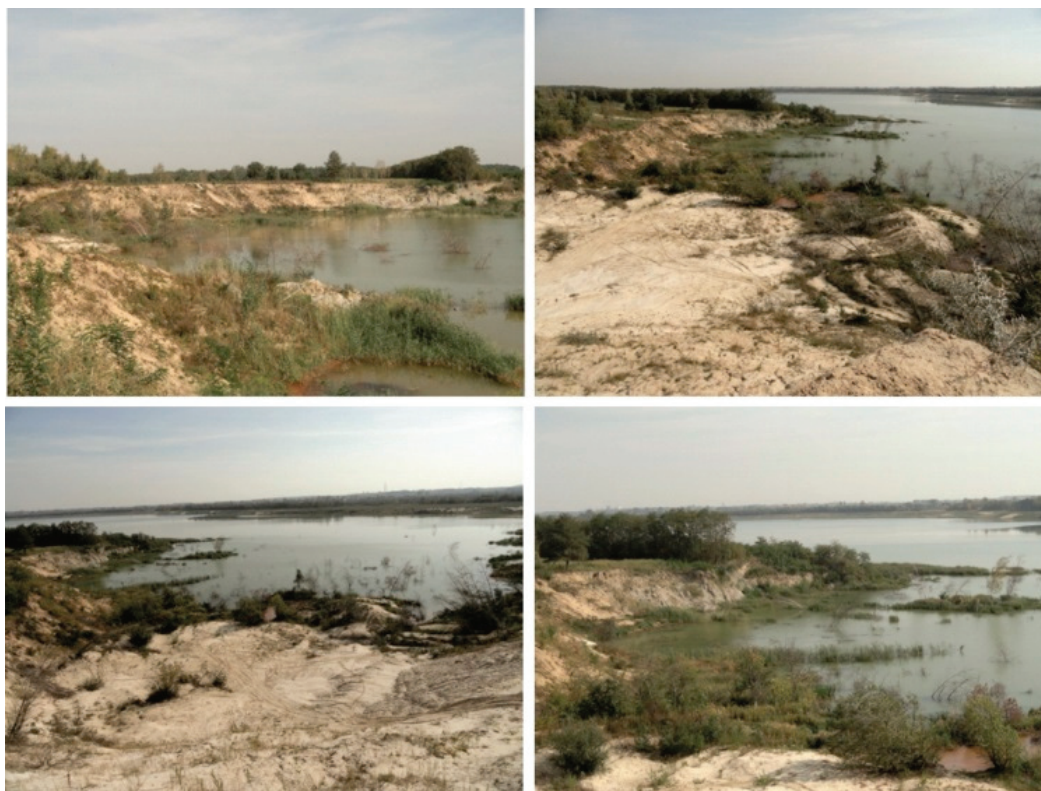
Fig. 1. State of the slope after the formation of the landslide  
(Source: photo by J. Jakóbczyk)

approximately 6 hectares. The range of the landslide is presented with red line in Fig. 2. As a result of this phenomenon the water level rose by 56 cm – approximately 600000 m<sup>3</sup> of soil masses were displaced under the water. The total volume of ground masses was estimated to be over 1.0 million m<sup>3</sup> in the initial period of movement. Figure 1 shows the state of the slope after the occurrence of the landslide.

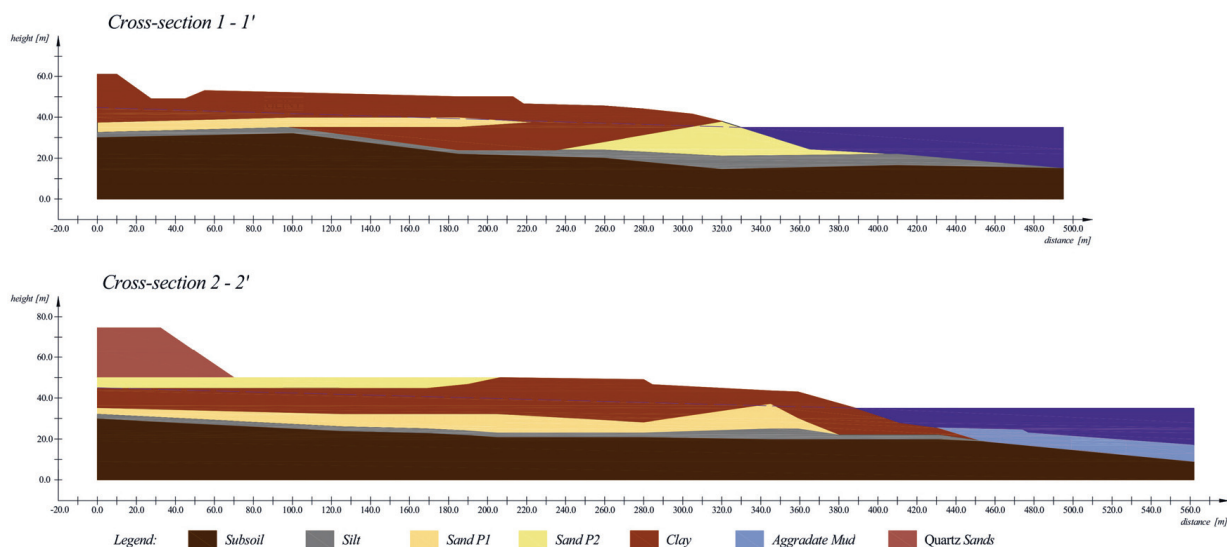
Fig. 3. The geometry and geological structure for the cross-sections 1-1' and 2-2'  
(Source: figures by J. Jakóbczyk [6])

Figure 3 shows the geometry and geological structure of the individual cross-sections.

The stability analysis of cross-sections 1-1' and 2-2' was made assuming their geometry (Fig. 3) and values of the geotechnical parameters presented in Table 1. Based on [1], it was noticed that the water table in the excavation is 35.0 meters above the sea level (Fig. 4).
