# ULTRASONIC WAVES AND STRENGTH REDUCTION INDEXES FOR THE ASSESSMENT OF THE ADVANCEMENT OF DETERIORATION PROCESSES IN TRAVERTINES FROM PAMUKKALE AND HIERAPOLIS (TURKEY)

ALICJA BOBROWSKA, ANDRZEJ DOMONIK

University of Warsaw, Faculty of Geology, Department of Geomechanics, Warsaw, Poland.  
E-mail: a.bobrowska@uw.edu.pl; a.domonik@uw.edu.pl

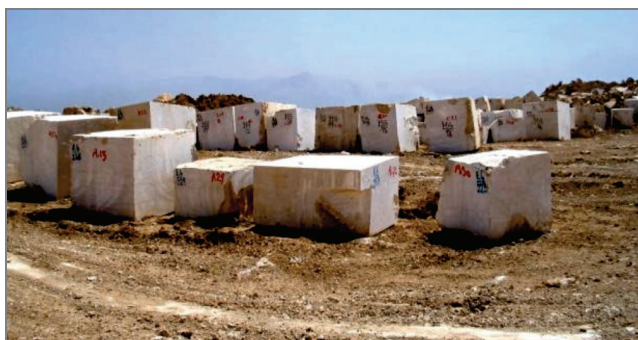
Fig. 2. Typical stone blocks produced in the Pamukkale–Hierapolis travertine quarries

One of the largest producers of large stone blocks in the world [26], including travertine blocks, is Turkey, whereas the leading area in travertine deposits is the Denizli–Kaklık district, located in western Anatolia – Aegean Turkey, with the Pamukkale–Hierapolis deposit [27] (Fig. 2).

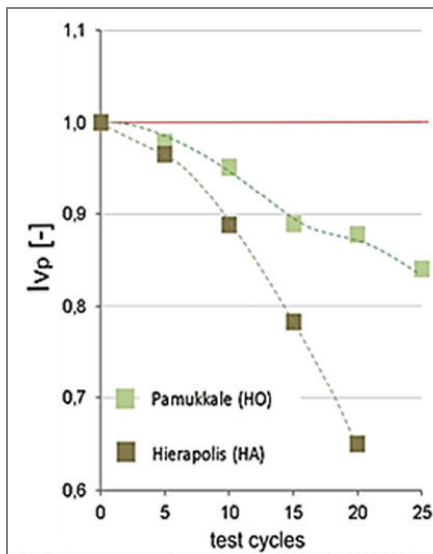
Fig. 4. Ultrasonic waves index  $I_{Vp}$  after the impact of frost

Comparison of the  $I_{Rc}$  and  $I_{Vp}$  indexes, assuming that the material that was not subject to deterioration is characterized by the value  $I = 1$ , clearly indicates that the largest resistance changes take place after the impact of frost, particularly in the weathered travertine from Hierapolis, where the strength reduction index ( $I_{Rc}$ ) is low and reaches 0.49. In this sample the lowest  $I_{Vp}$  index value is equal to 0.65. The stone material from Pamukkale is characterized by much higher resistance to frost, because the  $I_{Rc}$  index averagely reaches 0.68. Such high resistance is reflected in the analysis of the ultrasonic waves index  $I_{Vp}$  with values at 0.84. Low resistance of weathered travertine to the impact of frost in relation to material without seasoning is distinct on the correlation diagrams of  $I_{Rc}$  and  $I_{Vp}$  indexes (Figs. 3, 4).

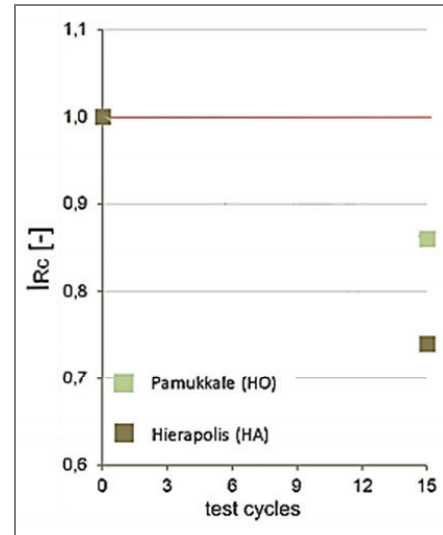
Fig. 5. Strength reduction index  $I_{Rc}$  after the impact of temperature oscillations (insolation)

Resistance prediction based on comparison of the relationships between the two indexes  $I_{Rc}$  and  $I_{Vp}$ , graphically presented in Figs. 5 and 6, indicates that resistance changes may proceed nonlinearly in the initial stages of insolation. Ultrasonic diagnosis of deterioration processes in conditions when the rock skeleton dilates as a result of increased temperature is thus more correct for the final stages of deterioration.

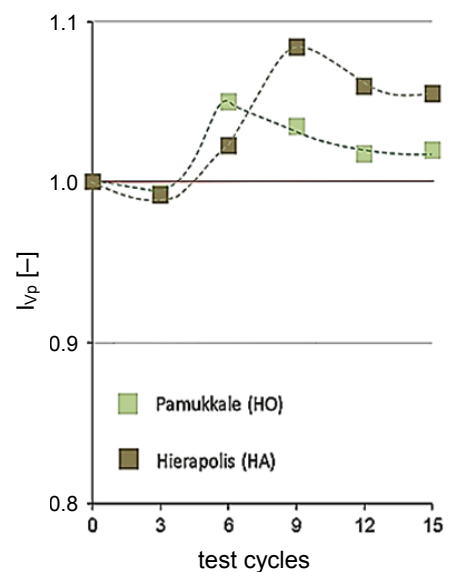
Fig. 10. Advancement of deterioration reflected in the ultrasonic waves index  $I_{Vp}$  after the impact of salt crystallization

The investigations show that after the impact of soil crystallization, the  $I_{Rc}$  index varies from 0.79 for the material from the active quarry (Pamukkale) to 0.68 from the material from a quarry active in ancient times (Hierapolis). Despite this, the values of the  $I_{Vp}$  index are equally high and reach 1.02 for the travertine from Pamukkale and 1.06 for the travertine from Hierapolis, respectively. Comparison of changes of the  $I_{Vp}$  index values in relation to the  $I_{Rc}$  index, based only on point resistance measurements, are not diagnostic enough for the structural transformations taking place in the macroporous material (Figs. 10 and 11).
