Improved image processing of road pavement defect by infrared thermography

This paper intends to achieve improved image processing for the clear identification of defects in damaged road pavement structure using infrared thermography non-destructive testing (NDT). To that goal, 4 types of pavement specimen including internal defects were fabricated to exploit the results obtained by heating the specimens by natural light. The results showed that defects located down to a depth of 3 cm could be detected by infrared thermography NDT using the improved image processing method.

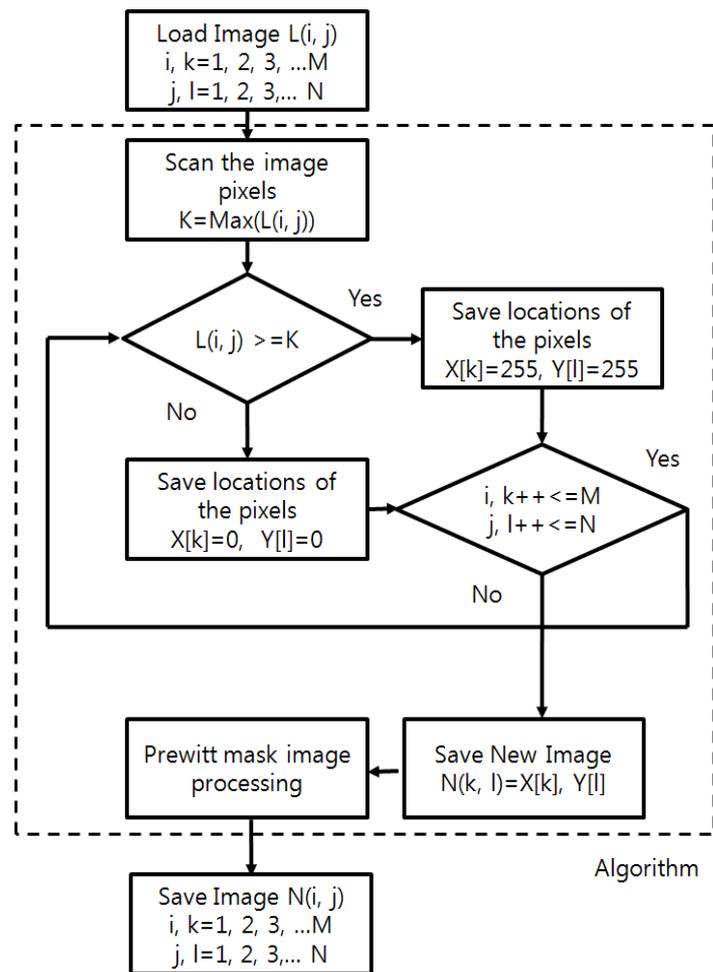
Figure 2: Image processing procedure [7]

Smoothing is done on the inter-pixel image change obtained by Gauss filtering through the introduction of the weighting factor expressed in Eq. (4). For the image modified by such weighting factor, the difference is calculated by the process expressed in Eqs. (5) and (6). Here, Eq. (4) is the weighting factor of the 5×5 mask in the Gauss filtering and σ is the input phase that is the standard deviation. Eqs. (5) and (6) are the images calculated at the coordinates corresponding to the X, Y masks of the Prewitt mask, respectively. The magnitude of the gradient obtained by differentiation is finally approximated by the sum of the absolute values of each component as expressed in Eq. (7). The Prewitt mask is an edge detection algorithm, which separates the image into the 3×3 mask shown in Fig. 1(c), stores the value obtained by adding the products of the masks of Figs. 1(a) and (b) with the pixel of the image, and detect the edge corresponding to the central pixel of the so-calculated image. Fig. 2 presents the flowchart of the image processing procedure.

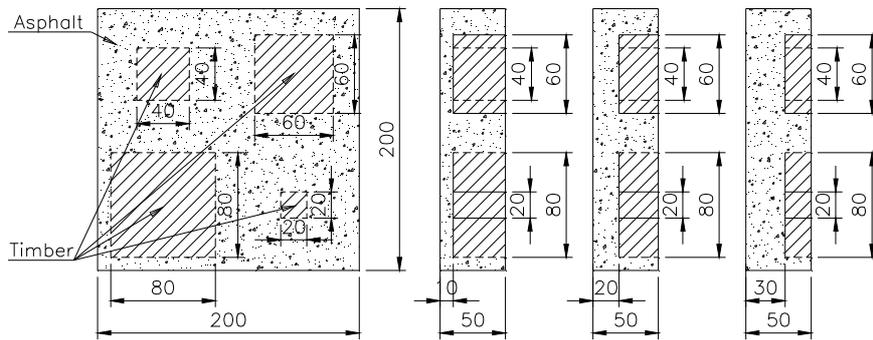
As shown in Fig. 3, the specimens for the detection of internal defect were fabricated using 200×200 mm frames in which square wooden blocks of 20, 40, 60 and 80 mm are disposed at depths of 10, 20 and 30 mm from the surface to simulate the defect. Fig. 4 depicts the frame made of wood. Fig. 5 shows the completed specimens after the placing of the asphalt mixture. Fig. 6 illustrates a view of thermal imaging test using natural light. Note that the distance between the infrared camera and the specimen is approximately 2.0 m. Table 2 gives the list and designation of the considered specimens with internal defect.

Figure 3: Details of pavement specimens with defect [9]

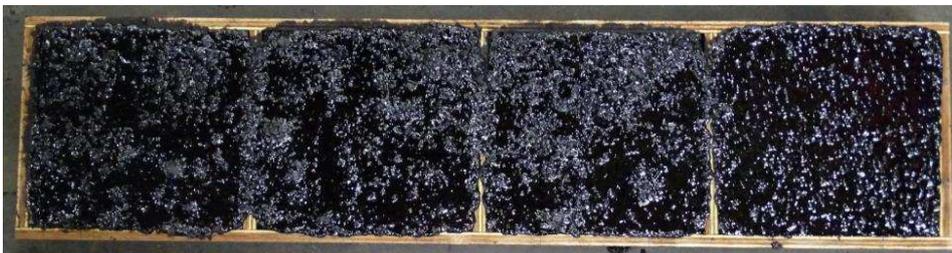
Figure 5: Completed asphalt pavement specimens [9]

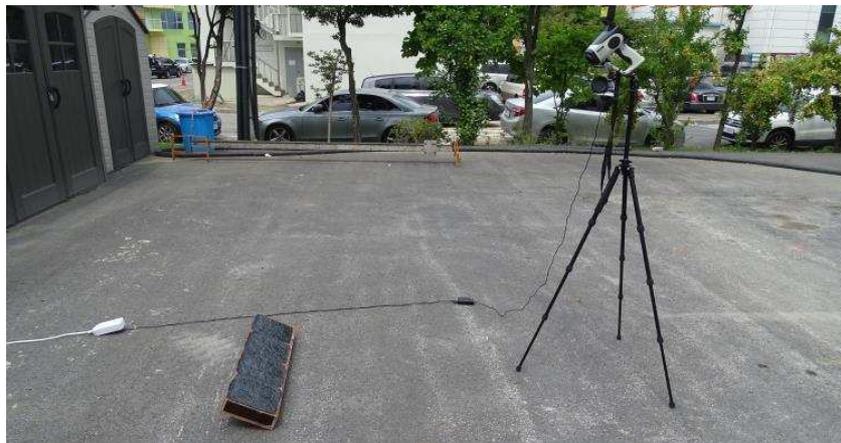
Figure 6: Thermal imaging using natural light [9]

Natural light is adopted as heat source in the defect detection of road pavement by thermography. Thermographic imaging is done every 10 minutes from 10:40am to 2:30pm on the asphalt specimens from a vertical distance of 30 cm to detect efficiently the internal defect in the road pavement.

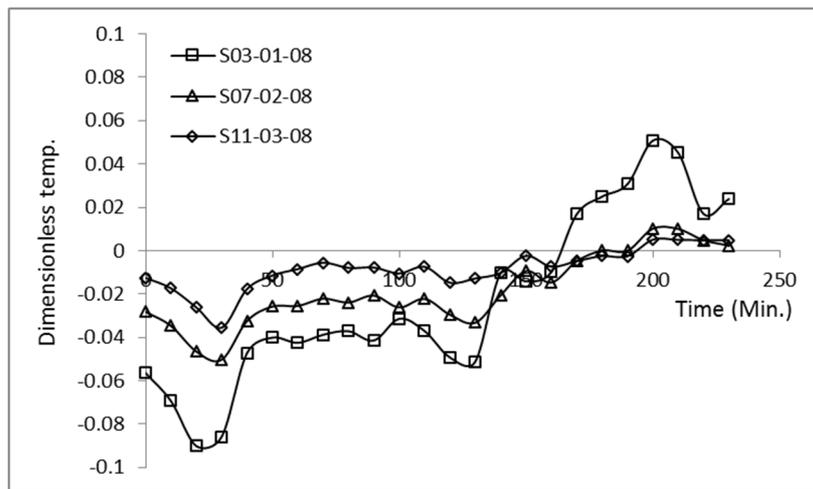
As shown in Fig. 7, when the defect size is 80×80 mm and taking time zero at 10:40am, the dimensionless temperature graph exhibits large difference and enables to distinguish any defect up to a depth of 30 mm. For the defect size of 60×60 mm in Fig. 8, large difference is observed in the dimensionless temperature graph even at 200 min corresponding to 2:00pm and makes it possible to detect all the defects. Moreover, the difference in the dimensionless temperature graph in Fig. 9 for the defect size of 40×40 mm enables to distinguish all the defects at 230 min that is 2:30pm. Finally, the dimensionless temperature graphs of Fig. 10 for the defect size of 20×20 mm also indicate all the defects at 140 min corresponding to 1:00pm. This series of observation verify that the dimensionless temperature graph can detect any defect up to 20×20 mm at depth of 30 mm using the change in the solar radiation being in morning or in afternoon.

Figure 7: Surface temperature distribution at defect with size of 80×80 mm [9]

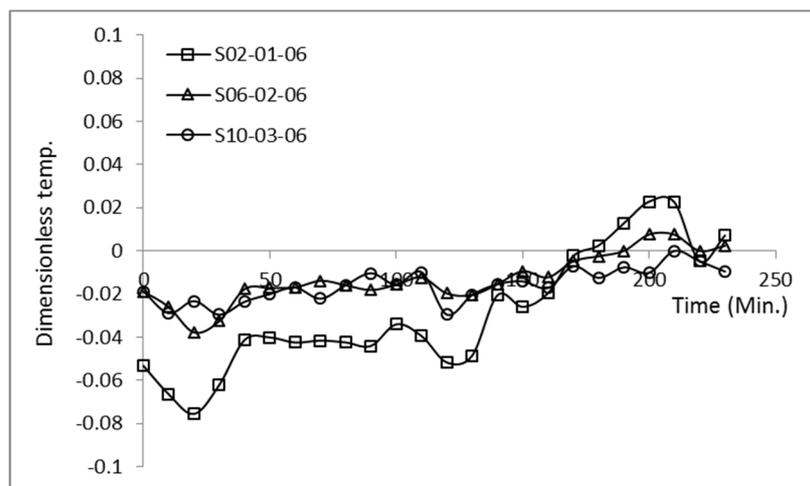
Figure 8: Surface temperature distribution at defect with size of 60×60 mm [9]

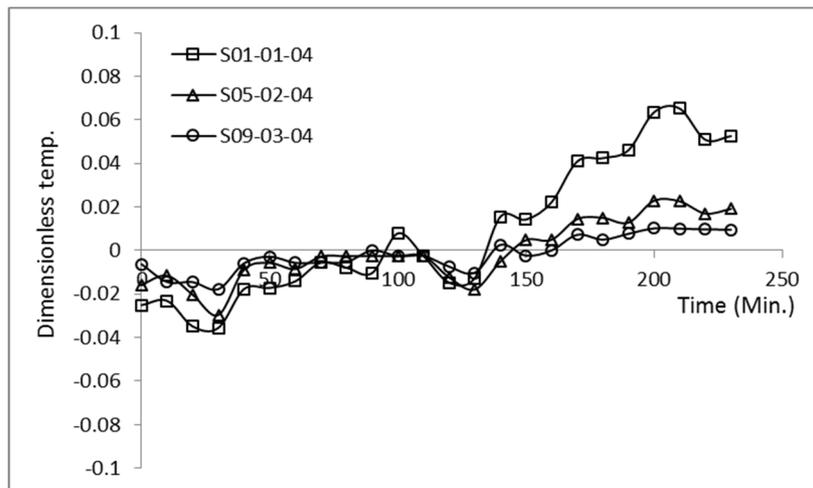
Figure 9: Surface temperature distribution at defect with size of 40×40 mm [9]

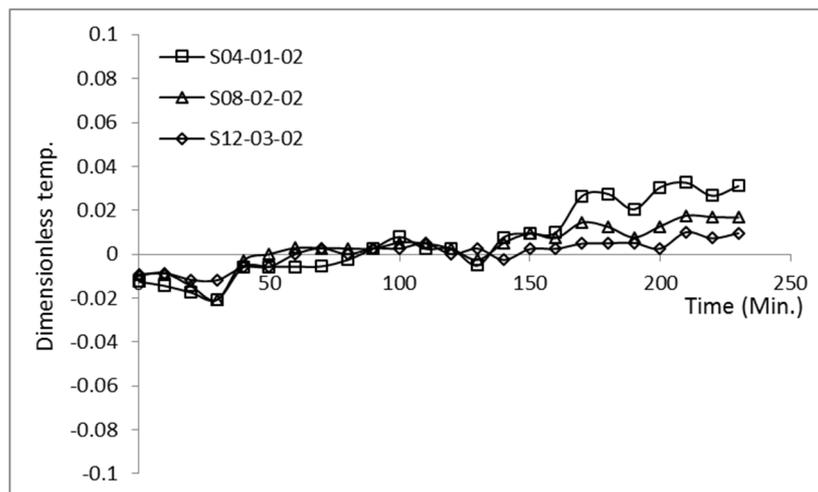
Figure 10: Surface temperature distribution at defect with size of 20×20 mm [9]

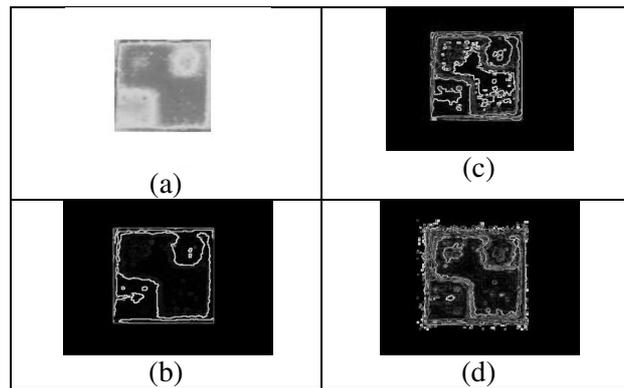
Fig. 11 shows the original thermal image captured at 10:40am on the specimen with defect at depth of 10 mm together with the images processed by Prewitt mask. Previously, defect detection could be done only up to S02-01-06 but it appears that detection of the defect can now be done up to S01-01-04 when applying a standard deviation of 0.15 in the Gauss filtering before Prewitt masking.

Figure 11: Result of Prewitt mask: (a) original image; (b) image processed with $\sigma = 0.35$; (c) image processed with $\sigma = 0.20$; (d) image processed with $\sigma = 0.15$ (defect at depth of 10 mm, 10:40am)

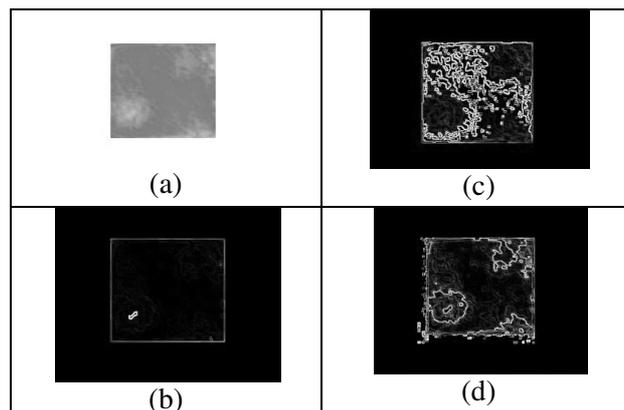
Fig. 12 relates the thermography of the specimen with defect at depth of 20 mm captured at 12:50pm. The previous image processing failed in identifying clearly the edge of the defect but it can be seen that, when a standard deviation of 0.15 is applied in the Gauss filtering, the image processing is improved to an extent enabling to distinguish the defect up to S06-02-06.

Figure 12: Result of Prewitt mask: (a) original image; (b) image processed with $\sigma = 0.35$; (c) image processed with $\sigma = 0.20$; (d) image processed with $\sigma = 0.15$ (defect at depth of 20 mm, 12:50pm)

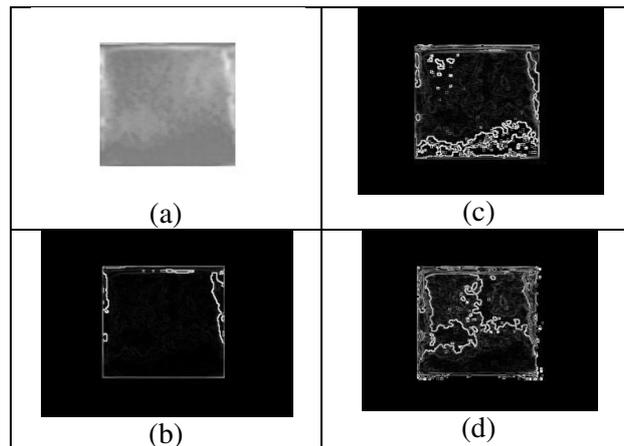
Fig. 13 arranges the images captured at 12:50pm for the specimen with defect at depth of 30 mm. Here also, the application of a standard deviation of 0.15 in the Gauss filtering appears to identify the defect edge of S11-03-08 that could be merely distinguished previously.

Figure 13: Result of Prewitt mask: (a) original image; (b) image processed with $\sigma = 0.35$; (c) image processed with $\sigma = 0.20$; (d) image processed with $\sigma = 0.15$ (defect at depth of 30 mm, 13:30pm)
