Preparation Measurements and Assessment of Roof Systems

Richard Baláž, Miloslav Bagoňa

Technical University of Košice

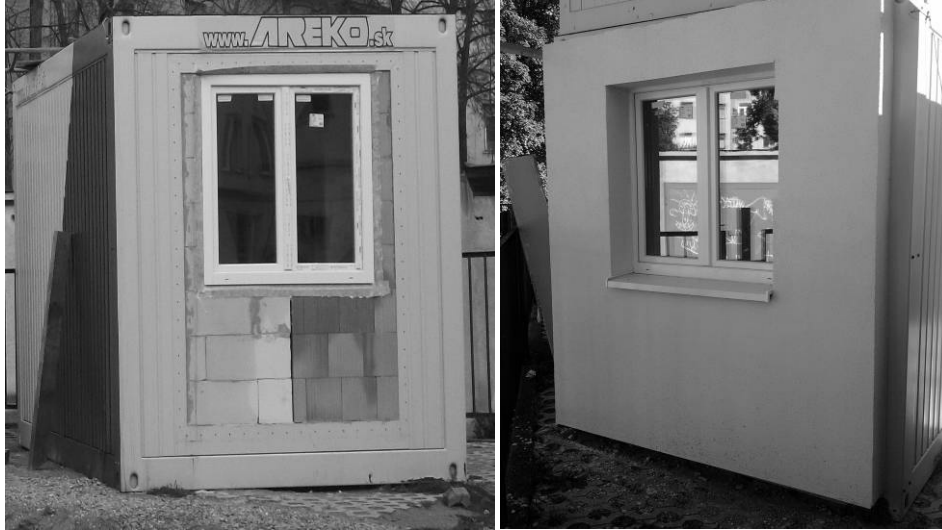
- Chamber 1 and 2 - consists of two masonry structures divided vertically - Autoclaved aerated concrete YTONG LAMBDA-P2 350 PDK and polished ceramic brick blocks HELUZ STI 30. The whole structure is insulated with graphite polystyrene - facade insulation board GreyWall 033 and a plaster rendering system using CERESIT. These test chambers is showed in Fig. 2.

Figure 2: Chamber no. 1 and 2

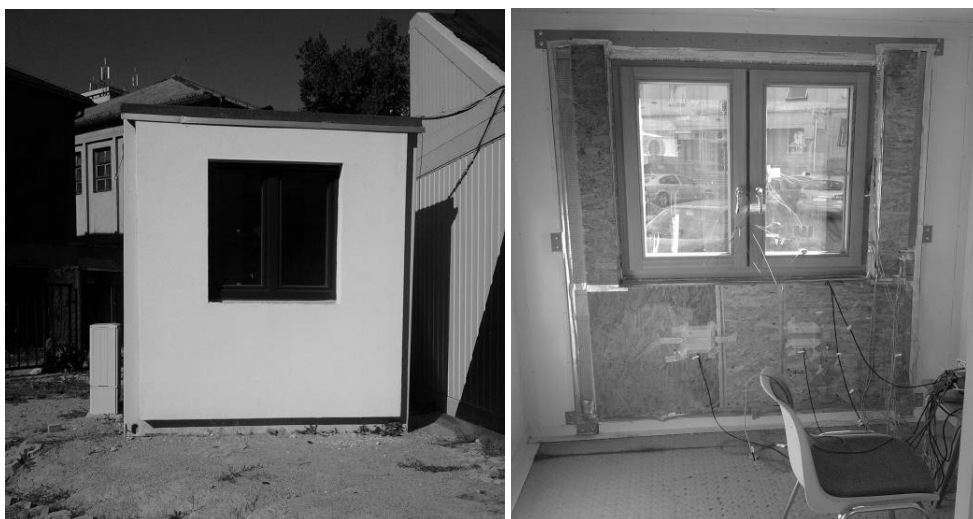
- Chamber 3 - wood particle board construction with thermal insulation - The inside surface consists of mineral insulation from Isover fiberglass - UNIROL PROFI covered with particle board - facade insulation board consists of longitudinal fibred ISOVER TF 100 insulation covered with a CERESIT plaster rendering system. Test chamber no. 3 is showed in Fig. 3.

Figure 3: Chamber no.3

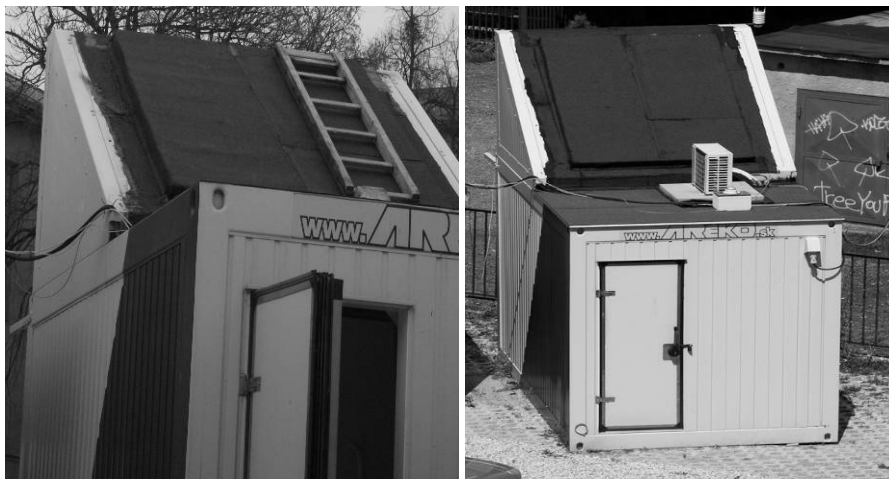
- Roof module in chamber no. 2 - timber frame construction filled with OSB particle boards. One side uses a vapour barrier while the other side omits the use of a vapour barrier; both using thermal insulation by ISOVER UNIRE-PRO. Roofing skin consists of asphalt strips filled with THERMOABASE thermal insulation. The ceiling is finished with dry walling. Roof module is showed in Fig. 4.

Figure 4: Chamber no. 2 – roof structure and roof element

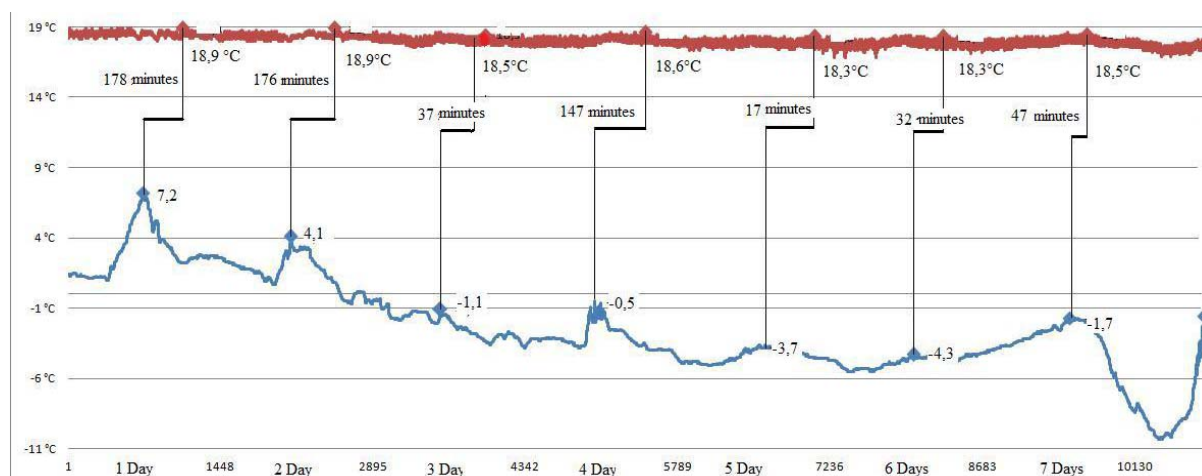
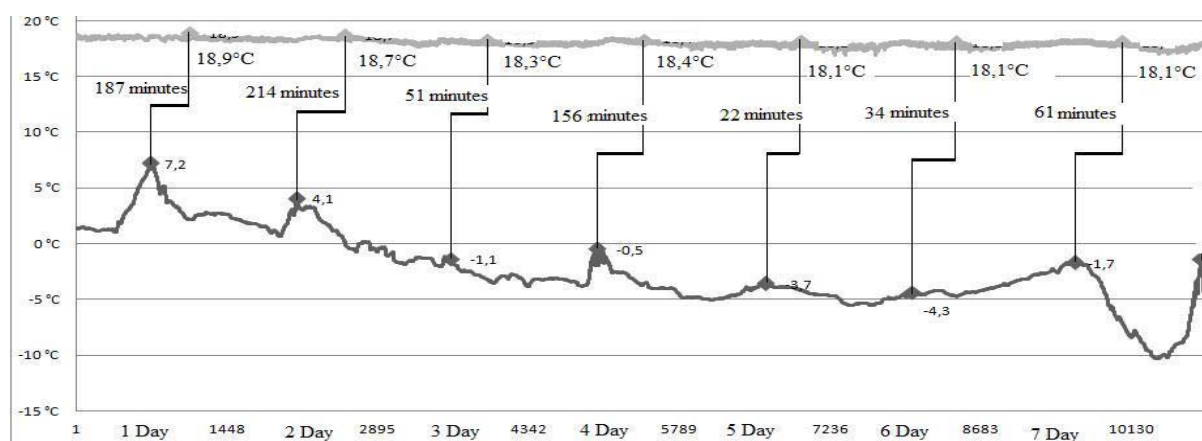
Graph 2. Day phase shift for winter period
January /day/

Blue graph-external temperature, red graph - surface temperature on Drywall roof S2

Brown graph-external temperature, grey graph - surface temperature on Drywall roof S1

Comparison of the phase of the temperature oscillation was assessed in the months October 2012, November 2012, January 2013 and February 2013. For the calculation itself is to be noted that as the inner surface temperature was used value from the sensor D/13 to construct sensor S1 and S2 D/14 for design. / Sensor measuring the surface temperature of the plasterboard /. In individual months were selected values of minimum and maximum outdoor temperature with their associated values of surface temperature in the roof structure and roof structure S1 and S2 they were subsequently compared.

The roof structure S1	The roof structure S2
Daily temperature oscillation phase shift for the winter season	October	$\psi = 81,59$ minutes	$\psi = 81,55$ minutes
	November	$\psi = 118$ minutes	$\psi = 98,42$ minutes
	December	$\psi = 104$ minutes	$\psi = 88,66$ minutes
	January	$\psi = 103,57$ minutes	$\psi = 90,57$ minutes
	February	$\psi = 133,85$ minutes	$\psi = 124,71$ minutes
