DESCRIPTION OF AN ECOTECHNICAL METHOD, PROPOSED FOR THE HÂRTIBACIU RIVER ALONG THE SECTOR IN AGNITA, SIBIU COUNTY

*Răzvan VOICU * and Liliana VOICU ***

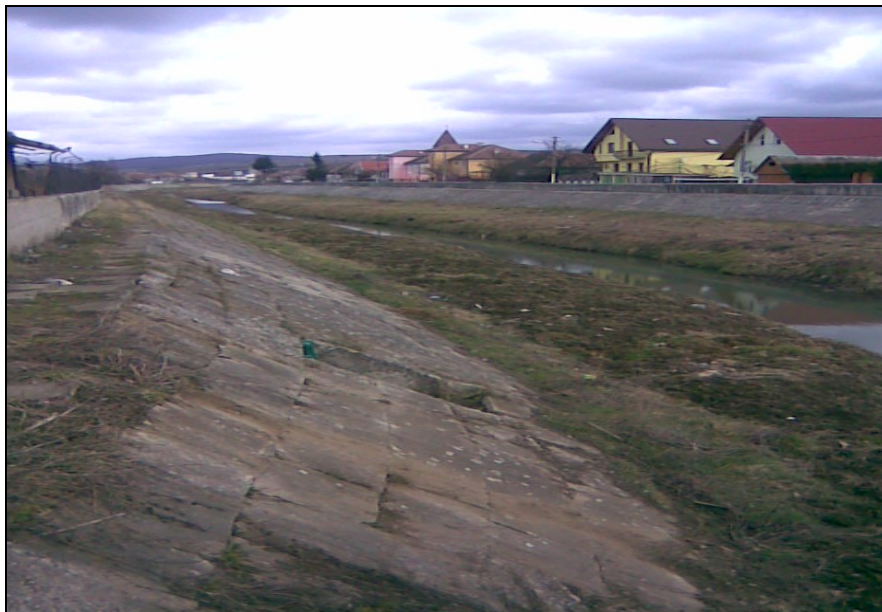
Figure 1: Hârtibaciu River (<http://ro.wikipedia.org>).

Along the lotic sector which passes through the city of Agnita, the Hârtibaciu River is almost completely dammed (Figs. 1 and 2) with solid concrete walls on the river banks.

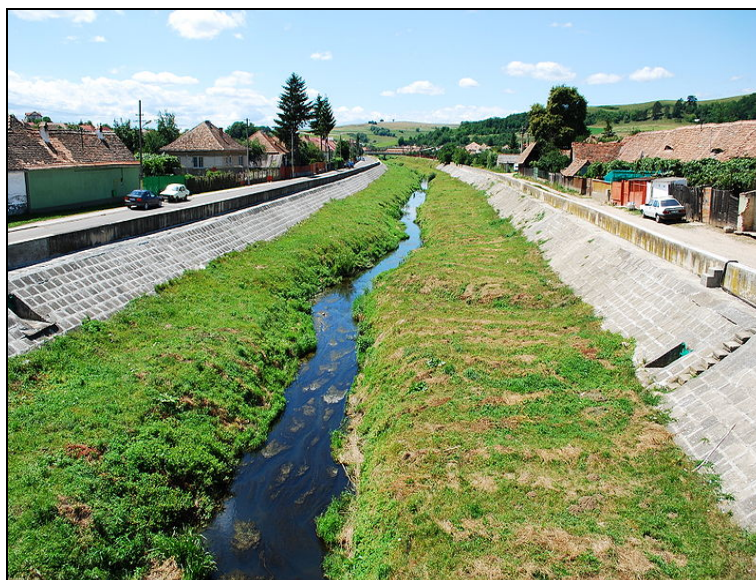
Figure 2: Hartibăciu River (<http://ro.wikipedia.org>).

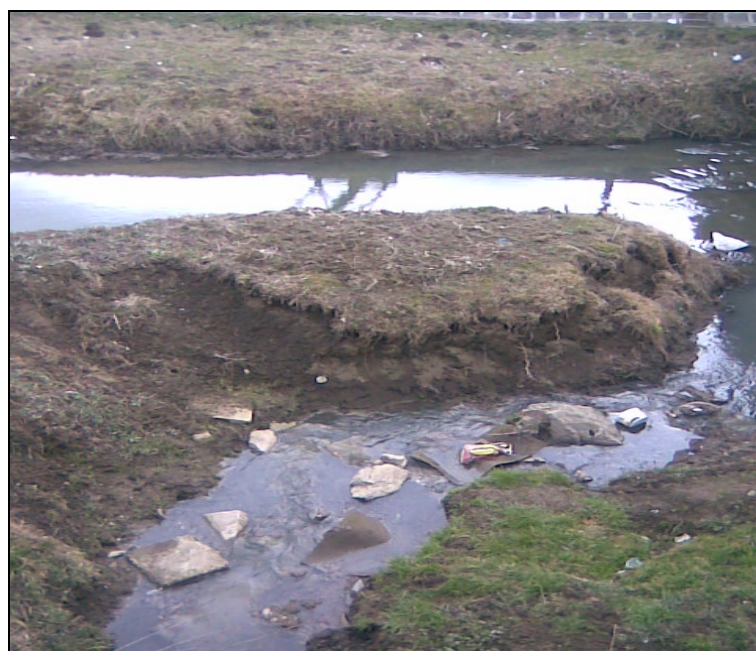
Figure 3: Pollution source, Hârțibăciu River.

Because the sources of pollution (industrial and domestic) from the city of Agnita (Fig. 3) and a complete lack of riparian vegetation, basic elements that support the selfcleaning of a lotic ecosystem were almost totally destroyed.

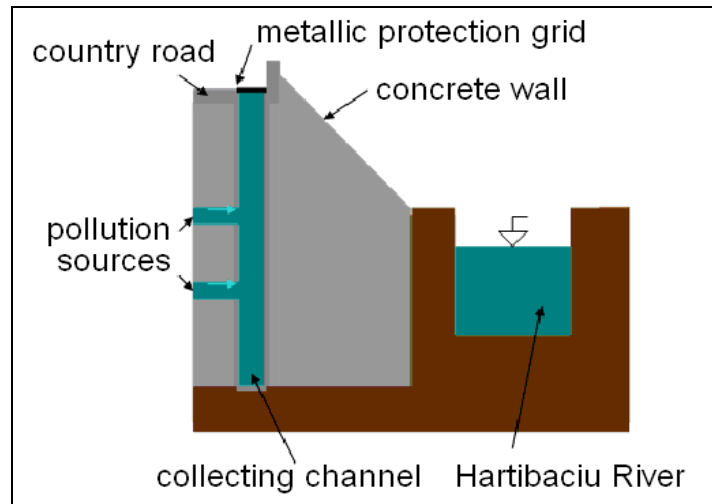
Figure 4: Collecting channel located on the right bank of Hârtibaciu River (scheme).

In order to finalize the ecological reconstruction of the Hârtibaciu River, the new river bed should be protected from any source of pollution, so the sources of pollution (city polluted water) must be captured through parallel channels built inside the concrete banks (Fig. 4).

Sizing parallel channels will be done according to the evacuated water flow (industrial and domestic) into the Hârtibaciu River.

This ecotechnical method is suggested for the riverbed sector effective starting to 400 m length up to the complete river sector arrangement. The river sector which passes through Agnita will be completed at the exit of the city. The collecting channels must have the same slope as the Hârtibaciu River. The ecotechnical reconstruction of the Hârtibaciu River will also continue downstream the city of Agnita, having about 500 m length and creating riparian areas and wetlands.

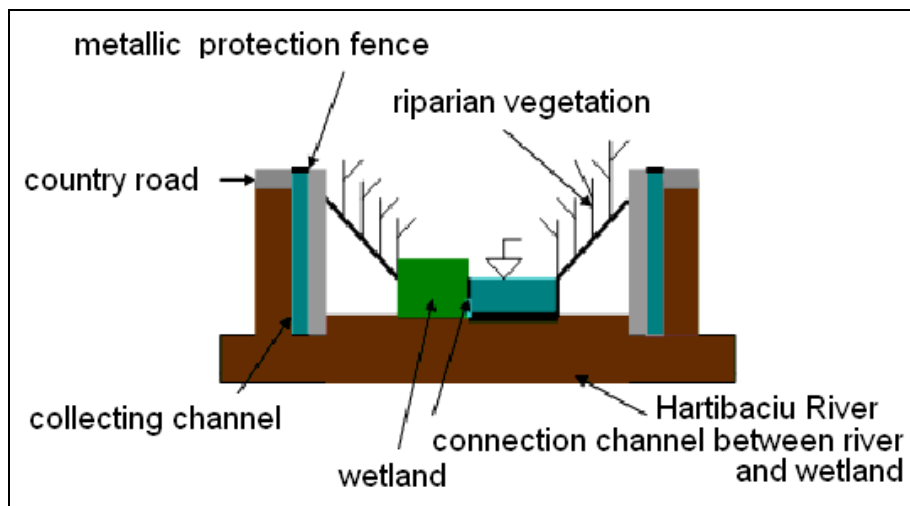
Figure 5: Ecotechnical arrangement of Hârtibaciu River in the city of Agnita - cross section (orientative scheme).

In the immediate vicinity of the Hârțibăciu River, wetlands will be built and linked to the river through a system of channels (Fig. 5).

A meandering river bed with green sides, having the form of an inclined plane (Cibin River) are necessary to be created. Water flow area will be made of wood or concrete according to regional flood frequency and amplitude. Various fast-growing woody species (alder, willow, etc.) but also herbaceous species having fascicular roots (sedge, fescue, etc.) will be planted in line or in the form of rhombs, along these banks. The banks will be filled up with soil up to the middle height of the dam protection (Fig. 5).

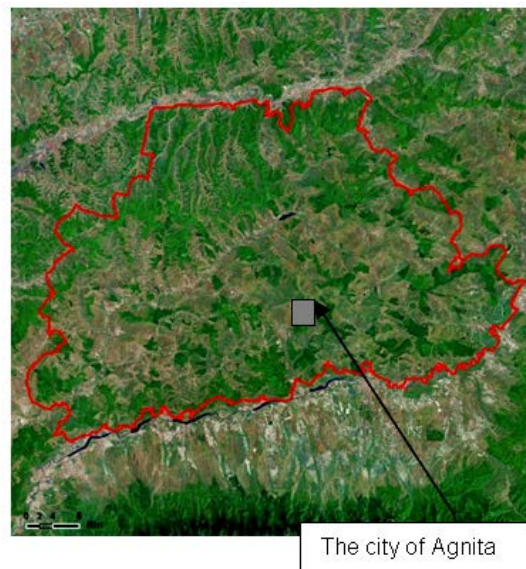
Figure 6: Hârtibaciu Plateau - Satellite image (source: Landsat Image © NASA).

According to GD 1284/2007, the Hârtibaciu Plateau (Fig. 6) has been declared a special area of avifaunistic protection becoming a bird protection area, as a part of the European Natura 2000 network in Romania. This SPA covers parts of the territory of the counties of Braşov, Sibiu and Mureş, 39 municipalities and the five cities of Agnita, Dumbrăveni, Făgăraş, Sighişoara and Rupea, being in size, together with Sighişoara-Târnava Mare area the second protected area in the country, after the Danube Delta. Most of this area is in Sibiu County, in the Hârtibaciu Valley (Fig. 7).

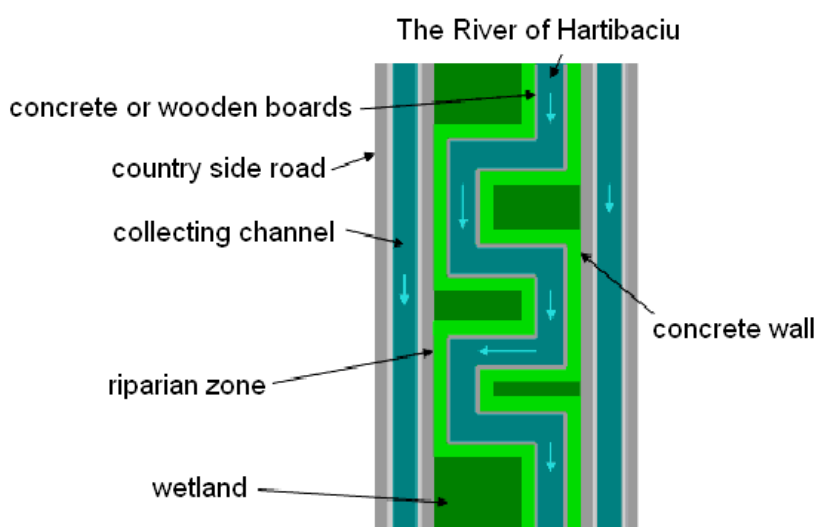
Figure 9: Ecotechnical arrangement of Hârtibaciu River in the city of Agnita
- cross section (orientative scheme).
