TECHNICAL SOLUTIONS TO MITIGATE SHIFTING FISH FAUNA ZONES IMPACTED BY LONG TERM HABITAT DEGRADATION IN THE BISTRA MĂRULI RIVER – STUDY CASE

KEYWORDS: Carpathian river, fragmentation mitigation technical elements.

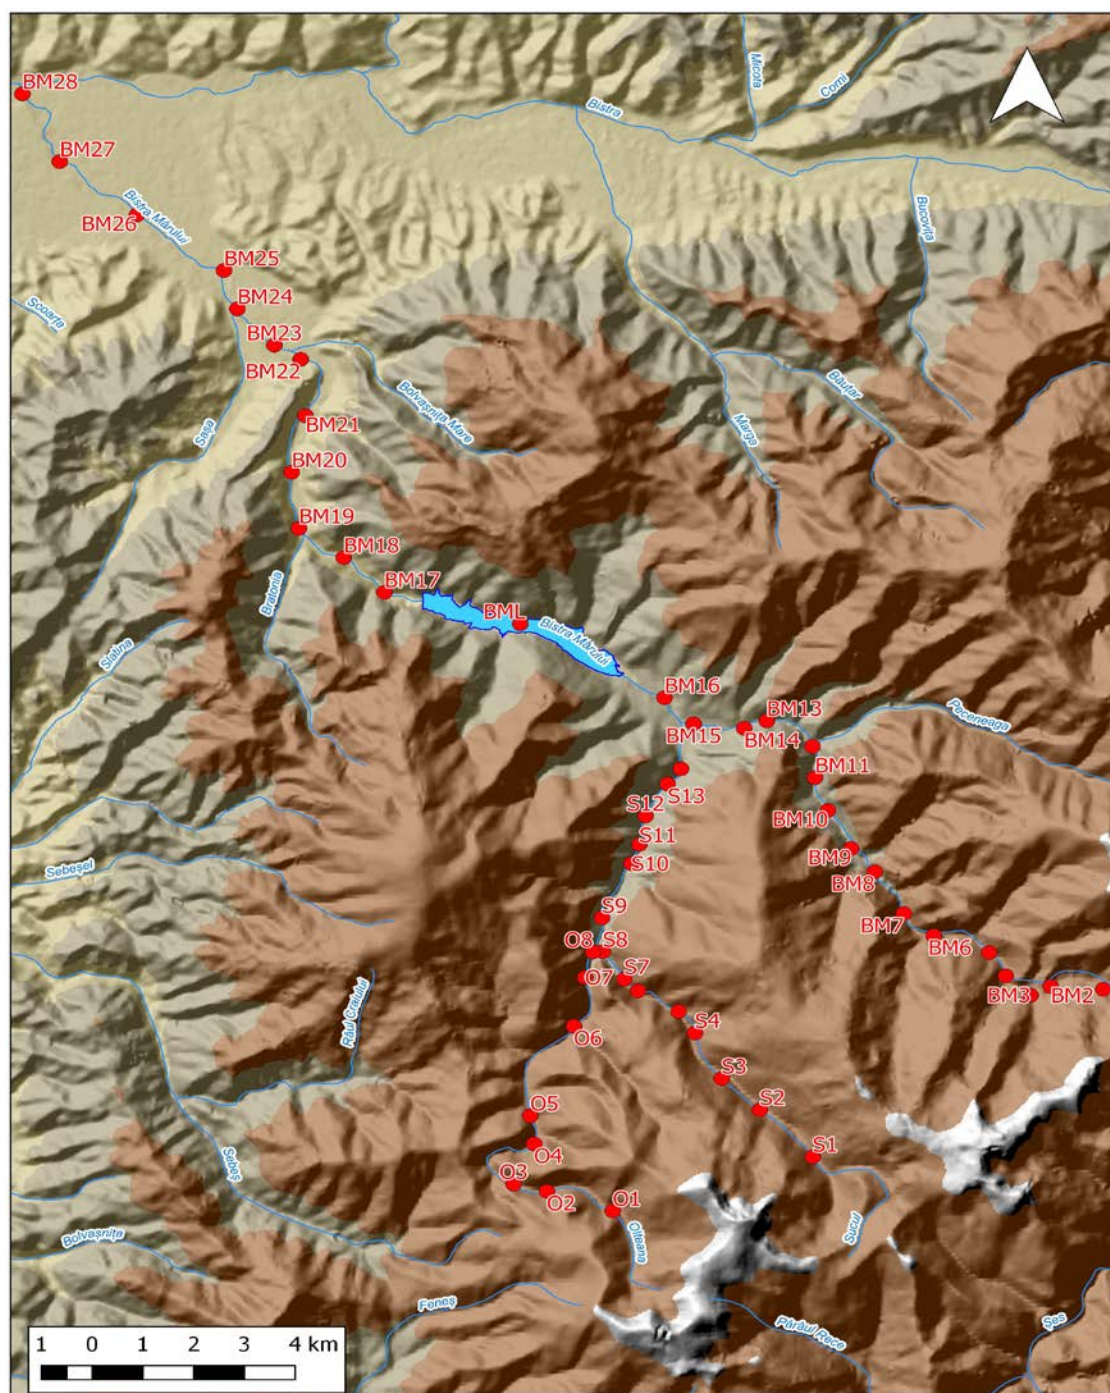
Figure 3: Sampling stations:
Bistra Mărului River (BM_n), Șucu Stream (Ș_n), Olteana Stream (O_n),
(GIS support – Pătrulescu A.).

The synthetic results of the Bistra Mărului River and two of its main tributaries (Şucu and Olteana streams) sampling stations (Fig. 3) fish fauna long term monitoring indicate a total catch of 19 fish species. The proportion of each species in the total catch changed substantially between 1980 and 2018 (Tabs. 1 and 2).

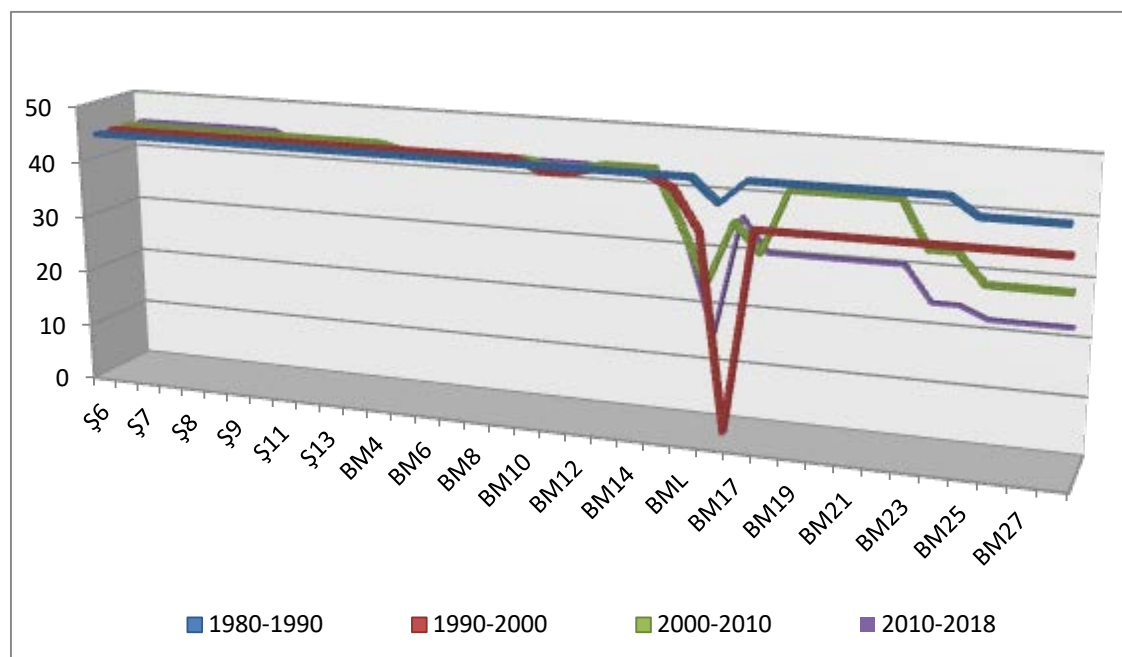
Figure 4: The decreasing trend of CF-IBI values/ecological status along the Bistra Mărului River and its tributaries Șucu and Olteana streams.

As a whole, the fish communities ecological status analysed based on the CF-IBI (Tabs. 1 and 2) register drastic deacrising especialy in the middle and lower streches and in the periods 1990-2000 – 2000-2010 – 2010-2018 (Fig. 4).

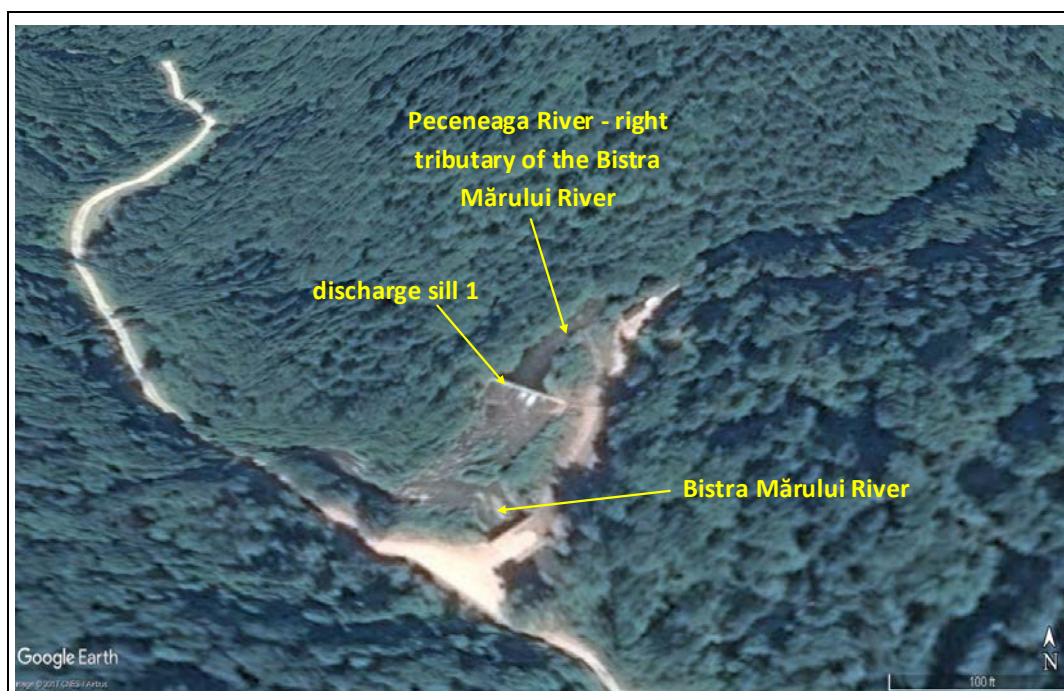
Figure 4a: Positioning the discharge sill at the confluence with the Bistra Mărului River.

On a tributary of the Bistra River (even at the confluence with it) (Fig. 4a) there is a spill threshold (1) of about 15 m long, the width of the canopy of about one m and the height of 2.3 m (Fig. 4b). The water passes through this spillway frontally through several rectangular internal breaches (Fig. 5). These characteristics block the upstream fish migration on this tributary. The engineering solution is the construction of a rectangular channel with a slope smaller than that of the river that is approximately 14‰. Thus, a rectangular channel of 1.5 cm thick concrete pallets (sheet piles) is fixed by the overflow threshold in front of the existing three breaches (Fig. 5). This concrete channel is also fixed to the concrete wall (Fig. 6) existing on the left bank of the river (tributary).

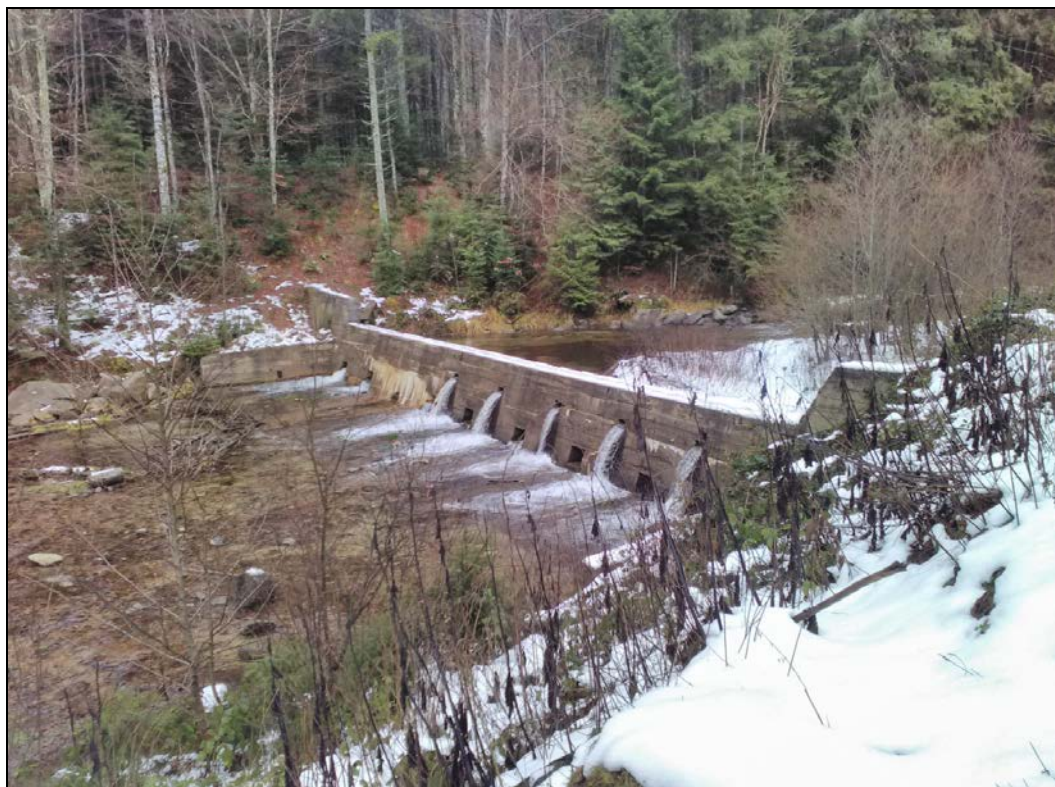
Figure 4b: The discharge sill on the tributary of the Bistra River.

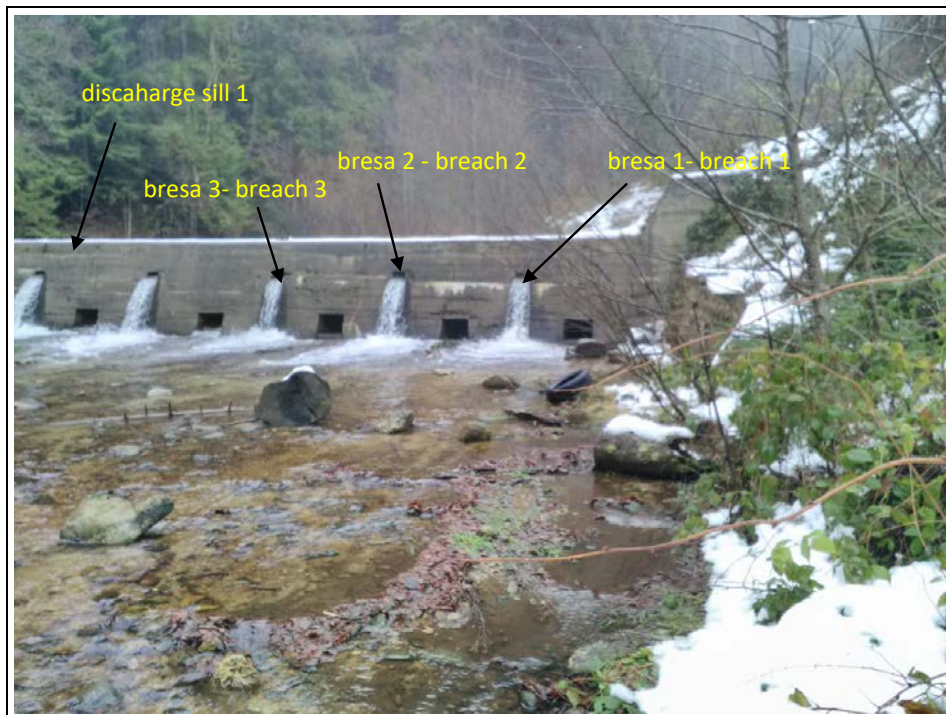
Figure 5: The three breaches located in the spill threshold 1.

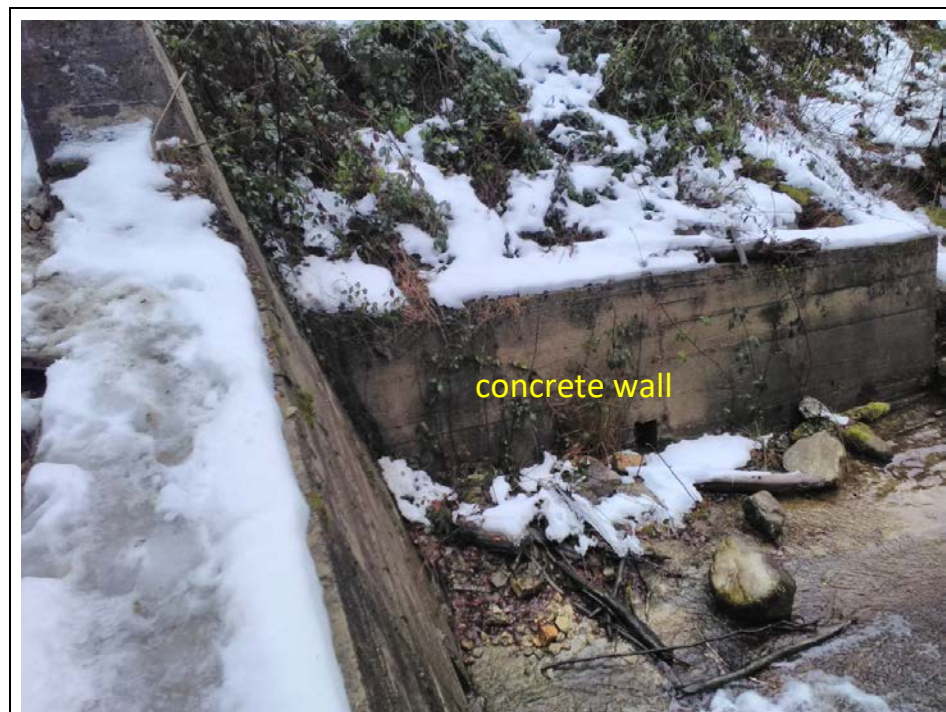
Figure 6: Positioning of the concrete wall at the left bank of the river.

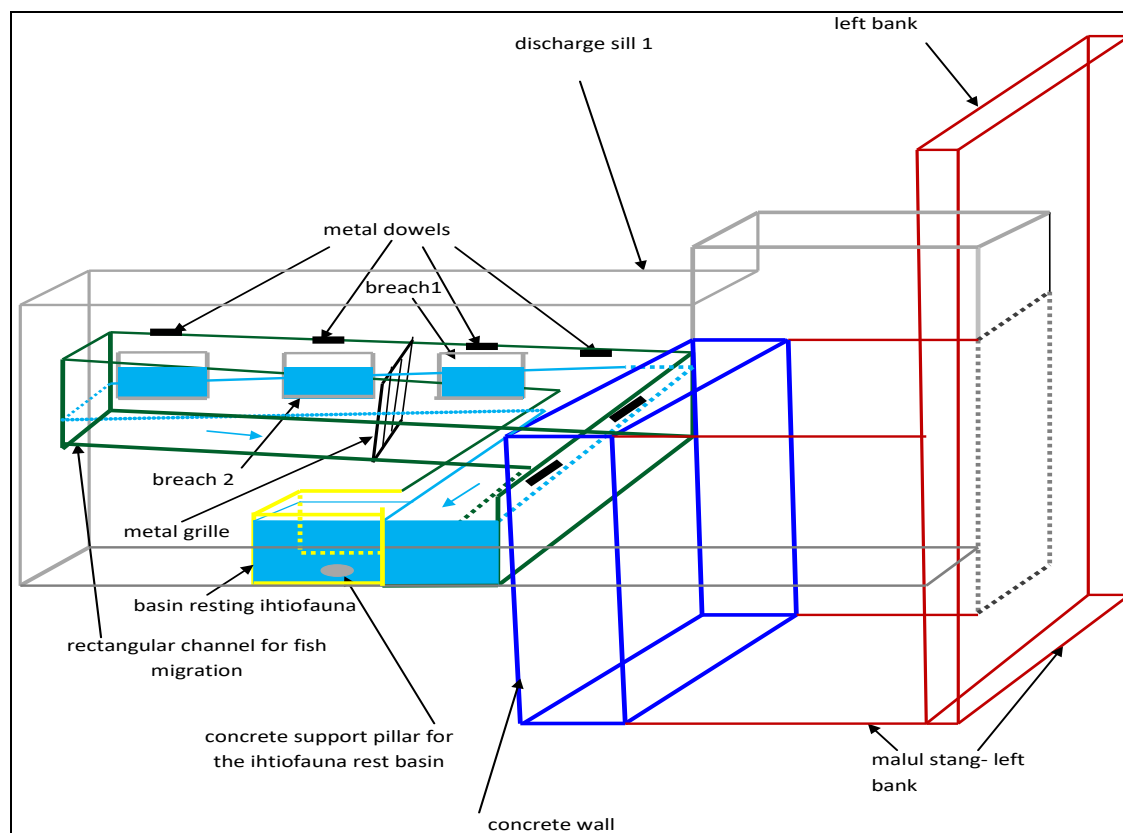
Figure 7: Positioning of the concrete channel on the spillway and the concrete wall – indicative scheme.

Before the fish migration canal goes over the concrete wall, an ihtyofauna rest pool is being built. This basin is actually a pocket of the fish migration channel and supports a concrete pillar (Fig. 7). The water inside the fish migration channel produces a remittal phenomenon within the breach 1, reducing the existing speed in this breach, thus favouring the climbing of the fish through the breach and reaching them upstream of the spillway 1. By this system, the breaches do not clog or obstruct they operate at normal capacity. Between the bust 1 and the bust 2 a metal fence is fixed to redirect the fish to the breach 1 (Fig. 7).

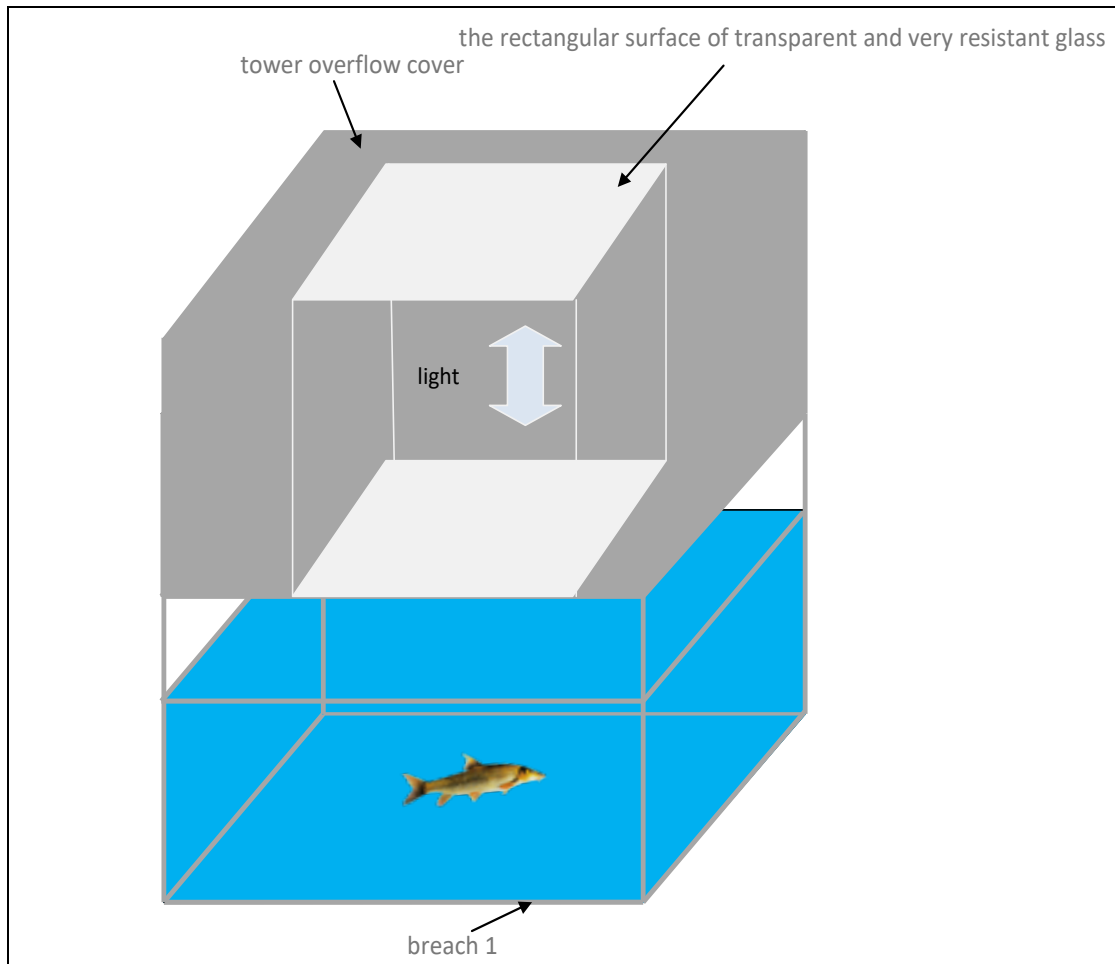
Figure 8: Positioning of the rectangular window with a transparent and very resistant glass – indicative scheme.

The concrete channel has a width of 40 cm and a height of 30 cm and is fixed in metal dowels above the three existing breaches (1, 2 and 3). We mention that each bust is 25 cm high and 30 cm wide. In the sheet pile which is fixed directly to the spill threshold there are rectangular spaces of the same size as the existing breaches in the spill threshold (Fig. 7). The water level captured from the bridges 2 and 3 must overcome by a few centimetres the first breach (1) or at least the water level in the rectangular channel for fish migration occupy two-thirds of the breach 1 (Fig. 7). Under these conditions, fish can easily migrate through the first breach. In the upper part of the first breach a rectangular parallelepiped must be constructed to light the brace 1. This rectangular parallelepiped is closed at the top (the crown of the spill threshold) and on the lower part (direct connection with the bust 1) with two rectangular glass surfaces transparent and very resistant (Fig. 8).

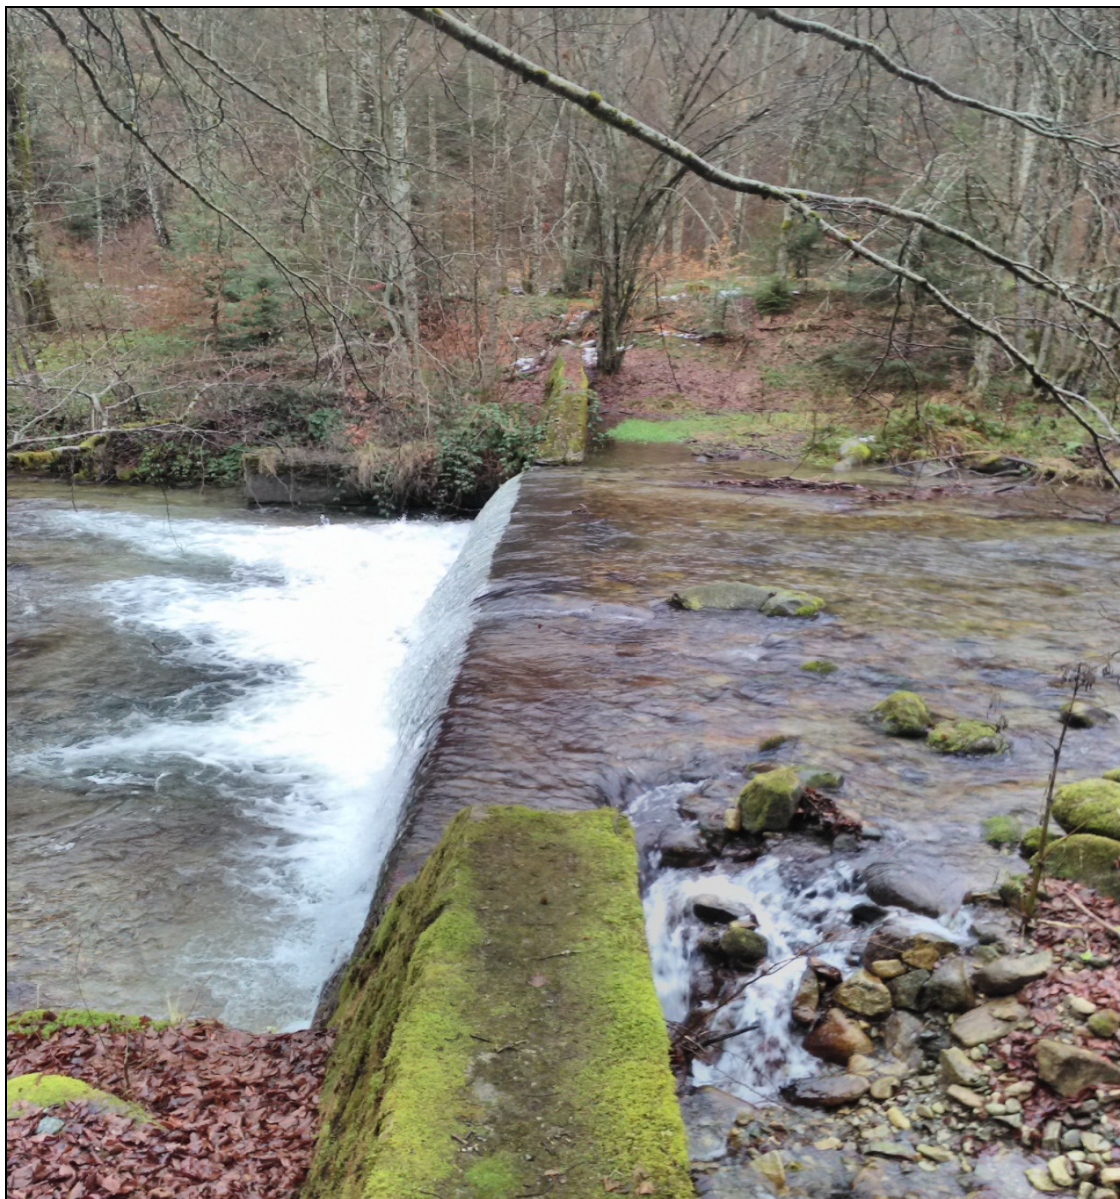
Figure 10: Discharge sill 5.

The length of the spill threshold (Fig. 10) on the Bistra River is about 10 m and the water speed is close to 0.8 m/s. The height of the spill threshold is 1.4 m and the width of the canopy of one m and the slope of the river in the area is about 12‰. At the threshold of the spillway 5 near the left bank of the river Bistra, a meter from the concrete wall is a breach (Fig. 11). The breach has a height of one m and a width of 40 cm.

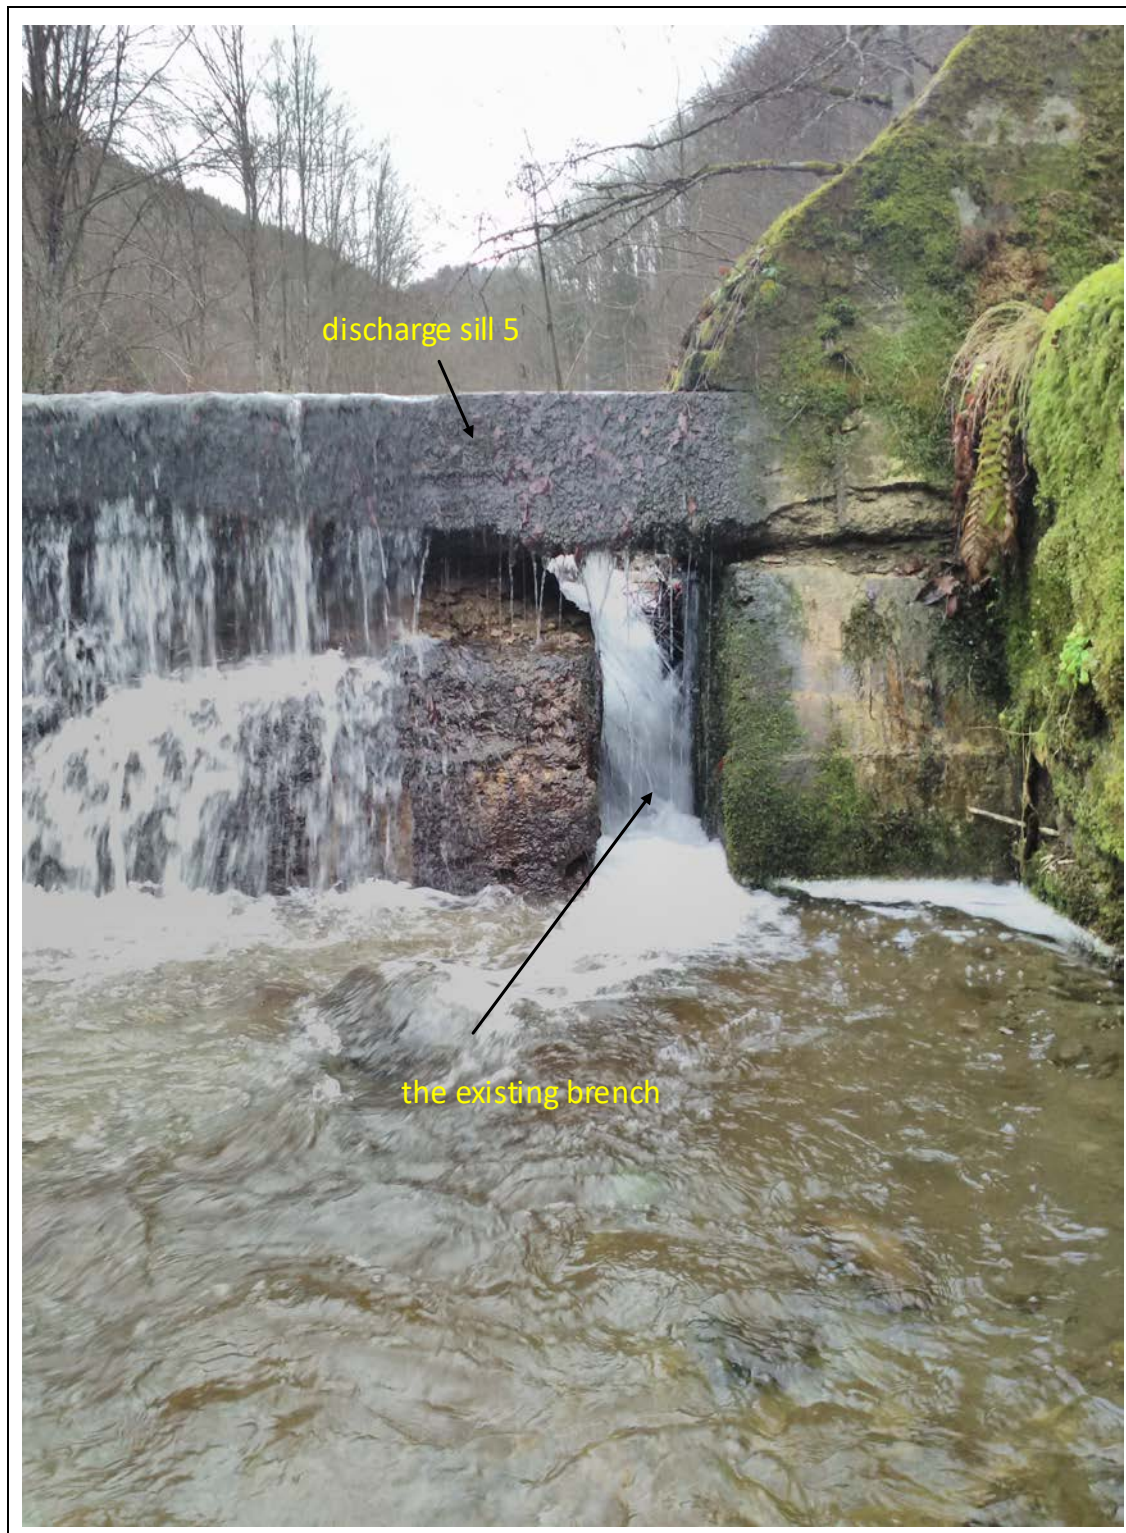
Figure 11: Positioning of the brench in the discharge sill 5.

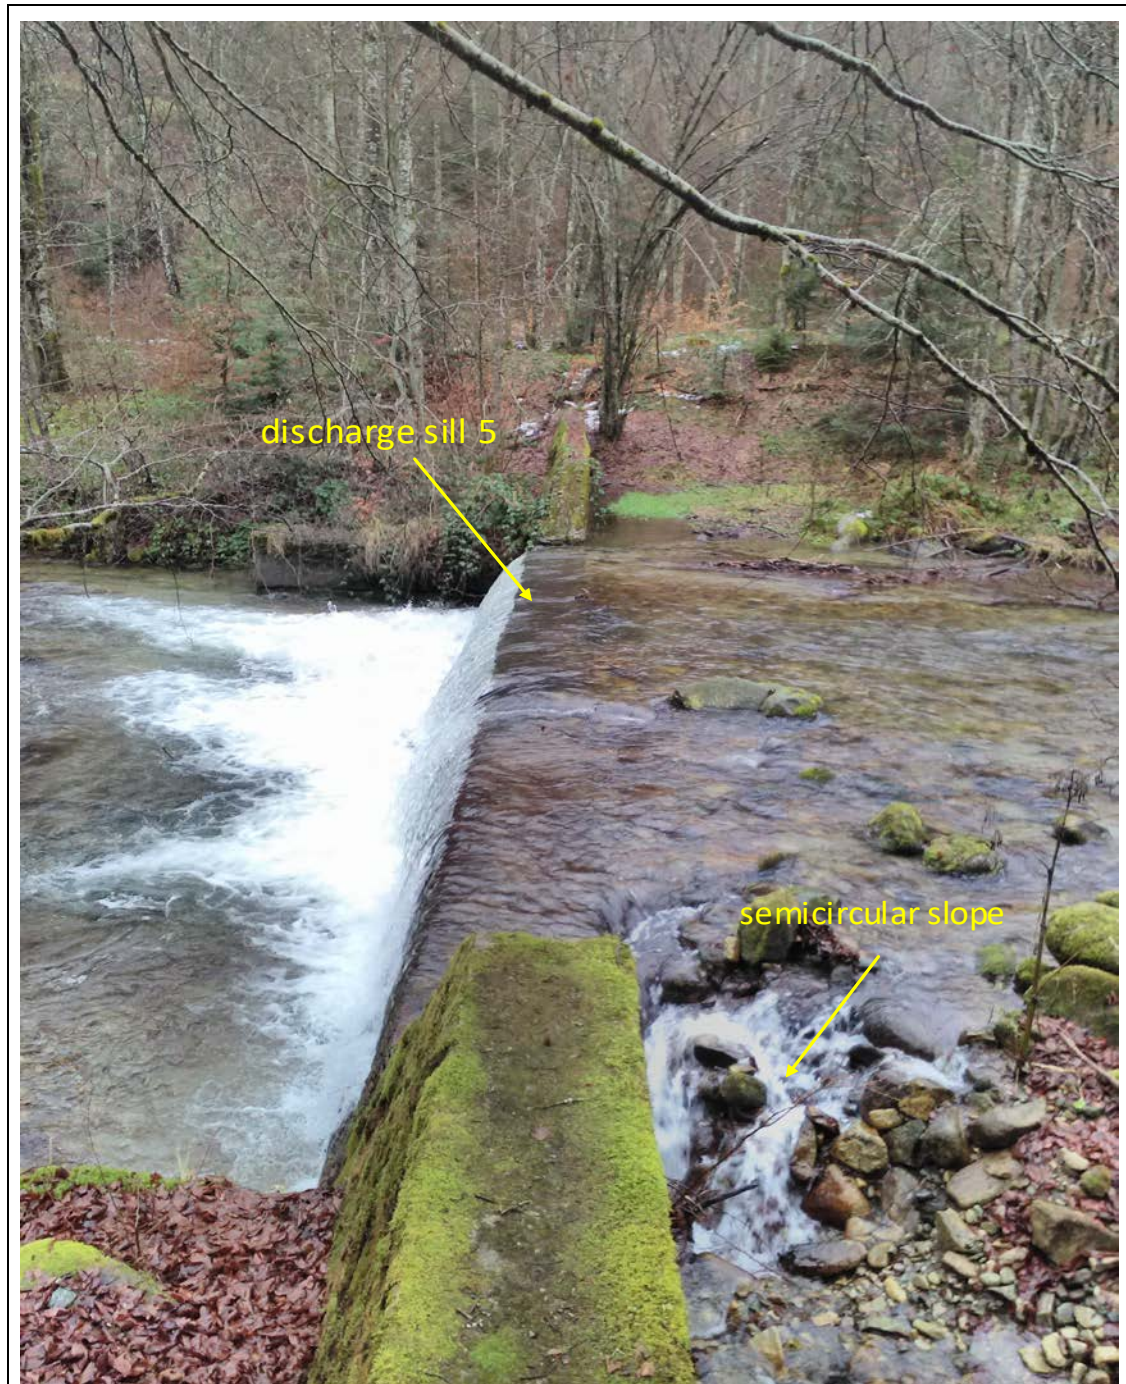
Figure 12: Capturing water in the existing breach with the help of the semicircular slope.

The water is captured in this breach by a natural semicircular slope with a large slope of about 60% (Fig. 12).

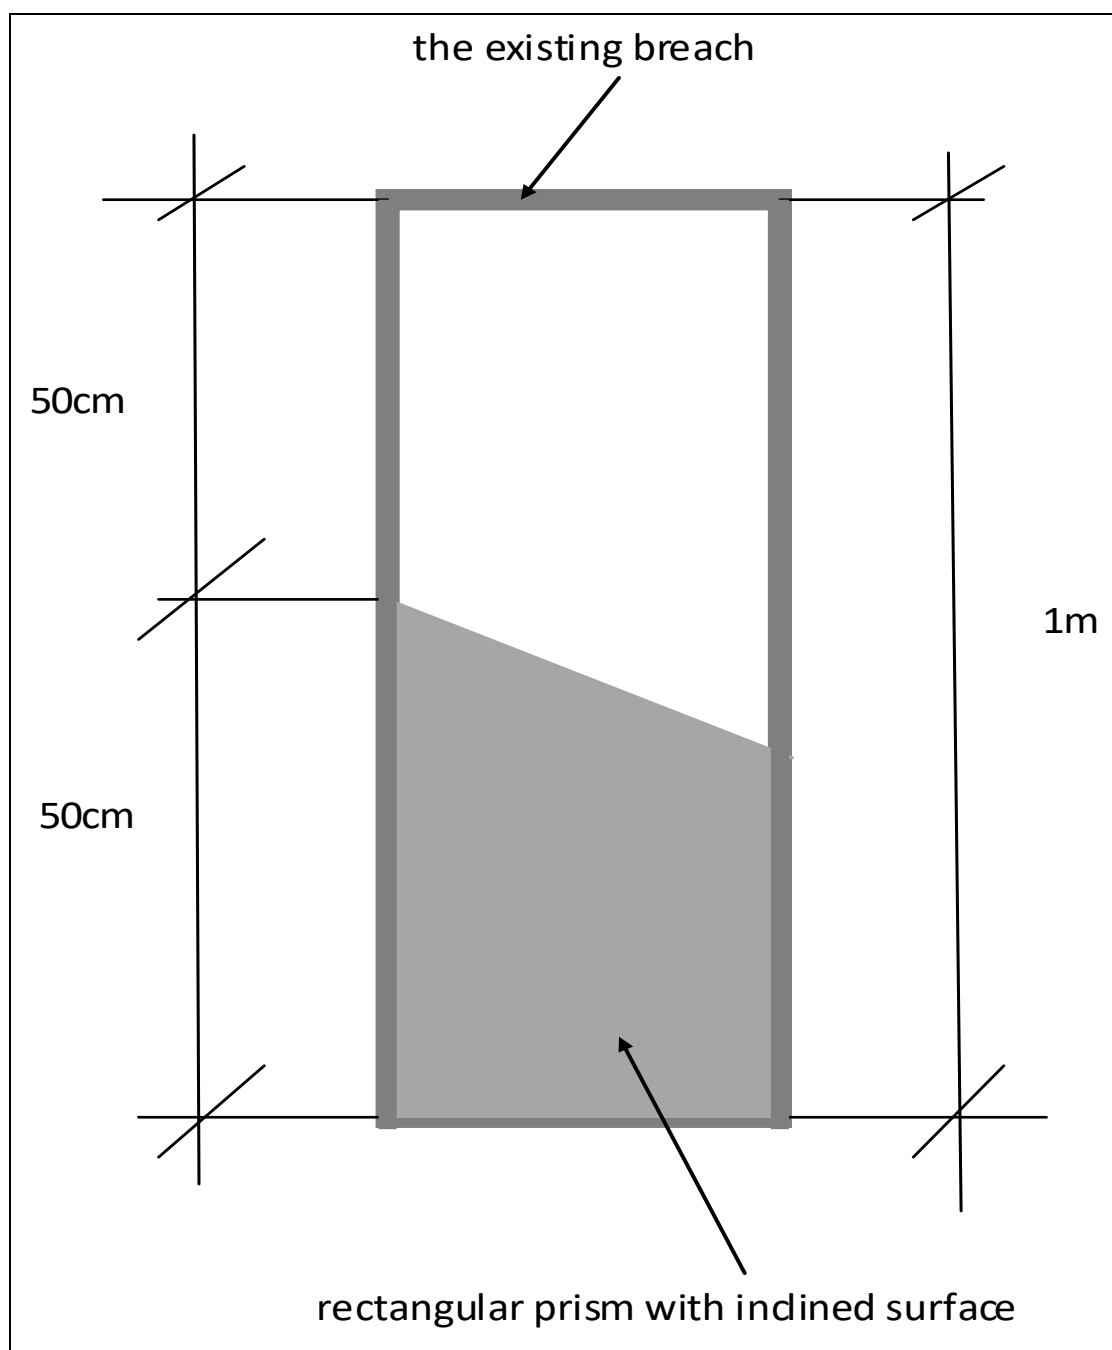
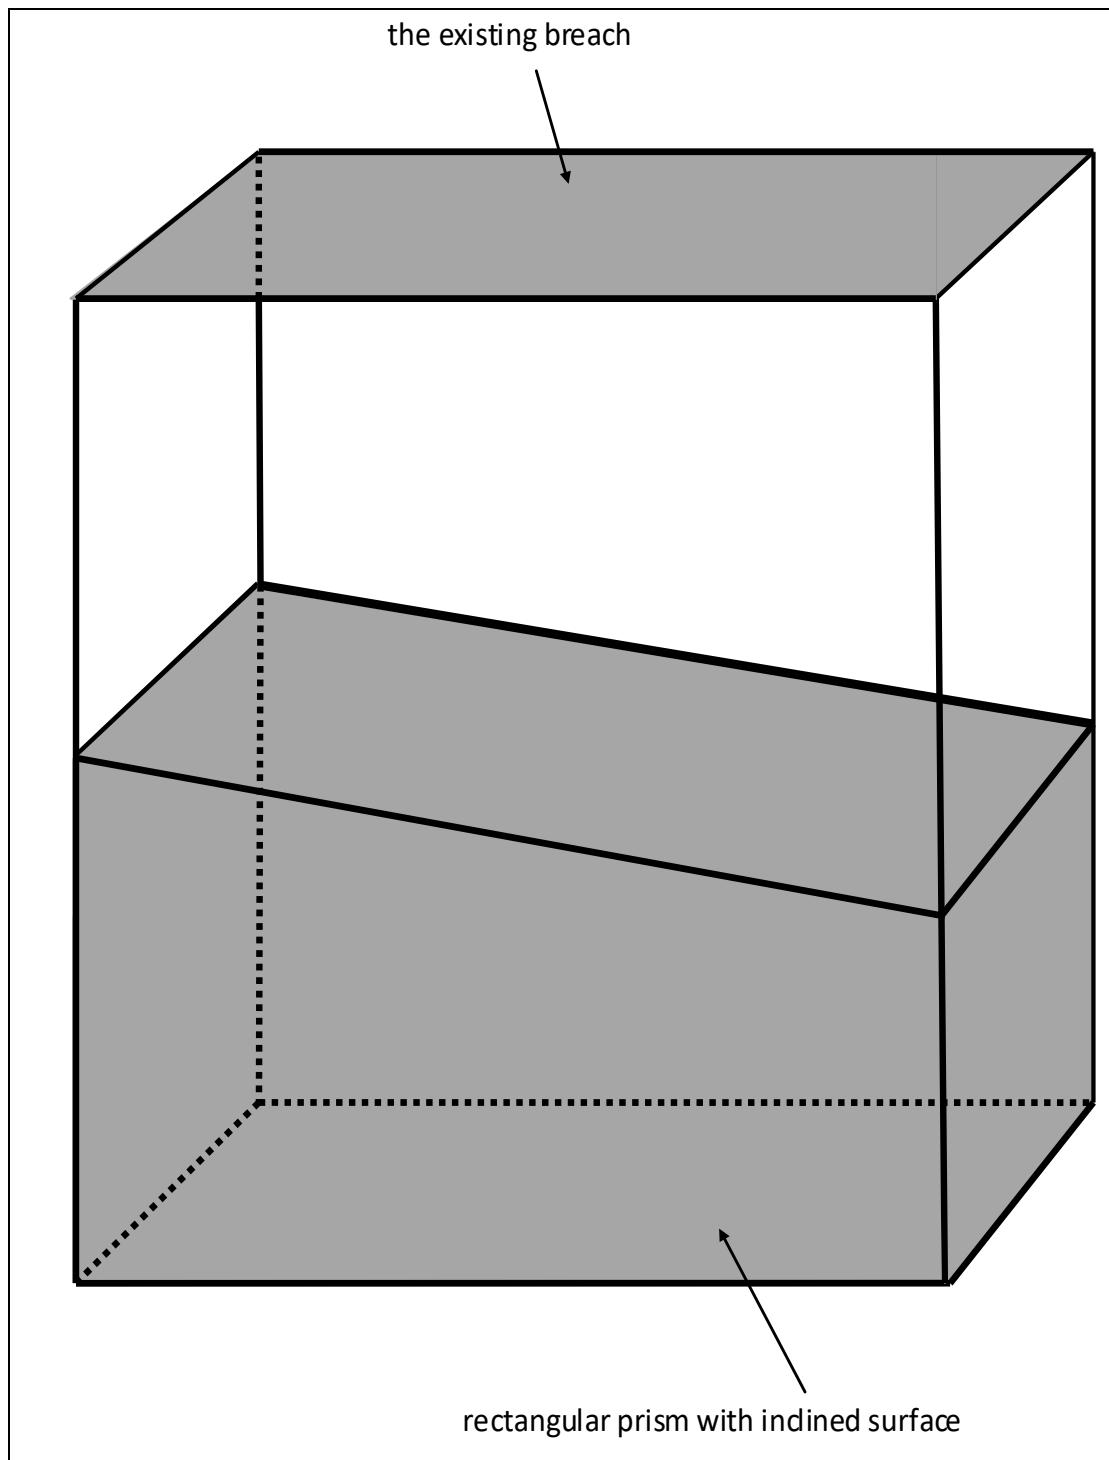
Figure 13a: Rectangular prism positioning with inclined surface
– cross section – indicative scheme.

Figure 13b: Positioning the rectangular prism with a tilted surface – indicative scheme.

A fish migration system must be developed within the existing breach. To reduce the slope, half of the slab must be filled with concrete. Fill it with a rectangular prism with a tilted surface (Figs. 13a and b).

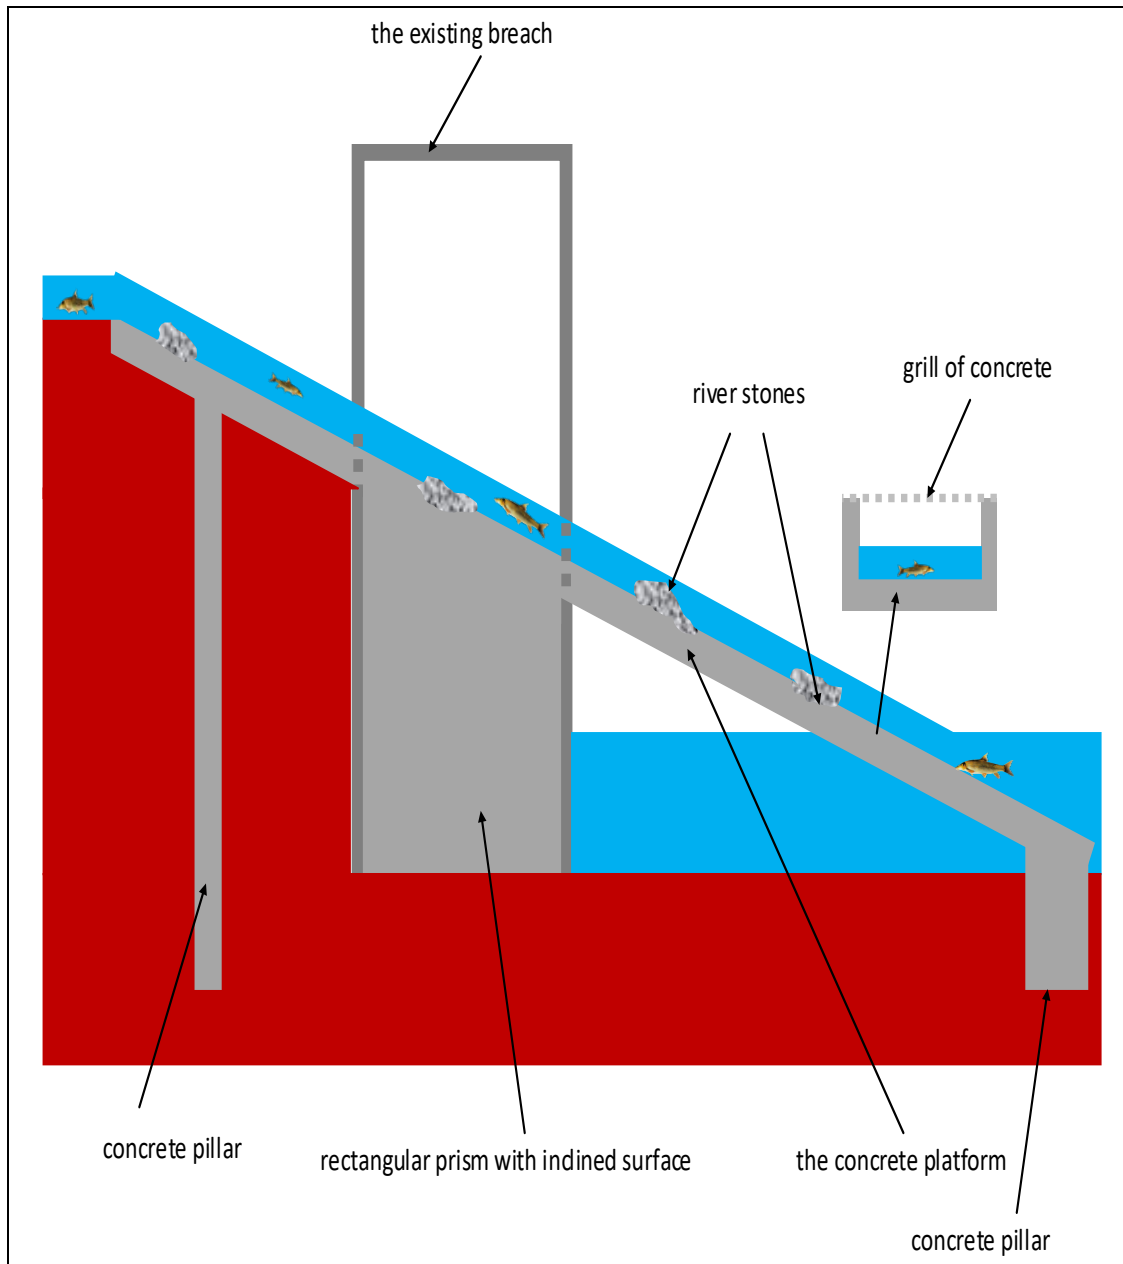
Figure 14: Positioning of the concrete platform upstream and downstream of the discharge sill 5 – indicative scheme.

The inclined surface will extend upstream of the discharge sill 5 to the upper level of the Bistra riverbed (Fig. 14). The river's riverbed must be arranged in a tilted plane on which will be fixed stones (Fig. 14). On the inclined surface, a concrete platform downstream of the discharge sill 5 will be fixed to the level of the Bistra riverbed (Fig. 14) and the downstream end will be fixed by a concrete pillar. The concrete platform will be fastened by a concrete pillar and at the upstream end (Fig. 14).

Downstream of the discharge sill the concrete platform will be framed by concrete parapets and above it will have a concrete grid as a defence against the poachers (Fig. 14). Upstream, the slopes limiting the concrete platform that the fish pass upstream – downstream of the spillway are stabilized with a concrete layer on which river stones are attached (Fig. 15). The slopes cannot be crossed by the fish.

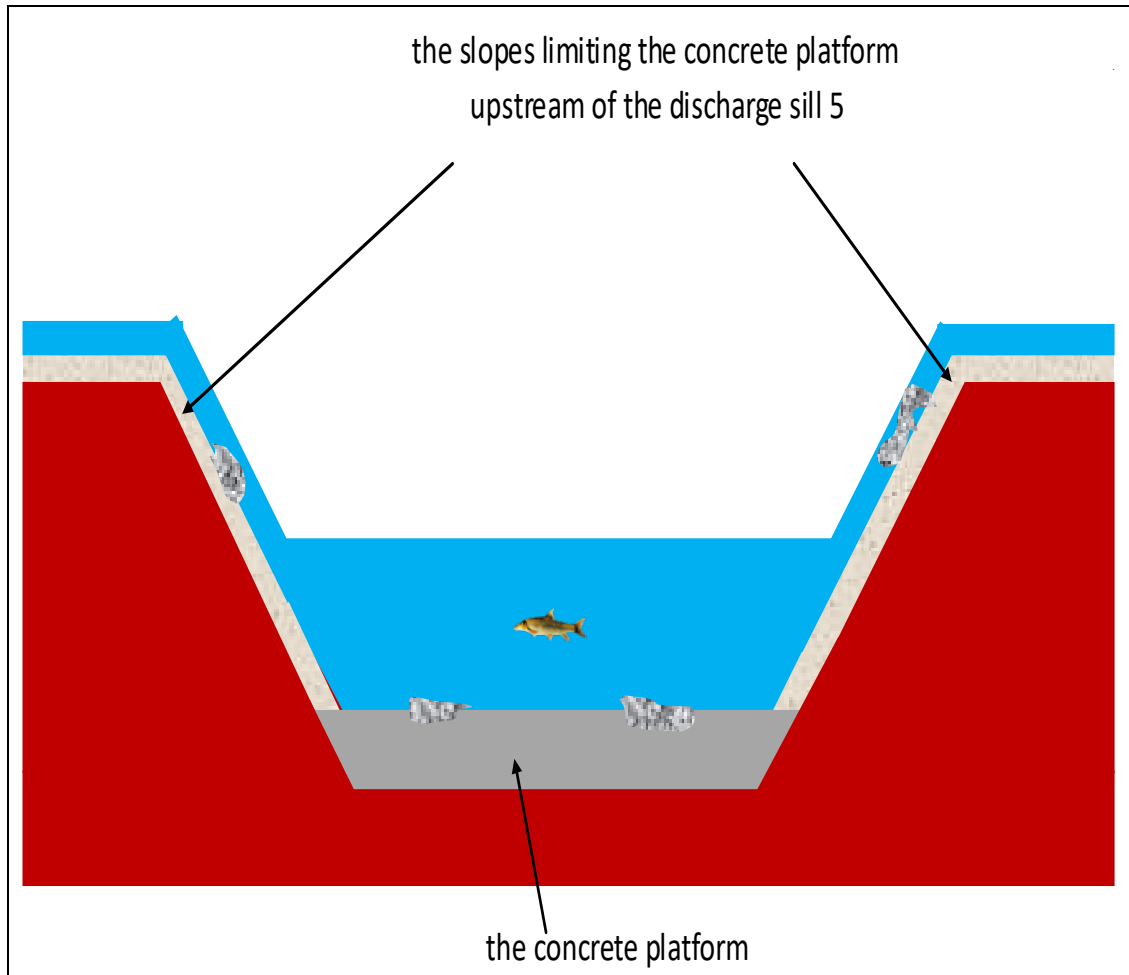
Figure 15: Reconstruction of the concrete platform slopes upstream of the discharge sill 5 – indicative scheme

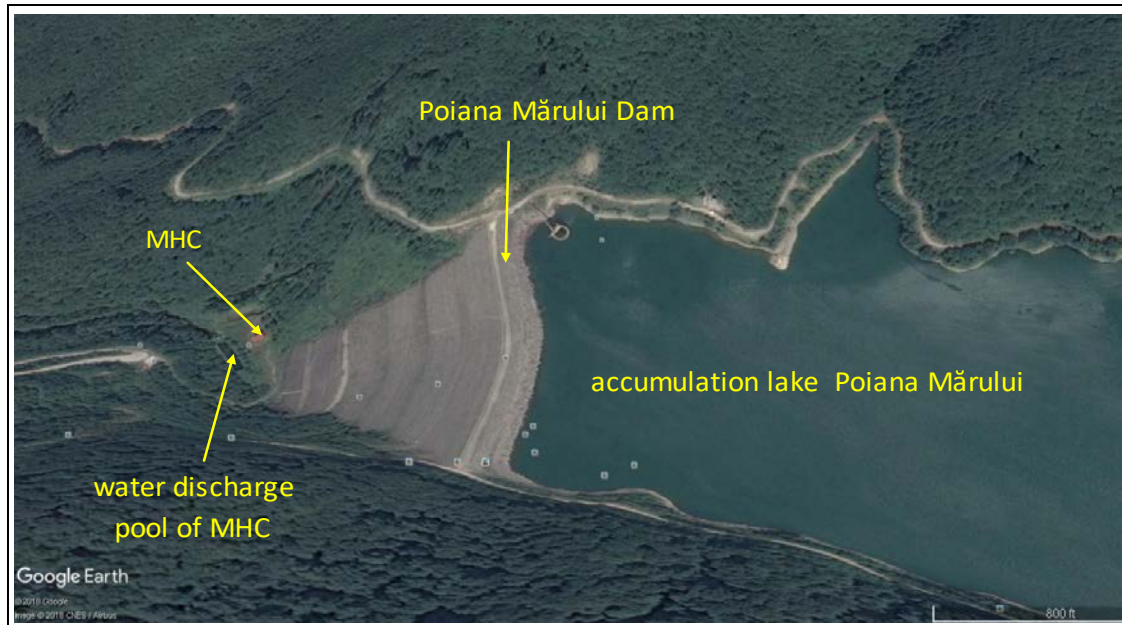
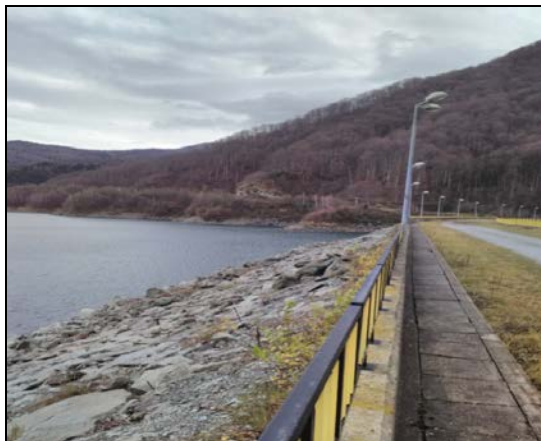
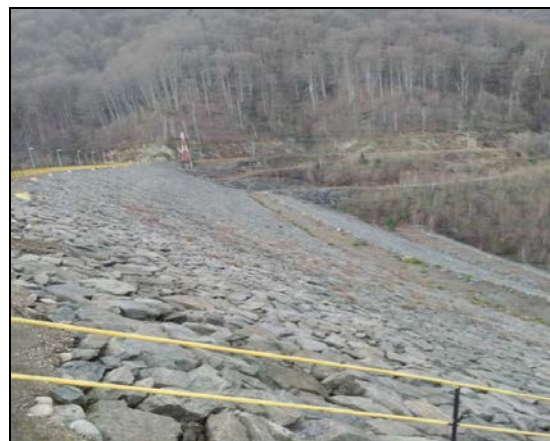
Figure 16a, b and c: Poiana Mărului Dam.

The dam of Poiana Mărului Lake (Figs. 16a, b, c) was conceived from rockfill with clay core. The emptying of the reservoir is carried out through a pressure inlet manifold up to the house of the lake emptying valves and is equipped with two flat valves in the housing and a free-standing gallery after the house of the valves. The discharge rate is about 159 m³/s. A bypass duct leaves the house of the valves and provides a service flow of one m³/s which in turn feeds MHC from the base of the dam. (http://www.hidroconstructia.com/dyn/2pub/proiecte_det.php?id=38&pg=1)

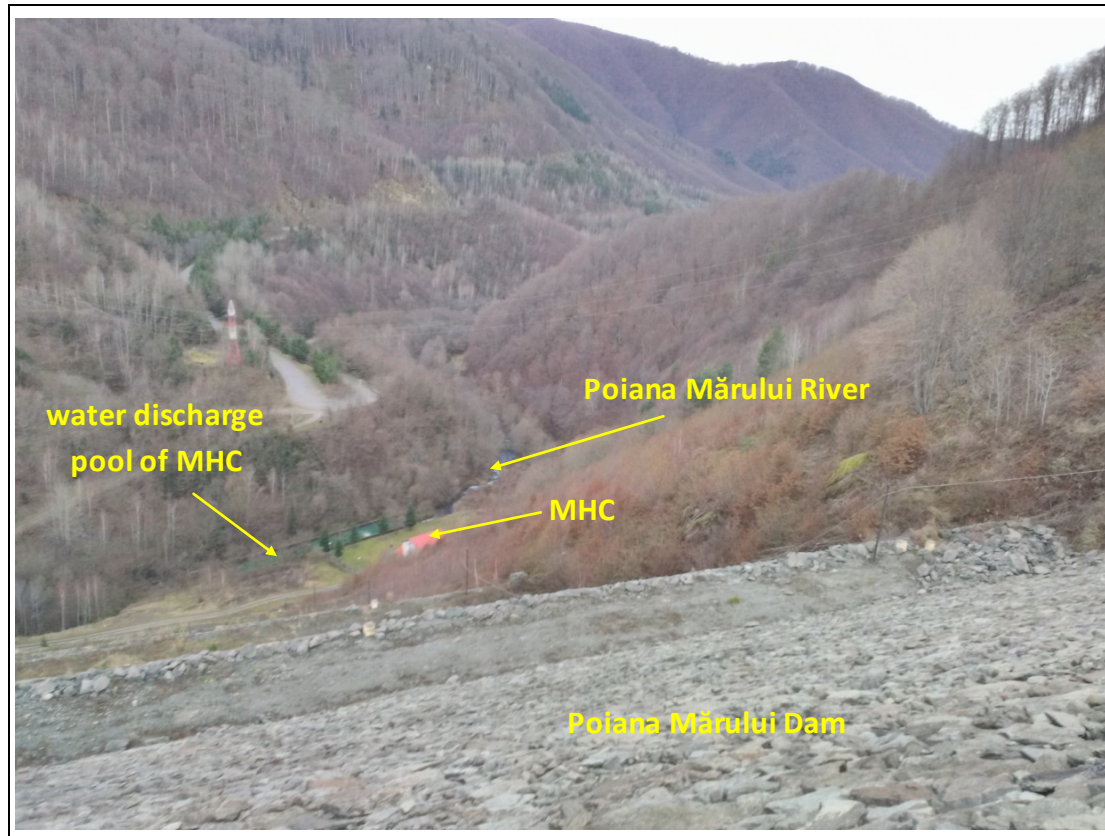
Figure 17: Positioning of the water discharge basin in MHC.

After feeding the MHC the water is discharged into a rectangular parallelepiped basin (Fig. 17) and from this basin the water returns to the river bed of Bistra Mărului (Fig. 17).
