TECHNICAL SOLUTIONS TO MITIGATE SHIFTING FISH FAUNA ZONES IMPACTED BY LONG TERM HABITAT DEGRADATION IN THE BISTRA MĂRULI RIVER – STUDY CASE

KEYWORDS: Carpathian river, fragmentation mitigation technical elements.

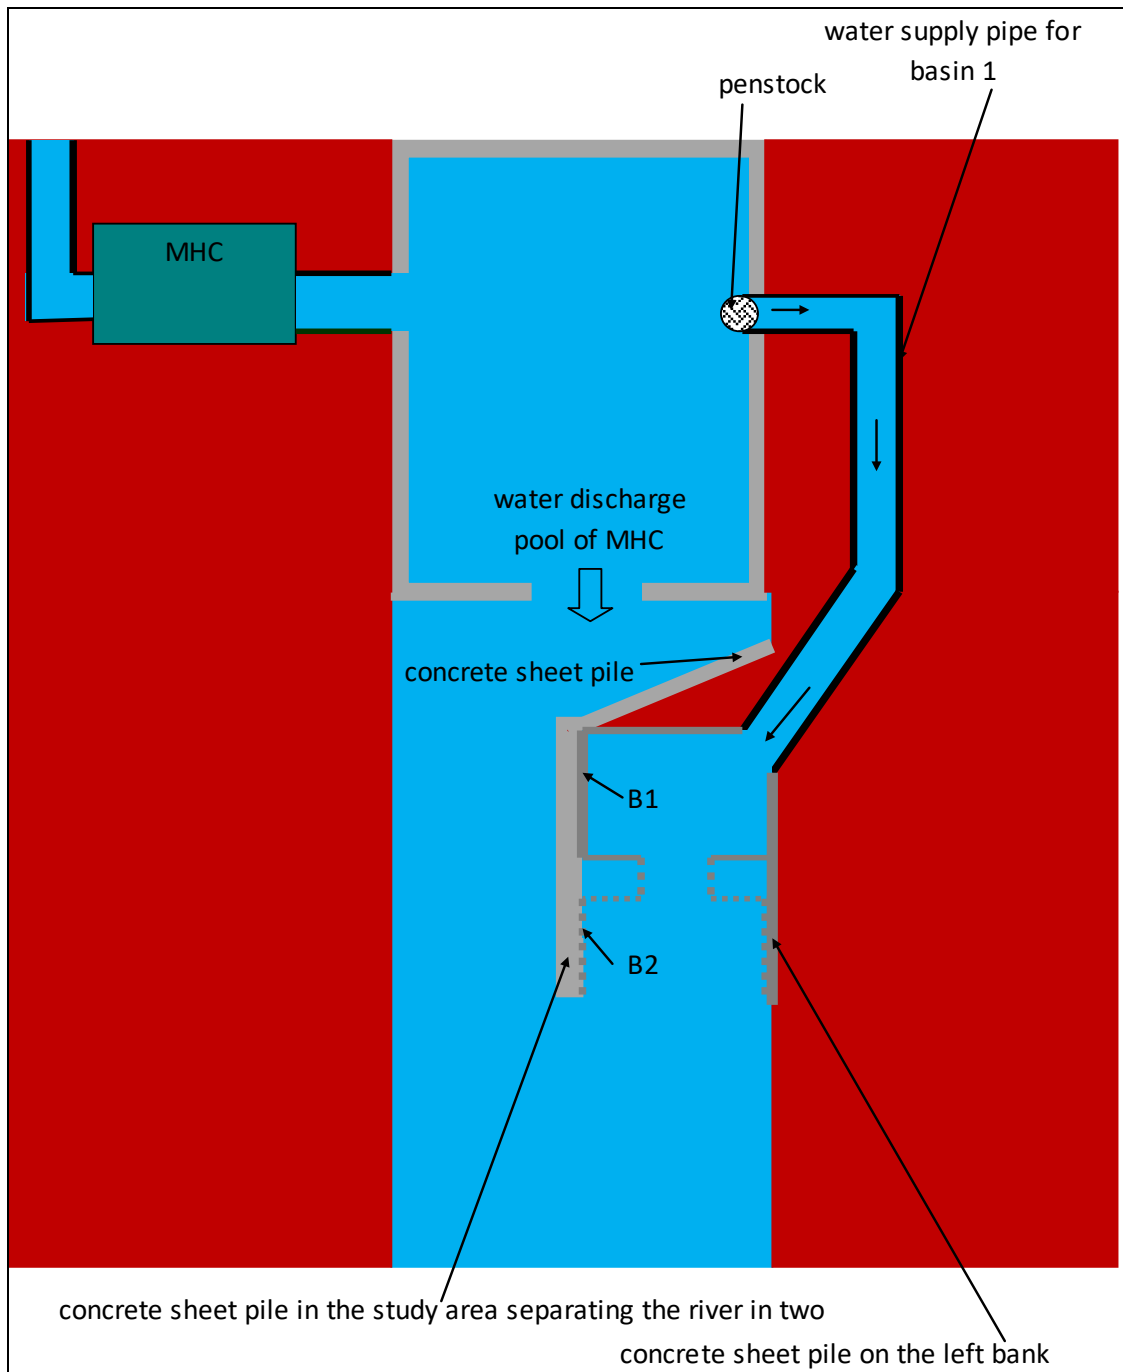
Figure 18: Positioning of the metallic pipe feeding the basins B1 and B2 and positioning of the two basins B1 and B2 – indicative scheme.

Downstream of the discharge basin (about five m), the river will be divided into half with a five cm thick concrete sheet pile and eight m long. In this basin must be a break in which a metal pipe with a manual or automatic valve must be fitted. On the left bank there will be a concrete sheet pile and a new concrete sheet pile will be attached on the first concrete sheet pile. The second concrete sheet pile will divide the river in half (Fig. 18). In the left side of the river divided by the concrete sheet pile, a rectangular parallelepiped basin of concrete (basin 1, quenching) will be built where the water discharged out of the pipe. The flow rate of the pipeline is about 0.5 m³/s. River flow in the area is about one m³/s. From the first basin, a hydraulic jump (40 cm) will connect a second basin (basin 2) (Fig. 18). The basin 2 will be parallelepiped and will be below the river level (Fig. 19).

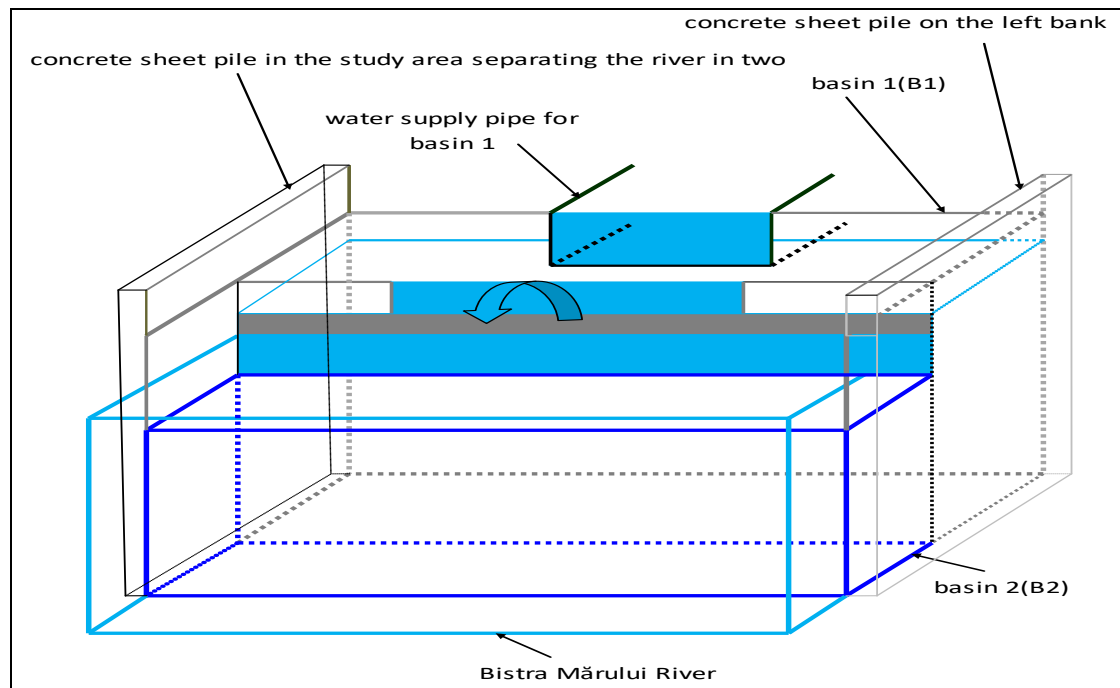
Figure 19: The link between basin 1 and basin 2 – indicative scheme.

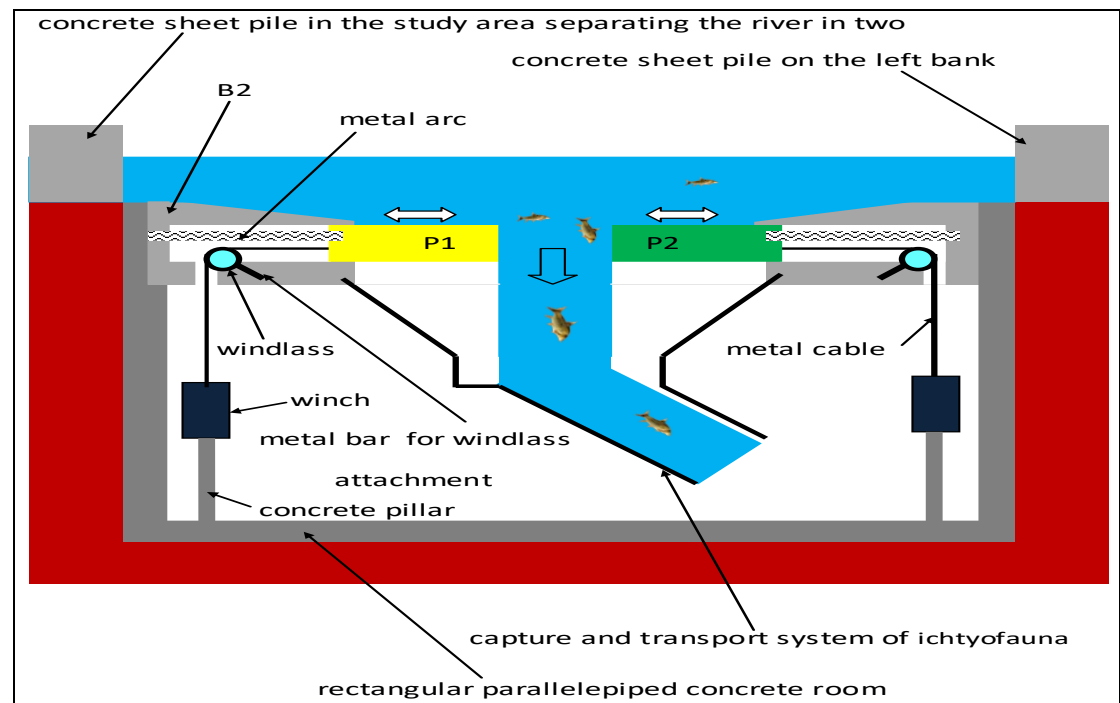
Figure 20: Placing of moving P1 and P2, windlass and trolleys inside the rectangular space – indicative scheme.

Approximately 20 cm of water is above the basin 2, in fact the Bistra Mărului River level is in the study area. The base of the basin 2 should be approximately 30 cm thick and include two moving concrete slabs in a horizontal plane. The upper part of the basin 2 is shaped like a funnel for water capture. A parallelepiped rectangular special room must be constructed under the base of the basin 2. There is an electric winch next to the downstream end of the P2 concrete sheep pile. There is an electric winch next to the upstream end of the P1 (concrete sheep pile). Next to each electric winch is a metal bar on which a windlass is welded. Over the two windlass are placed the two wires of the electric winches that will be fastened by the two mobile plates P1 and P2 (Fig. 20).

The metallic springs are fixed to the concrete sheet piles P1 and P2 and to the walls of the underground rectangular space (Figs. 20 and 21). At the moment when the windlass is moved due to an ichthyofauna sensor, the concrete plates are moved with horizontal movement. During the plate movements, the springs contract and de-contrast when the concrete sheet piles P1 and P2 return to the original position. The downstream end of the underwater capture and transport system of the ichthyofauna will be directly linked to a horizontal parallelepiped subterranean basin located horizontally. This does not have a vertical surface (Fig. 22). The downstream end of the underground capture and transport system of the ichthyofauna fixes on a metal arch a thin transparent and resistant plastic sheet pile that allows the water and the ichthyofauna to penetrate into the horizontal rectangular parallelepiped basin located in the horizontal plane (Fig. 22).

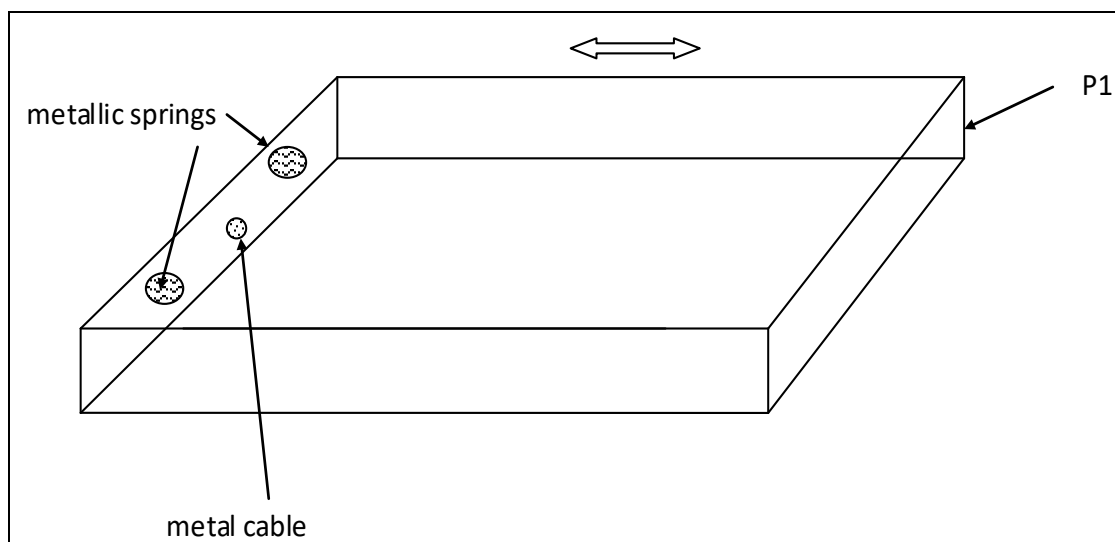
Figure 21: Positioning the metallic springs and the metal cable – indicative scheme.

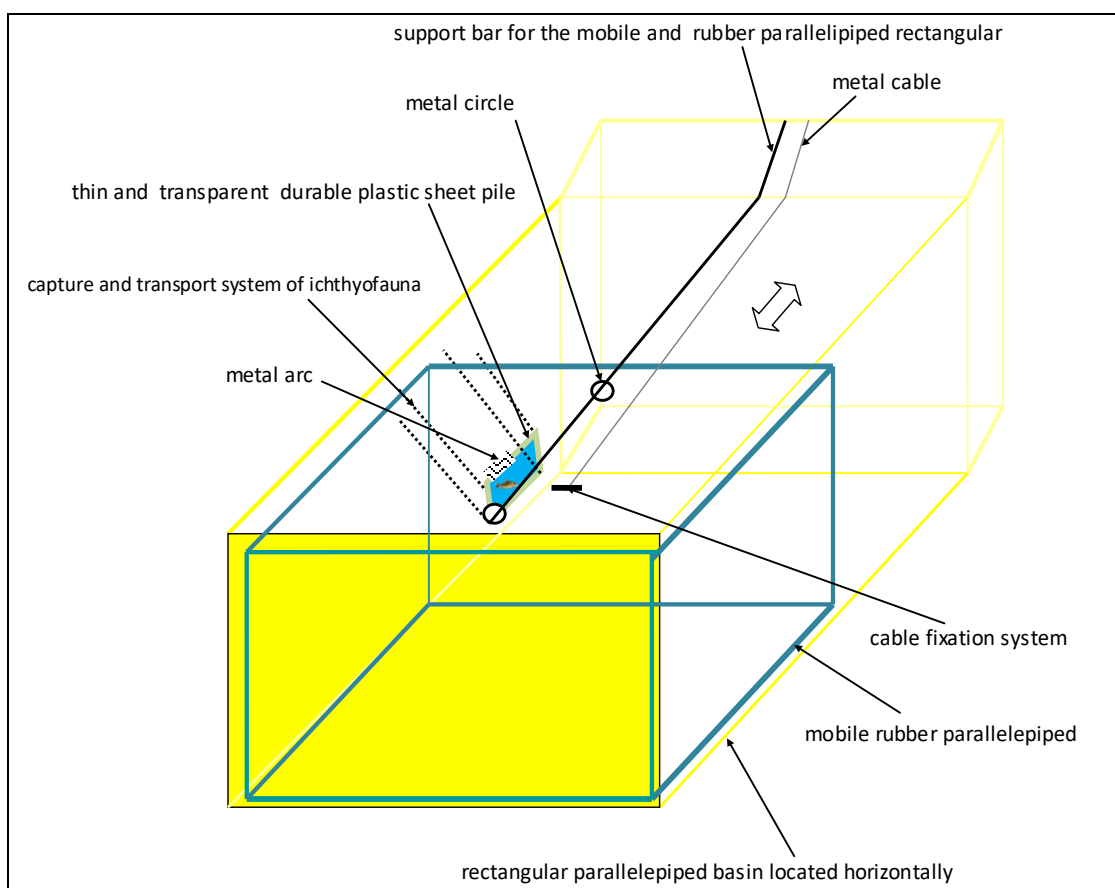
Figure 22: Positioning of the mobile rectangular parallelepiped from rubber – indicative scheme.

Inside the rectangular parallelepiped basin located horizontally, a parallelepiped of resistant rubber slides into the horizontal rectangular parallelepiped basin. Between the rubber parallelepiped and the top of the right (underground) basin located in the horizontal plane remain approximately 20 cm. These 20 cm remain the full length of the rectangular parallelepiped basin in the inclined plane. From the upper surface of the rectangular parallelepiped basin located horizontally, a metal reinforced bar is fastened. From this bar through two metal rings, the movable parallelepiped of rubber is fixed. The rectangular parallelepiped basin located horizontally will be extended also in inclined plane (Fig. 22). A metal cable (Fig. 22) should be attached to the rubber parallelepiped. The right-angled (subterranean) parallelepiped basin located in the horizontal plane will exit the underground and be fixed on concrete pillars and extend in an inclined plane and then horizontally up to the dam (Fig. 23). The upstream end will be secured by a concrete pillar (Fig. 23). The movable rectangular parallelepiped of rubber will be towed up to the upstream end of the rectangular parallelepiped basin located horizontally by a winch located on a concrete pillar on the bank of the accumulation lake Poiana Mărului (Fig. 23). At the moment of closing the transparent and resistant plasterboard with a sensor, the winch is automatically placed on a concrete pillar on the bank of the accumulation lake Poiana Mărului. Detaching the water from the fish migration system will be done through a free-standing rectangular canal.

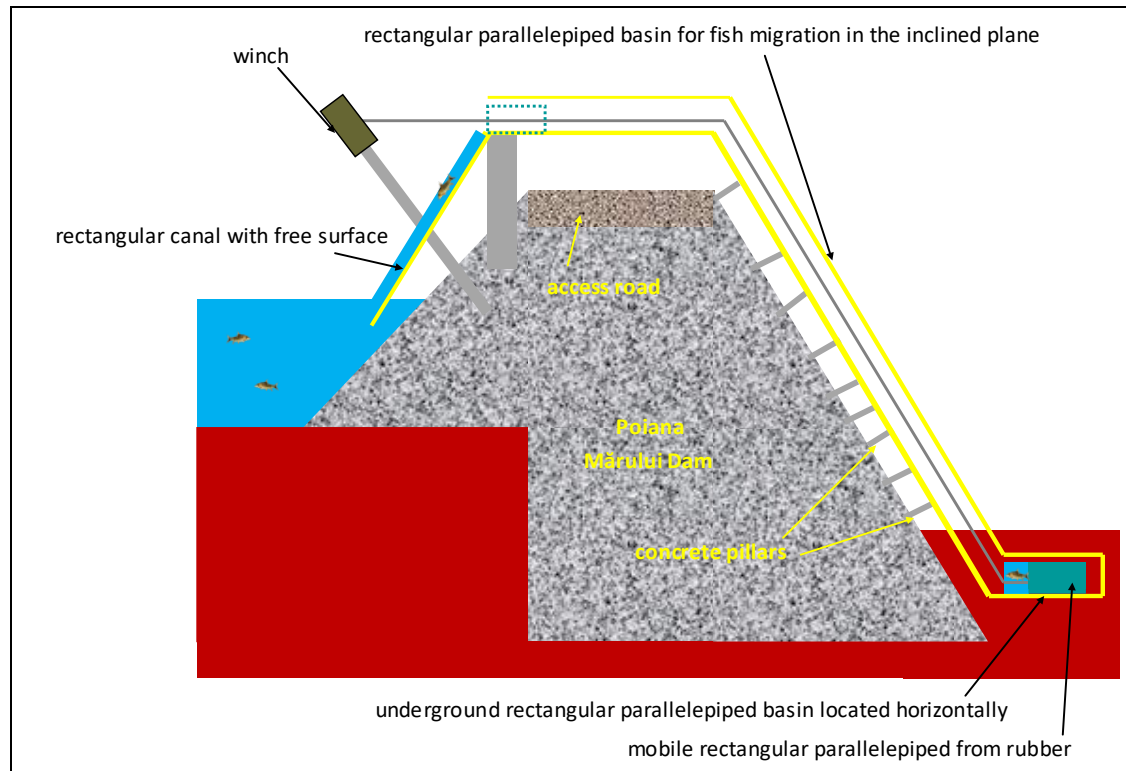
Figure 23: Positioning the rectangular parallelepiped basin on the Poiana Mărului Dam – indicative scheme.

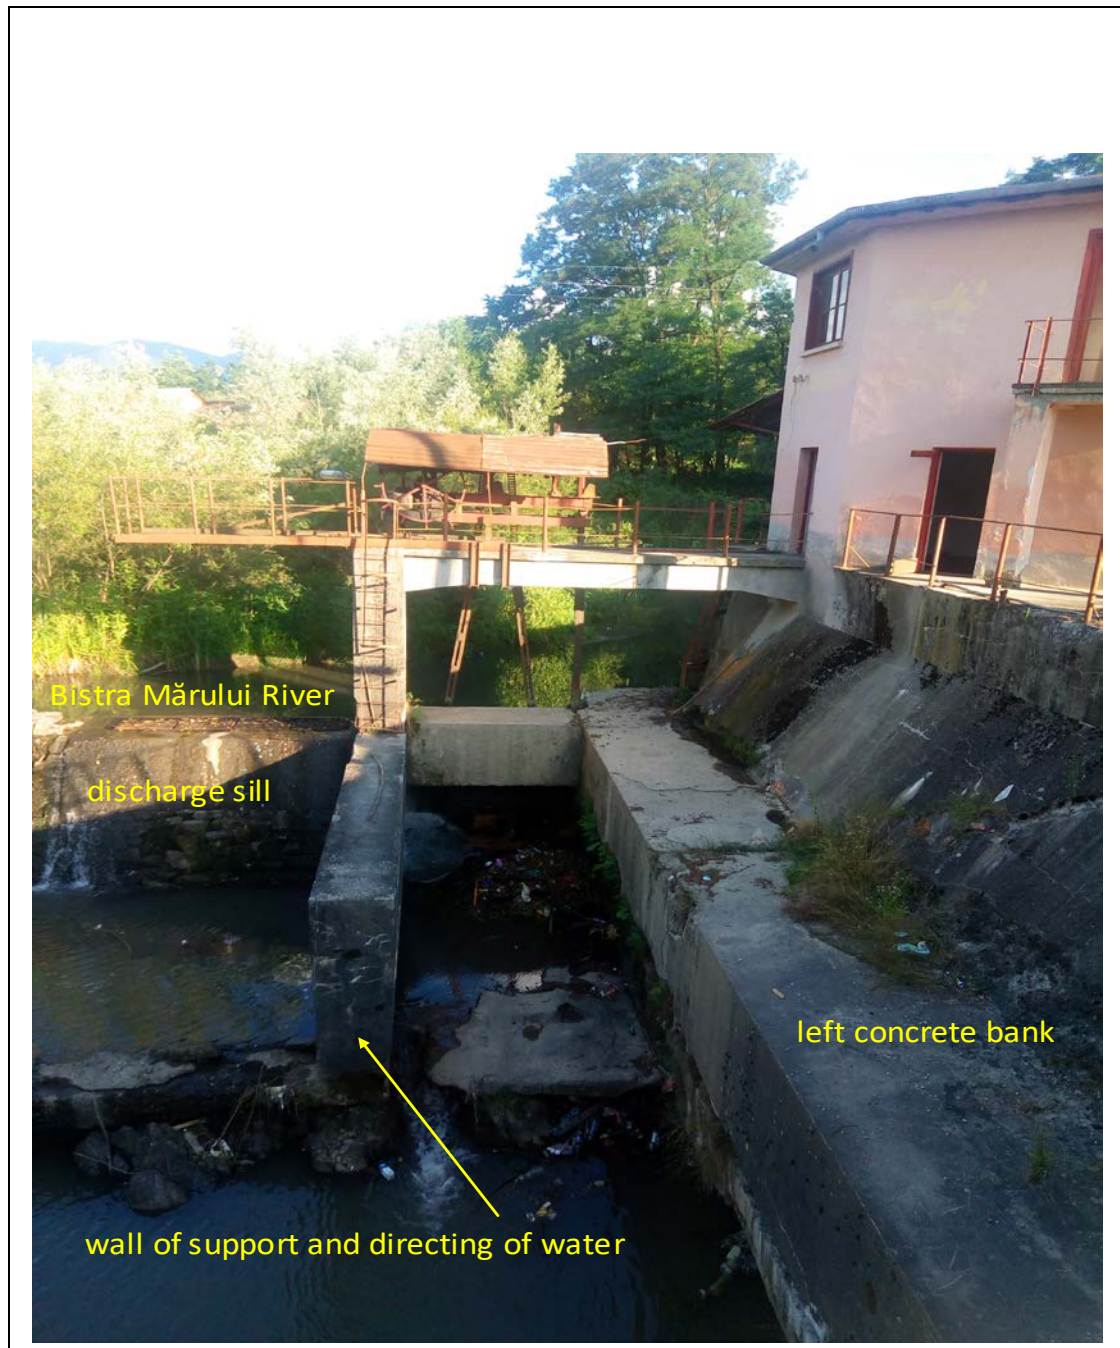
Figure 24: The discharge sill of the lower Bistra Mărului River sector.

3. The lower Bistra Mărului River is significantly fragmented by a four m high spill threshold (Fig. 24).

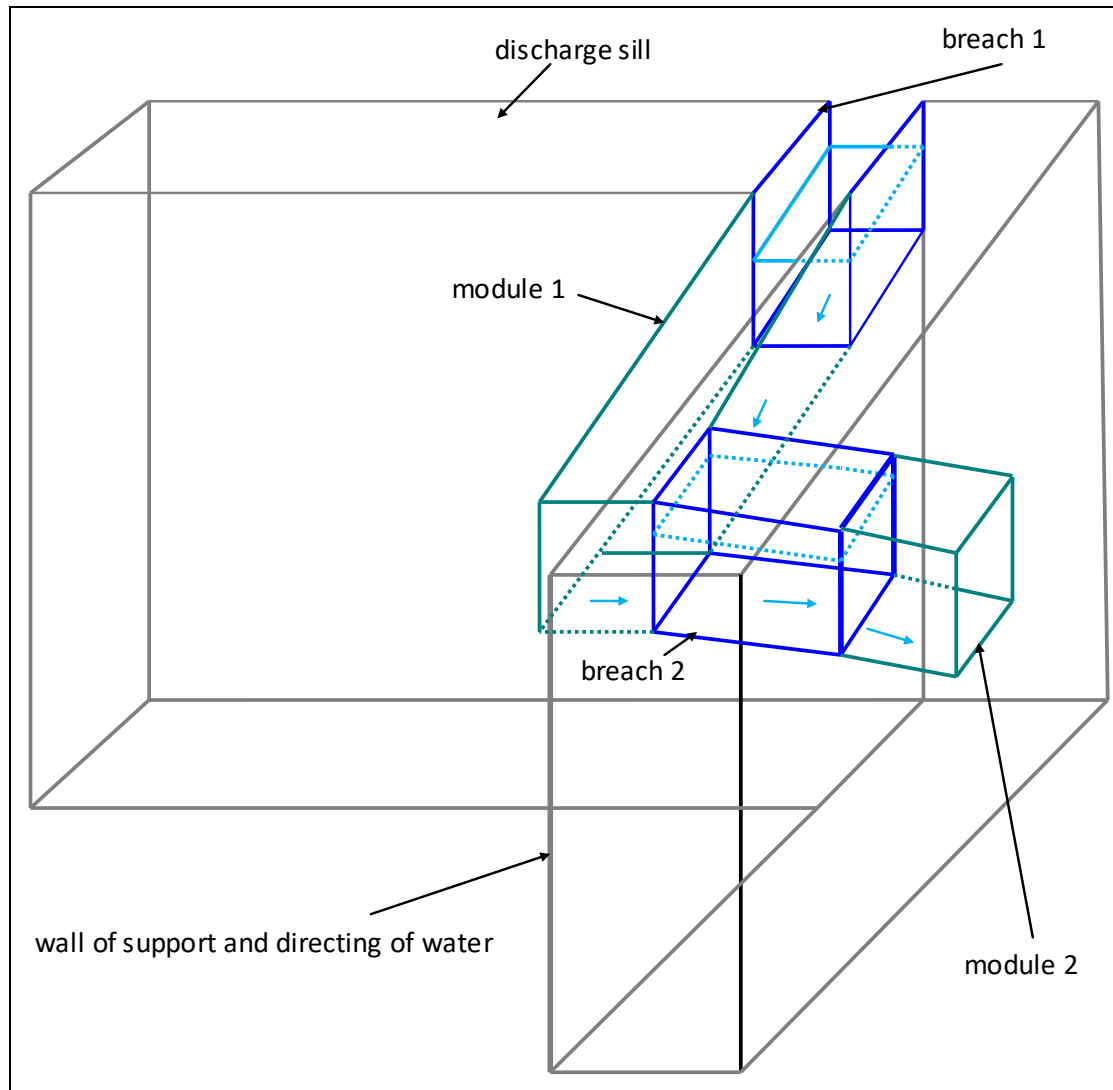
Figure 25: Positioning the two breaches and the two modules.

Two rectangular breaches of 40 cm width and 60 cm height must be made, one made in the barrage near the supporting and watering wall, and the other in the water support and guide wall (Fig. 25). Between the two breaches on the support wall and the water direction, a rectangular channel (module 1) of concrete piles of three cm thick (Fig. 25) is fastened by means of metal dowels and horizontal bars. Thus the two breaches are directly related. The water from the first breach reaches the second bay through module 1 (Fig. 25). A second rectangular channel (module 2) is also attached to the downstream end of break 2 by three cm thick concrete sheet pile and having the same dimensions as the first module (Fig. 25).

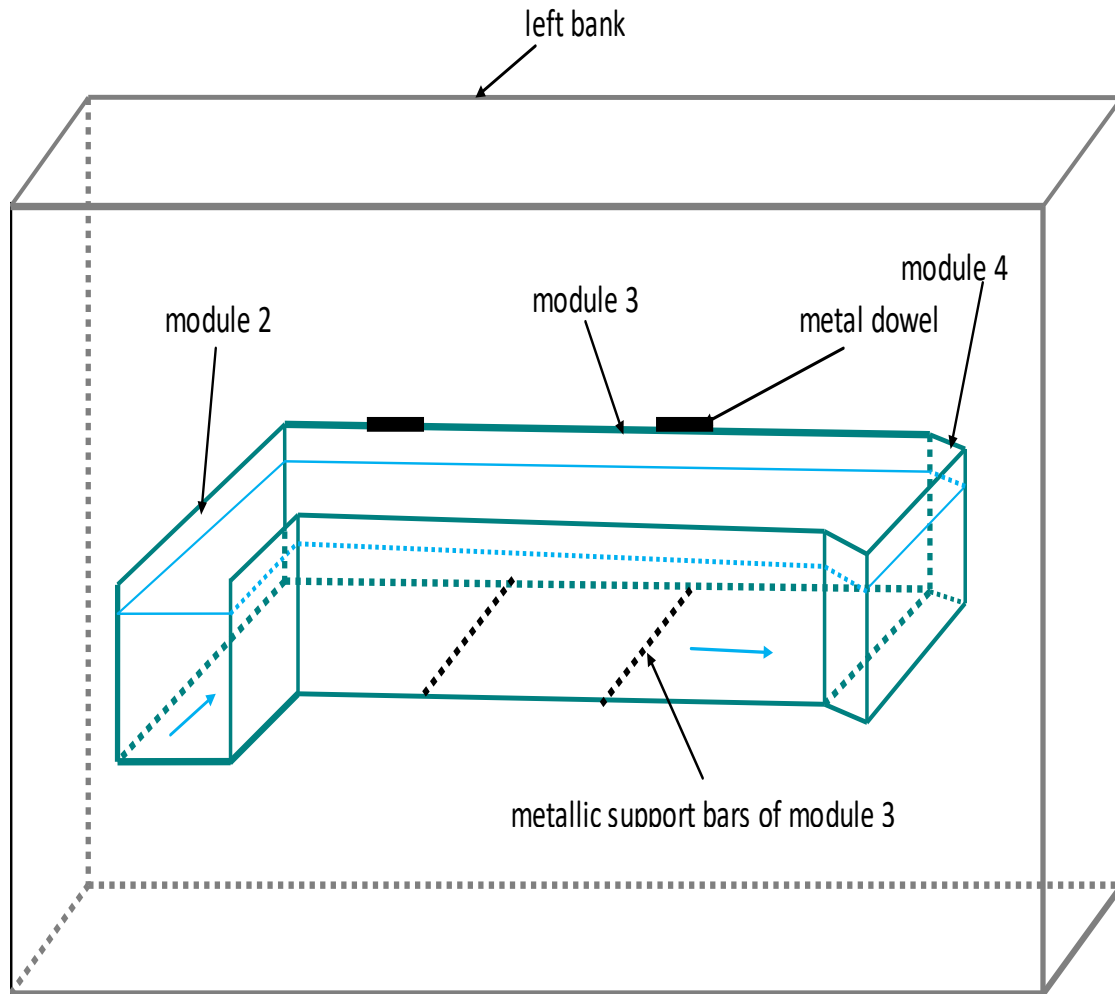
Figure 26: Positioning modules 2, 3 and 4.

Module 2 continues to the right bank. On the right bank concrete module 2 connects to module 3 (Fig. 26).

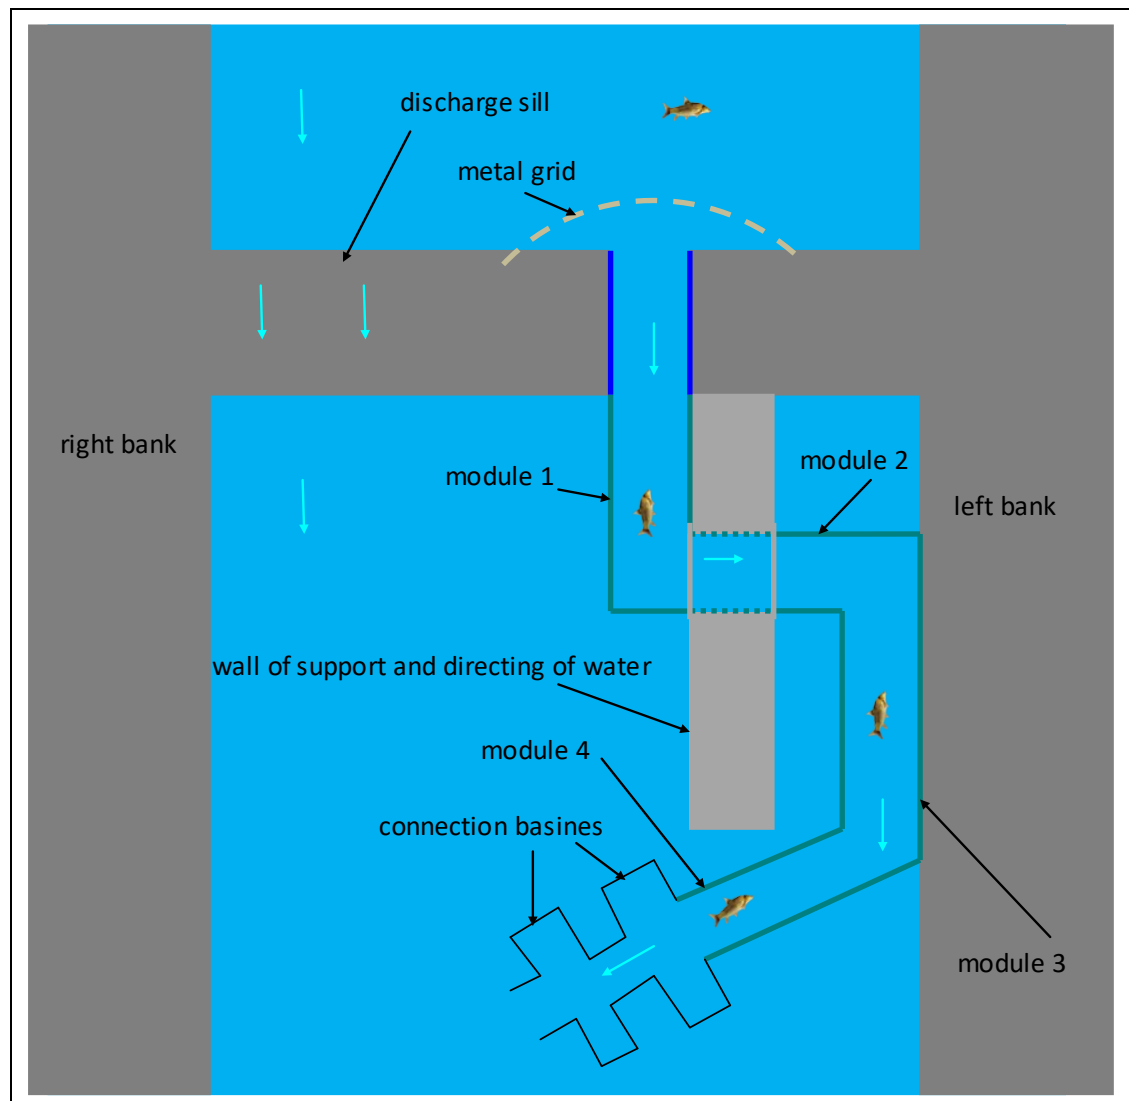
Figure 27: Positioning of the two connecting basins.

From the downstream end of Module 3 will start Module 4 which will have the downstream end in two hydraulic junction basins of five cm (Fig. 27). The slope of all modules is smaller than the river slope in the study area. At the upstream end of the beam 1, a metallic grid in the semicircle, which stops the pet or floating wood material, will be fixed to the spill threshold. The grill will be 40 cm thick and will rise above the water at least five cm. The system has a durable structure and can withstand flooding.
