IN-SERVICE FLAW DETECTION AND QUANTIFICATION IN THE COMPOSITE STRUCTURES OF AIRCRAFT

Krzysztof Dragan, Piotr Synaszko

*Air Force Institute of Technology
Warsaw, Poland*

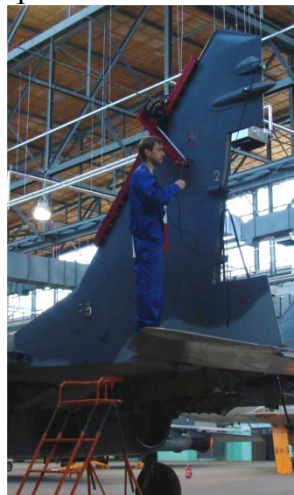
Pic. 1. Composite vertical stabilizer inspection.

To perform structural integrity test of airplane composite vertical stabilizer, ultrasound testing was delivered. The total surface area for inspection were approximately 11 sq. meters per one aircraft.[1] The aircraft population selected to tests were more than 30. So total area for inspection was more than 360 sq. m Classical tests with use manual hand scanning were very difficult or impossible, because work has been done on the airplane[2]. Automated scanning procedure was applied. MAUS ®V system was used. MAUS® system (Mobile Automated System) is an hybrid construction and makes possible inspection with such techniques as: ultrasound, eddy current, MIA, Pitch-Catch, Resonance and with the Phased Array module for ultrasound[2]. System is fully portable and enables inspection on horizontal and vertical inverted surfaces. That is possible due to flexible track system equipped with special handle. On the picture 1 inspection of vertical stabilizer composite skin of MiG-29 is presented.

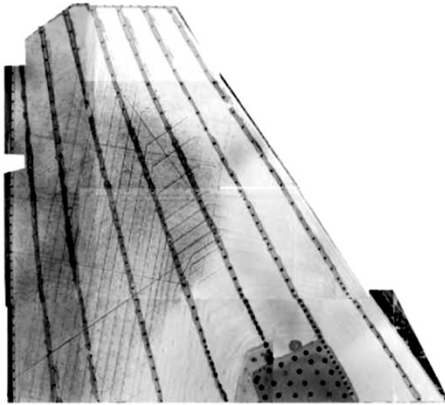
Pic.2. Amplitude C-scan F16 horizontal stabilizer

Resonance & UT inspection with MAUS system are quantitative methods. Results are presented in C-scans mode. MAUS® measurement interface, gives possibility for Amplitude and TOF (Time Of Flight) C-Scan data presentation [2]. On the pictures 2 and 3 C-scans (Amplitude C-scan of F-16 horizontal stabilizer and TOF C-scan of MiG - 29 vertical stabilizer) are presented. On the amplitude data different colors are connected with different signal attenuation. Amplitude mode is useful for detection of disbonds. Color range in the TOF data gives information about different composite skin thickness as well as about delamination depth [2]. That system of data presentation is very helpful for damage description as well as for fast damage location finding. If we needs more information about damage we can do additional full waveform capturing with B-scan visualization]. This kind of results is applied for detection of delamination and foreign object inclusion. Typical distribution of damages of vertical stabilizer MiG-29 is a bottom part of stabilizer (Pic. 4).

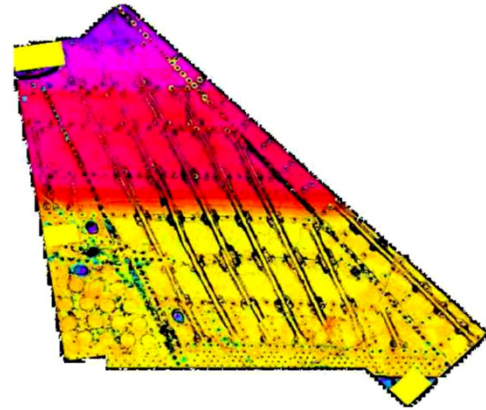
Pic.3. TOF C-scan MiG-29 vertical stabilizer

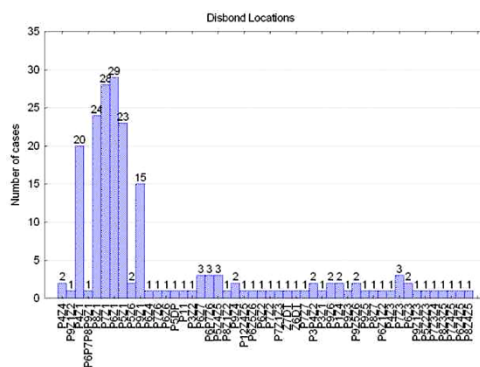
Pic.4. Distribution of damages MiG-29 vertical stabilizer

Automated inspection increased reliability and speed of inspection reducing so called "human factor" during the measurement. As you can notice in the chart presenting damages location distribution, it occurred in random position. From that point of view there is necessity for periodical inspection of composite skin of vertical stabilizers. In the face of future planes connected with Air Force development gained experience gave us potential to work with new aircrafts introduced to Armed Forces.

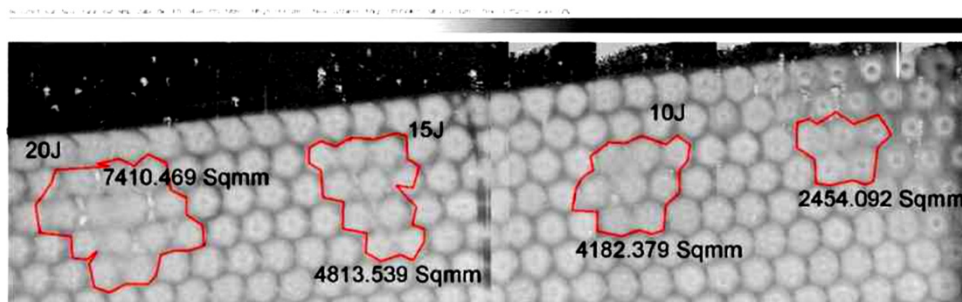
Pic. 5. MIA results main rotor blade inspection

And take information about size of damage. More of NDT application deal with honeycomb sandwich (like a W3 composite main rotor blade inspection Pic.5) [3]. Very interesting results to bring inspection wing is B1-PW-5 glider. Skin of this wing is a sandwich with 5 mm DIVINYCELL foam core. For reason high attenuation of ultrasonic signal in foam core inspection this kind of structure is very difficult [4]. Low frequency signal that we use in MIA methods is much better for foam core inspection. C-scan image give one-valued information about condition of bond line between spar and sandwich skin. Inspection test probe (Pic.6) consists of sandwich panel and laminated spar give us the same result. Additional test probe consists two small disbonds (1sqmm and 1.5 sqmm) they are visible in the C-scan (Pic.7).

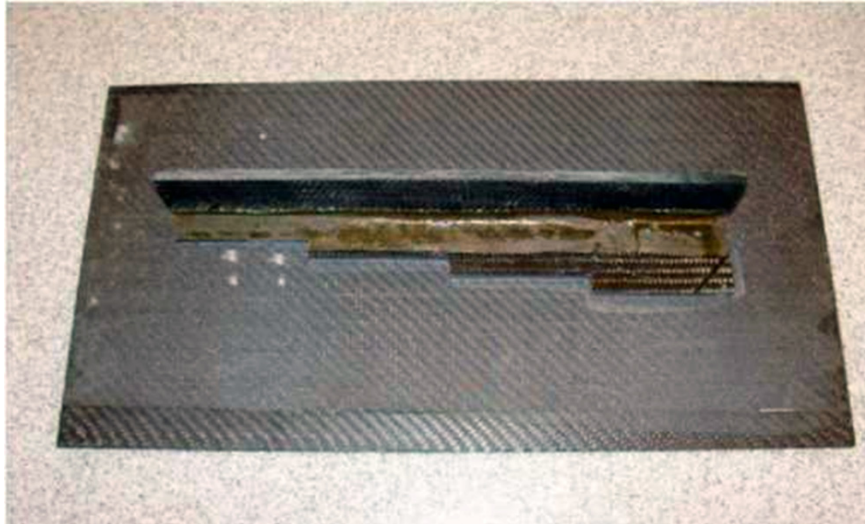
Pic. 6. Test probe

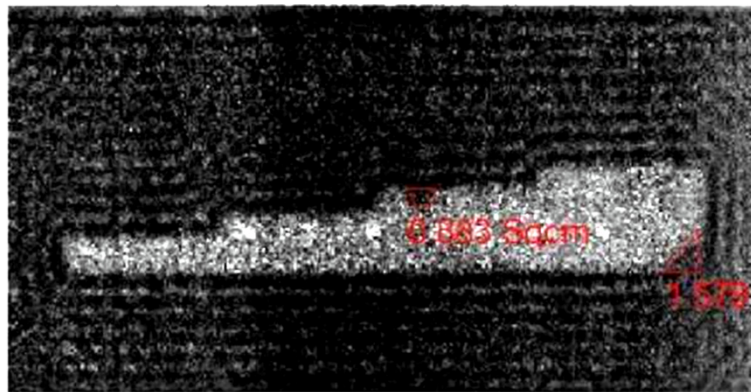
Pic. 7. MIA results test probe
