EVERY START IS CHALLENGING: FITTING A NEW ARTIFICIAL LAKE INTO THE LANDSCAPE, ZALAKAROS, HUNGARY

Abstract

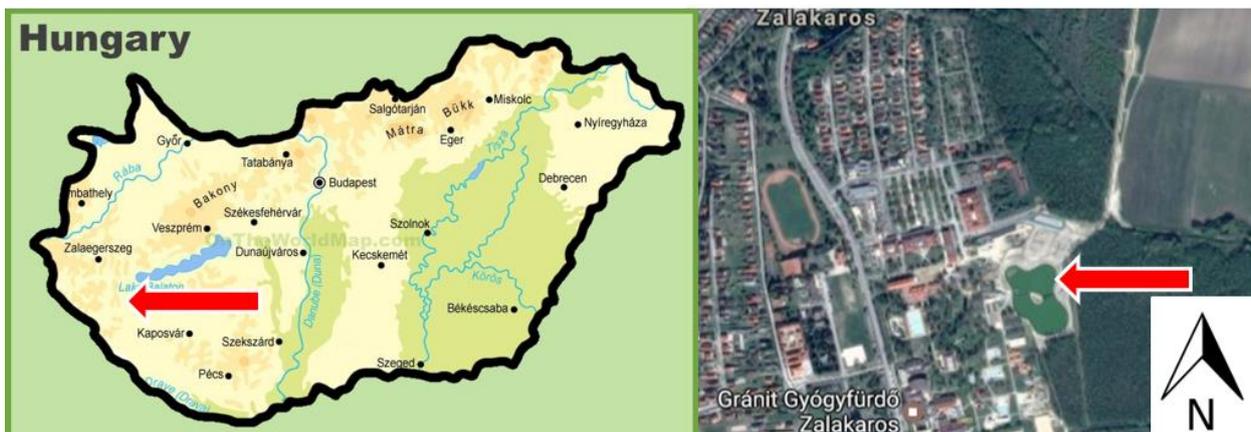
Fig. 1 Location of the study area

The study area and the thermal lake is located in Western Hungary, at the administrative area of Zalakaros town. There are closed forests on the eastern side of the lake, and gallery forests on the south (Fig. 1). The surface area of the artificial lake is 12900 m², its average water depth is 1.5 m (with a shallow cover of 0.4 m at a part of the lake bed around the “flagstones”), its maximum depth is 1.8 m, its volume is 19000 m³. The length of the shoreline is 484 m, the shoreline development index is 1.2 without the island, and 1.41 including the island. The lake is isolated; its water supply is ensured by using the drain-off of the thermal water ((in other words: used bathing water). The daily amount of the bath’s excess water is 600-800 m³. The average detention time in the lake is approximately 30 days. The banks’ average bend is 1:2, and are covered by crushed limestone which unfavourably limits the vegetation growth. The lake is functioning as a “park lake”, providing aesthetical value to the city. It is prohibited to use this lake for bathing and swimming it serves only spectacular purposes and not further balneological ones.

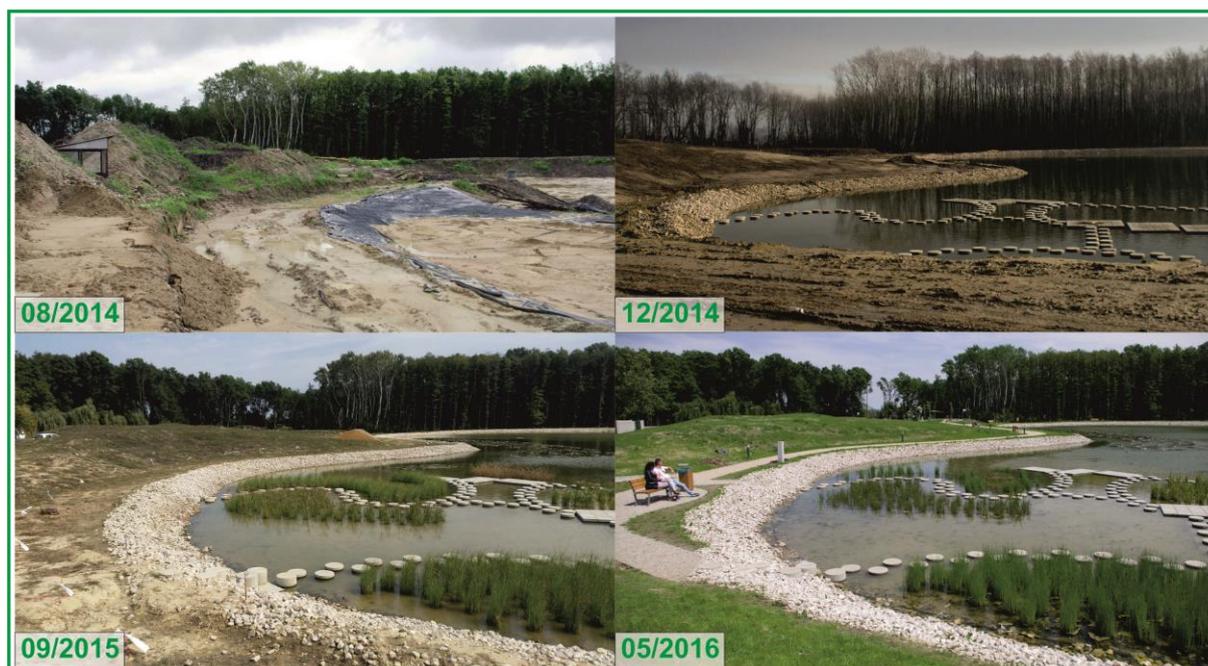
Fig. 2 Formation of the lake bed and the planned macrophyte plantings at the shallow area of the lake (near the “flagstones”)

The submersed species also had to be planted directly to the bottom, in a density of 3 pcs/m². Planting on the banks protected by rip-rap demanded an untraditional procedure as well. Proper quality rhizomes had to be collected of riparian plants (mostly: *Typha angustifolia*) (Hawke and José, 2002; Henderson et al. 1999; Robinson, 2006) that were surfaced from canal dredging in the region. The rhizomes wrapped in jute sacks had to be fixed between the bank's rocks, 30-50 cm under the operating water level. The riparian plants in the shallow area were distributed at operating water level, at an average stem distance of 50 cm, placing the planting baskets directly on the bottom (Fig. 2).

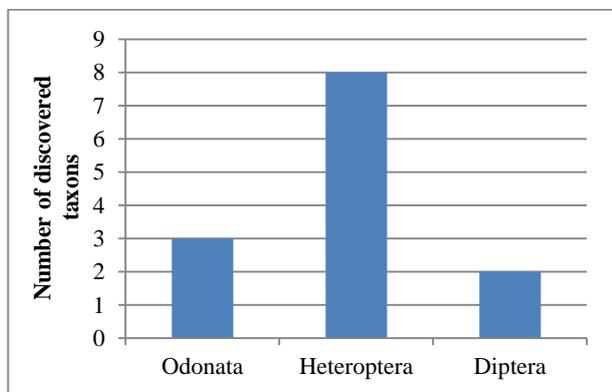
Fig. 3 Number of the discovered taxons/species in the three insect groups

It is ascertainable that the most diverse group consisted of true water bugs, as 8 from the discovered 14 taxons belonged here. However, regarding the population size diptera was the most numerous in the invertebrate group. In general, the organism group was scanty, species of many groups were completely missing, due to the unfavourable trend of water quality. On the other hand, the high number of dipterous larvae individuals stabilised in the lake was noteworthy. Probably the reason for this is that the threat of the scarcity of direct dissolved oxygen has significantly decreased. Although a regular oxygen supersaturation typical of hypertrophy occurs daily in the lake, probably oxygen is not consumed completely, as these creatures does not utilize atmospheric oxygen like true water bugs, but dissolved oxygen instead. This can be connected to

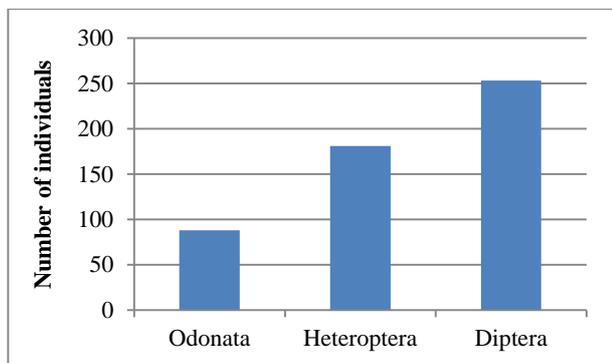
Fig. 4 Number of individuals in the three insect groups
