Baltic Sea coastal erosion; a case study from the Jastrzębia Góra region

Grzegorz Uścińowicz*, Regina Kramarska, Dorota Kaulbarsz, Leszek Jurys,
Jerzy Frydel, Piotr Przewdziecki, Wojciech Jegliński

Abstract

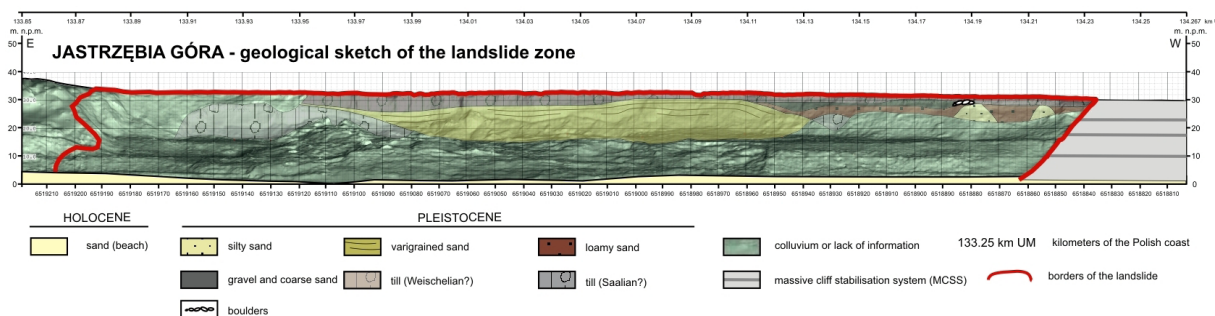
Fig. 2. Geological sketch and digital terrain model of the landslide in frontal view
