Freeze-thaw Damage Dependence on Wind-driven Rain of Outdoor Exposed Concrete – A Case Study

It has been shown in previous studies that the existing precast concrete element building stock in Finland has quality issues, especially with freeze-thaw durability and reinforcement corrosion. In addition, it has been presented that deterioration rate is the fastest in coastal area and decreases towards north which has been supposed to be a reason of lower amount of wind-driven rain (WDR). The aim of this study was to examine the connection between the amount of WDR on structures and the freeze-thaw damage more comprehensively. Condition investigation reports of 472 precast concrete element buildings were reanalysed to study the relation and the results were compared to climate data of the same time period to study the correlation between condition investigation observations and the amount of WDR. In addition, the observations made in a condition investigations and their relation to climate load at the same building were studied as a case study. The results show that there is a significant connection between the WDR related climate load and the freeze-thaw damage occurrence. The results

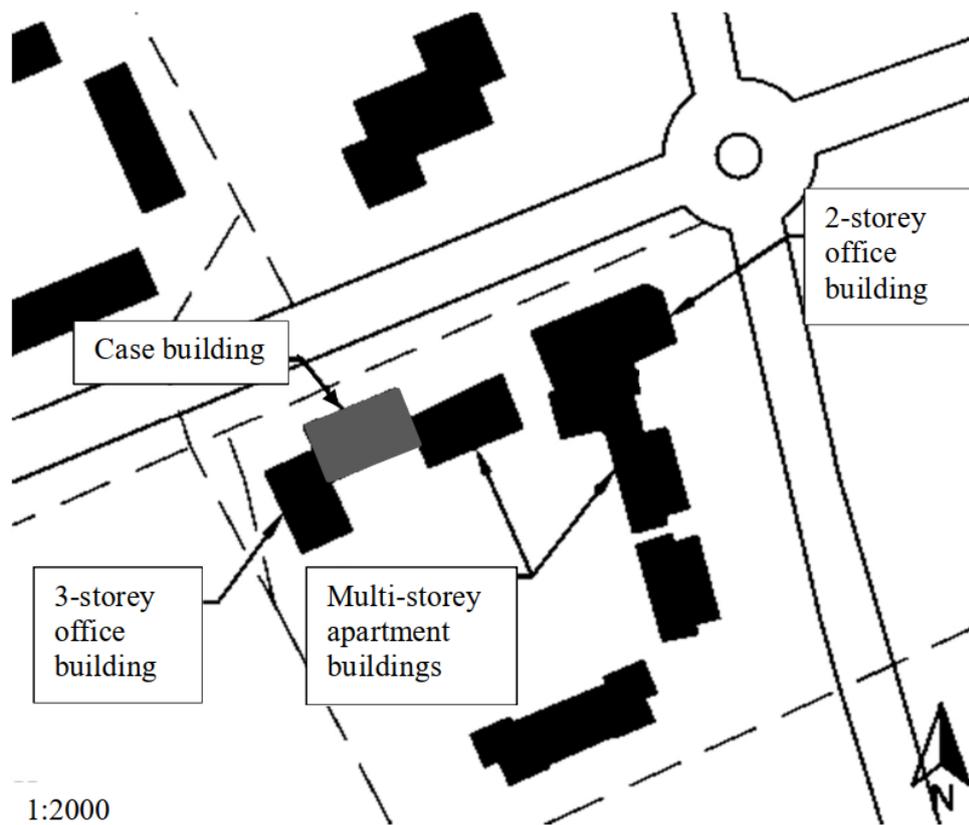
Figure 1 – Geography of case building in the block.

investigation reports as a representative for a typical suburban concrete apartment building with insufficient freeze-thaw durability properties and extensive collected data. The case study building is located in the city of Tampere, southern Finland. The 14-storey apartment building was built in 1977 and is made of precast concrete elements with exposed aggregate concrete surfaces. The building is located in an enclosed block surrounded by a low office building and multi-storey apartment buildings (Figure 1). The balconies are located on southeast-, south-west- and north-east-facing facades.

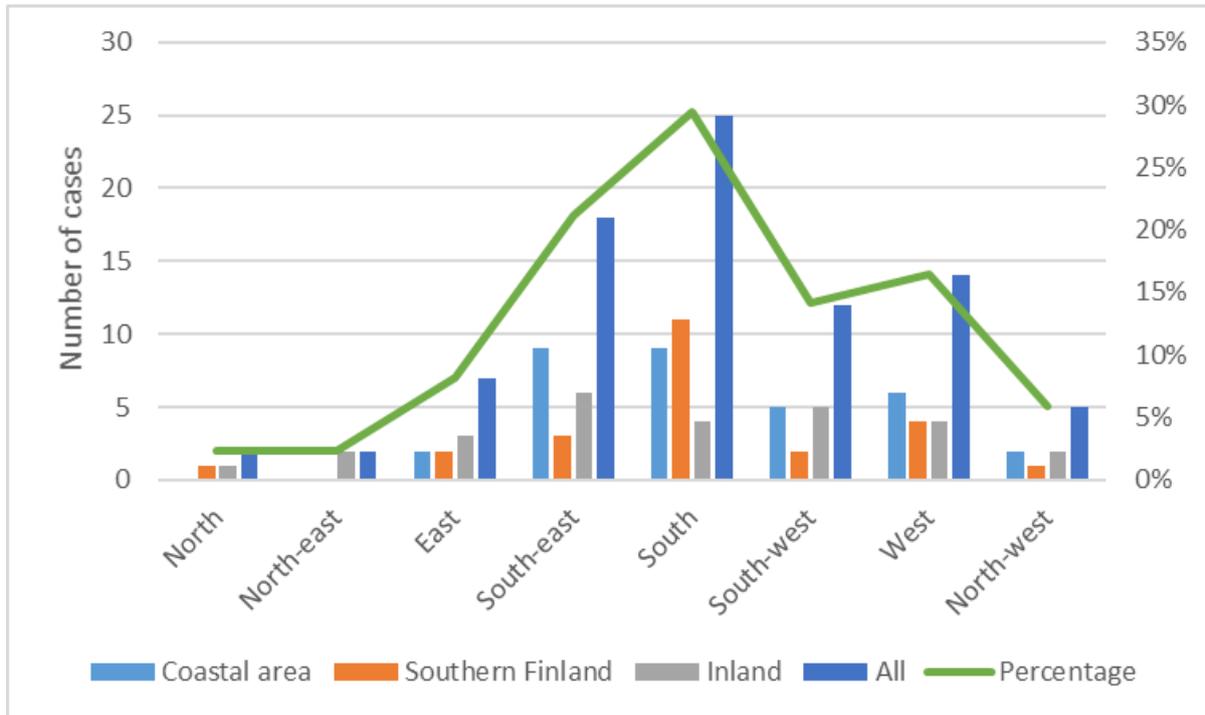
Figure 2 – Far-advanced freeze-thaw damage observed in facades based on the condition investigation data.

Based on the condition investigation reports, 81% of far-advanced freeze-thaw damage was located in west-, south-west-, south- and south-east-facing facades. Based on the geographical location, the shares are 88%, 83% and 70% in the coastal area, southern Finland and inland, respectively. In balconies, the share is 84%. However, with balconies it must be taken into account that most of them are located on western and southern facades to maximise the daylight and evening sun. The distribution of observed far-advanced freeze-thaw damage in facades and balconies is presented in Figures 2 and 3, respectively.

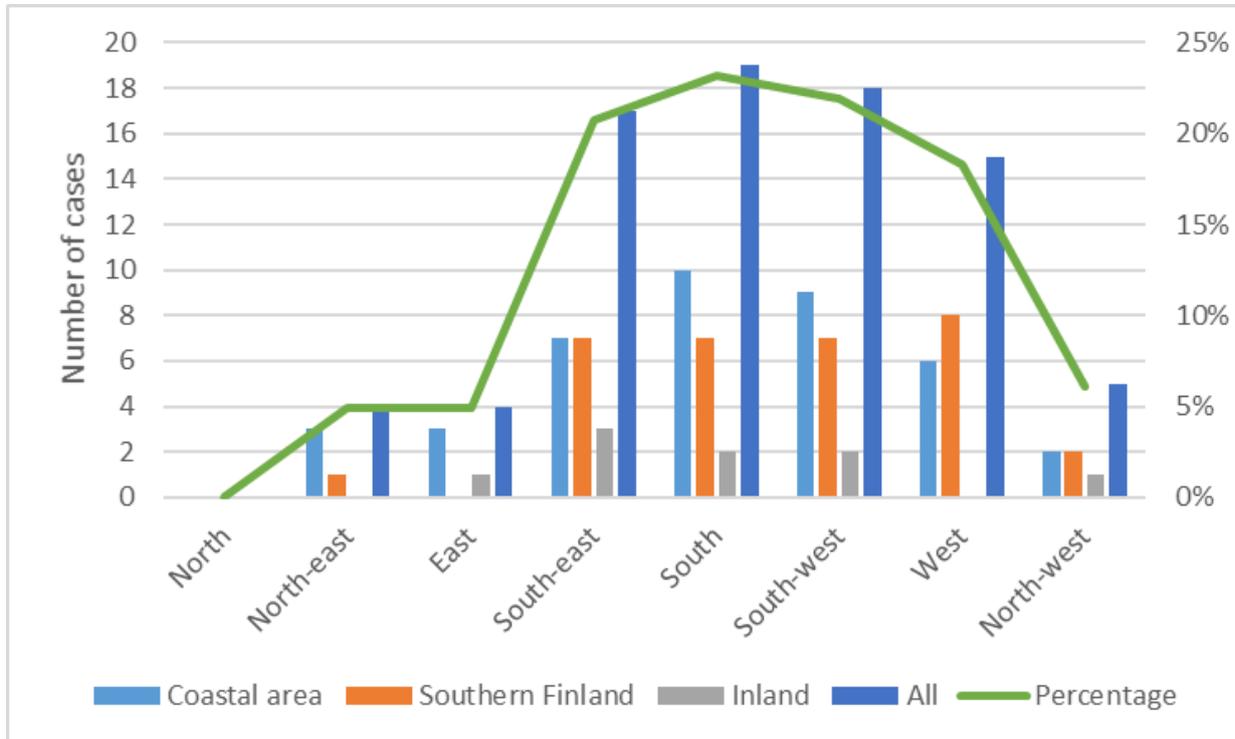
Figure 3 – Far-advanced freeze-thaw damage observed in balconies based on the condition investigation data.

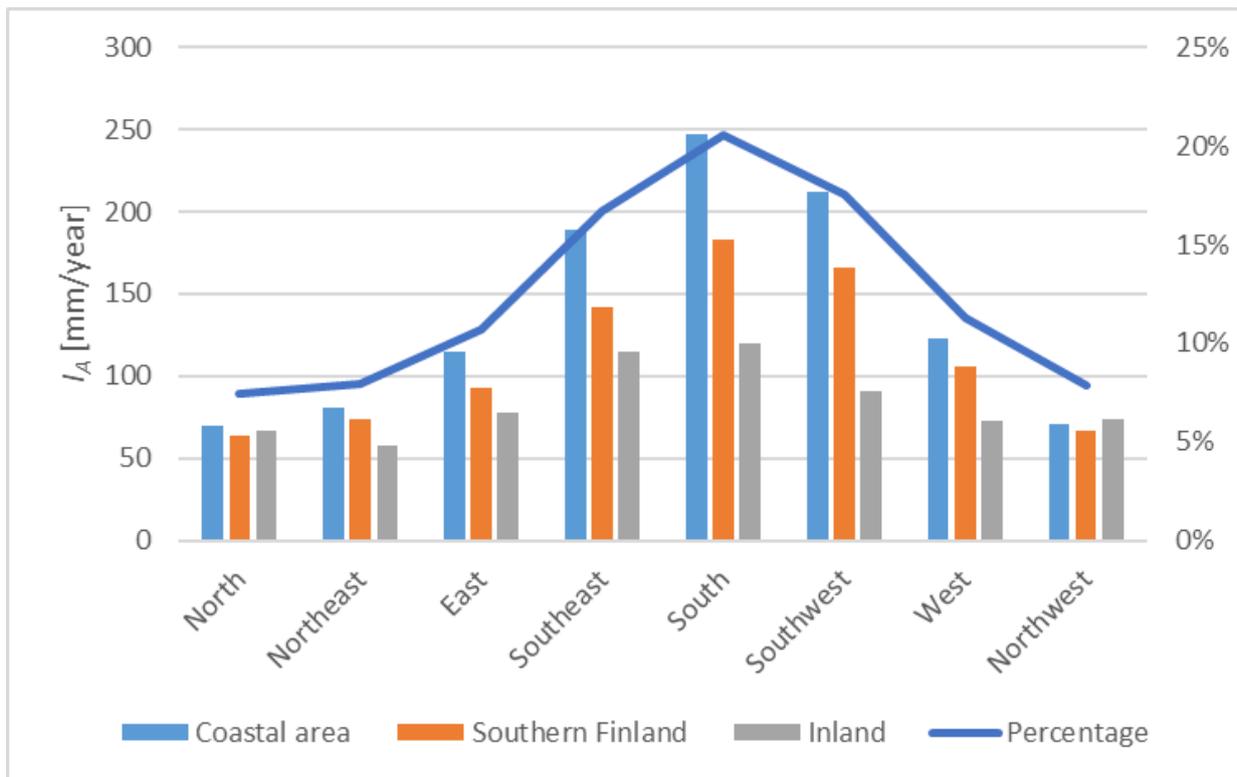
Figure 4 – Airfield annual index from different directions at the three locations studied.

Figure 4 shows Airfield annual index I_A to represent WDR from different directions, and Figure 5 shows I_A from different directions for up to three days before freeze-thaw cycles with a limiting temperature of -5 °C. The share of WDR from the west, south-west, south and south-east is 65% of all WDR. The share of WDR before freeze-thaw events is 78% and, when separated into coastal area, southern Finland and inland, it is 81%, 79% and 71%, respectively.

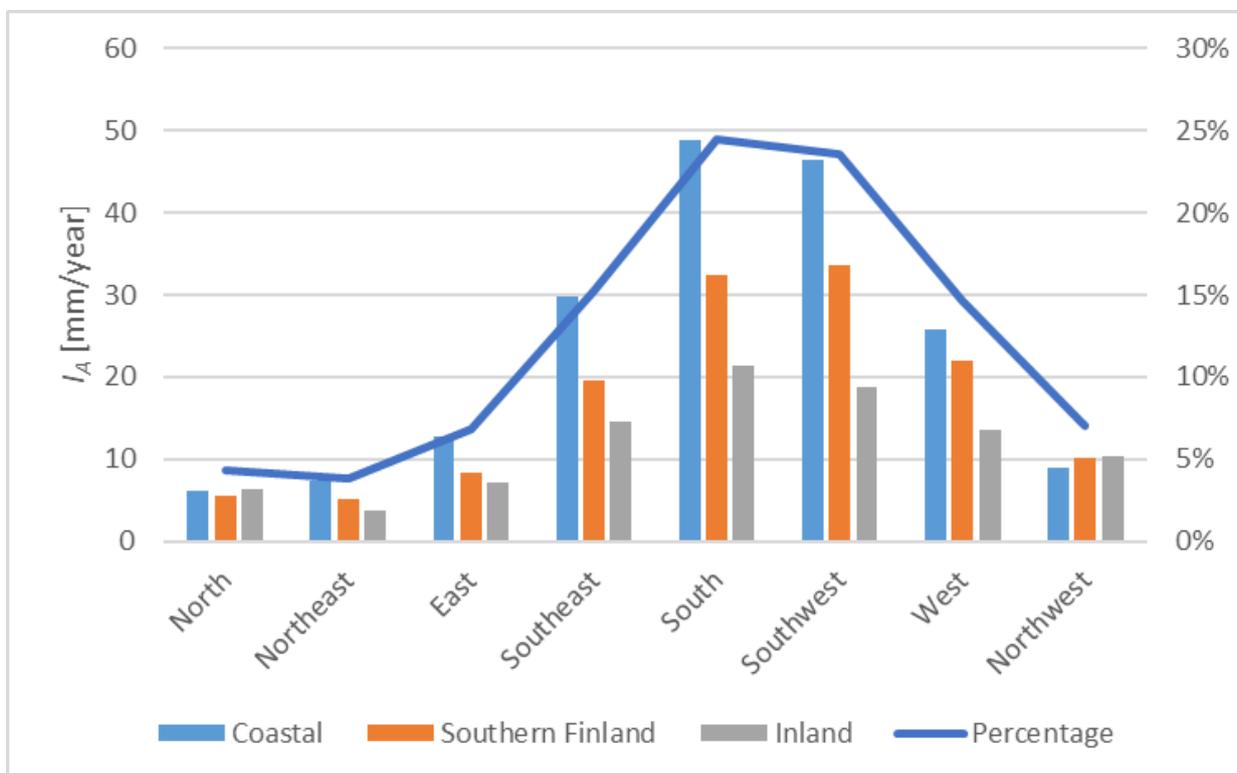
Figure 5 – Airfield annual index for up to three days before freeze-thaw cycles with a limit temperature of -5 °C from different directions at the three locations studied.

As the results show, the amount of WDR and especially the amount of WDR before freeze-thaw events has a significant relation to freeze-thaw damage observations.

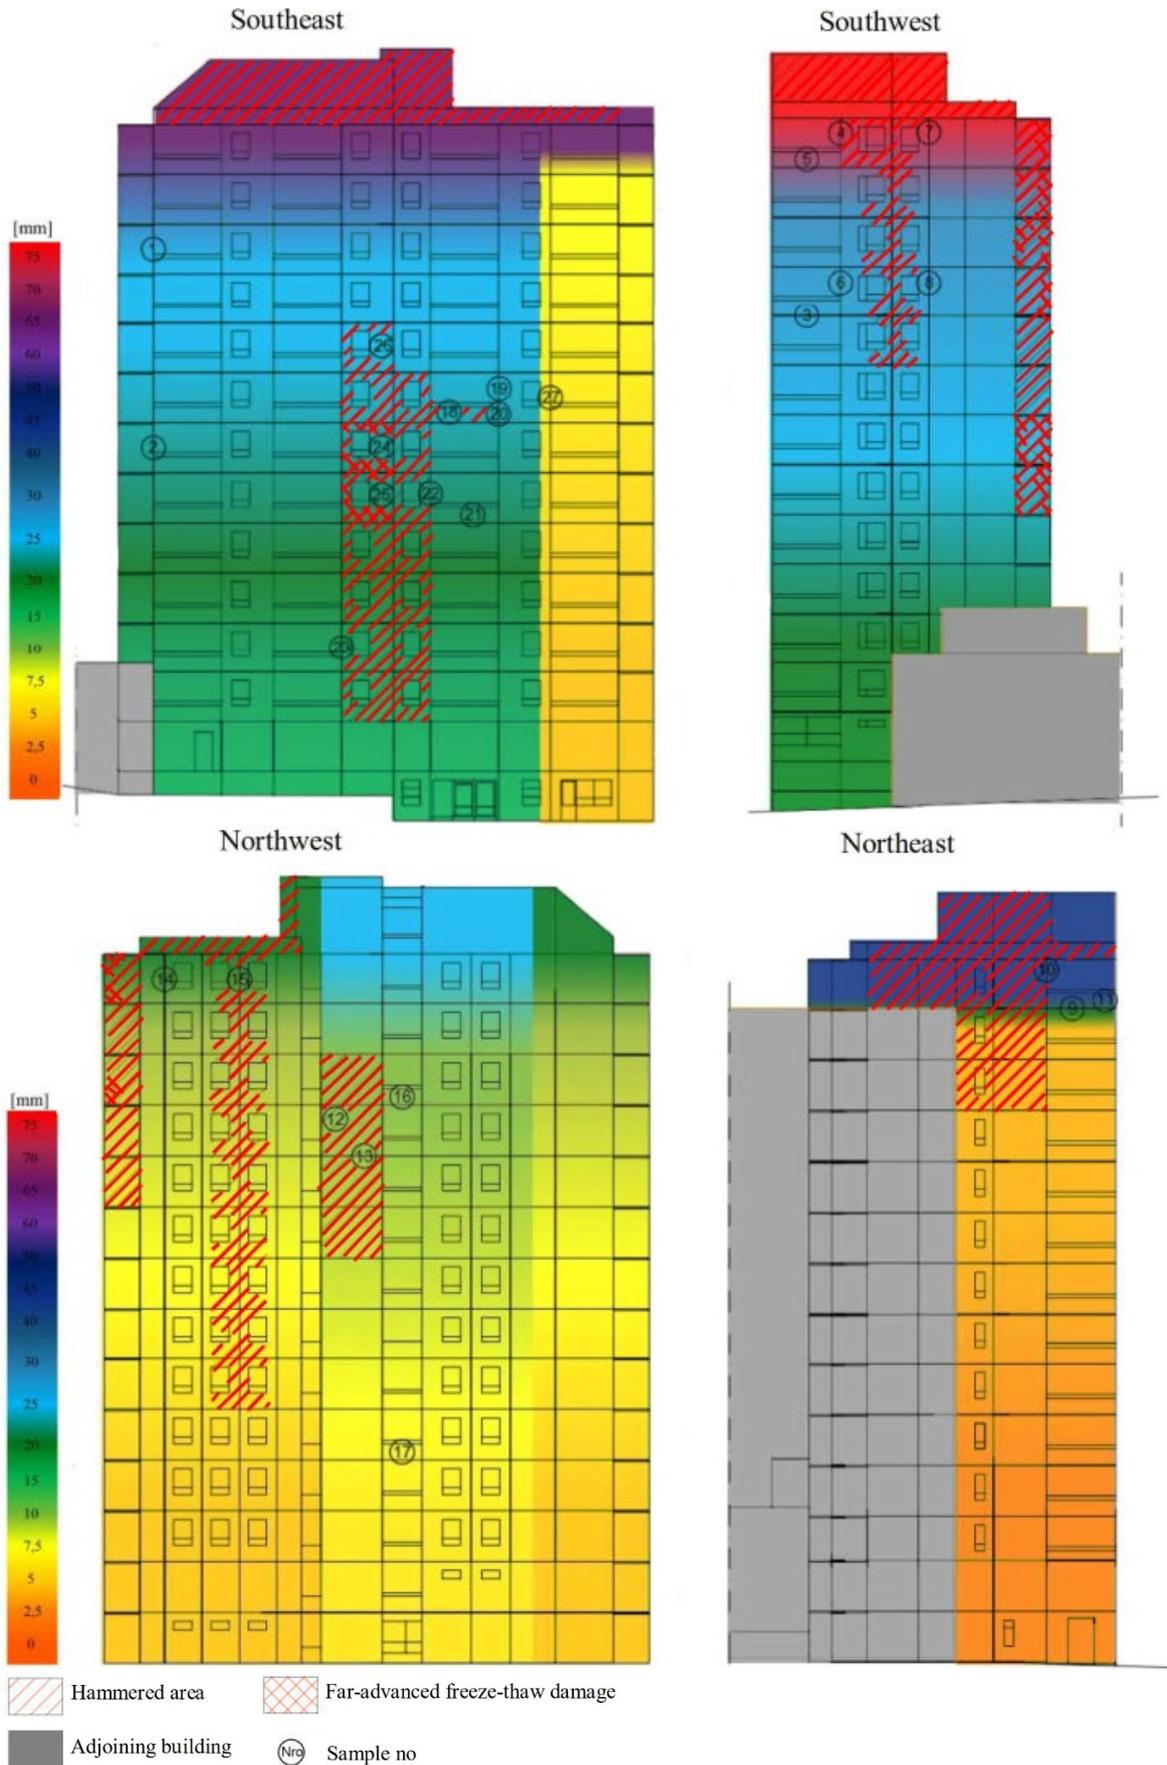
Figure 6 – Amount of I_{WA} on different parts of the facades, hammering areas and locations of the taken samples. The numbers and colour gradation on left present the amount of WDR.

Figure 6 shows the amount of I_{WA} on different parts of the facades, the hammering areas and the locations of the samples taken. Signs of freeze-thaw damage were detected:

- visually in facade sample no. 24 and balcony side panel sample no. 2
- in thin-section analysis in facade sample no. 26
- in tensile strength tests in facade samples nos. 8 and 27 and in balcony side panel samples nos. 2, 10 and 23.

All the freeze-thaw damage indicated by visual observations, hammering or studies of the concrete core samples were located in areas where the total amount of I_{WA} was over 21 mm. The level of such WDR was achieved on north-west and north-east facades only on their top 2.5 meters. On south-east and south-west facades, the same level was reached already at the fourth floor, i.e. above 12 meters from the ground.

Almost all the freeze-thaw damage observations were made on the south-east- and south-west-facing facades or balconies. During the same 20-year time period, the total number of rain events followed by freeze-thaw cycles (-5°C) were 161 from north-west-, 101 from north-east-, 192 from south-east- and 207 from south-west-oriented rain events. When only the airfield annual index I_A (see Equation 3), i.e. the WDR in an open area, is calculated, the total amount of I_A during the same time period was 123 mm, 132 mm, 479 mm and 489 mm, respectively. Thus, the amount of WDR before a freeze-thaw cycle was significantly lower during the rain events from north-west and north-east directions while the number of cycles was lower.
