The Specifics of Use of Composite Materials in Consolidation of Historical Monuments

Vlăescu Daniel, Djordje Krkljus, Dogaru Petrișor

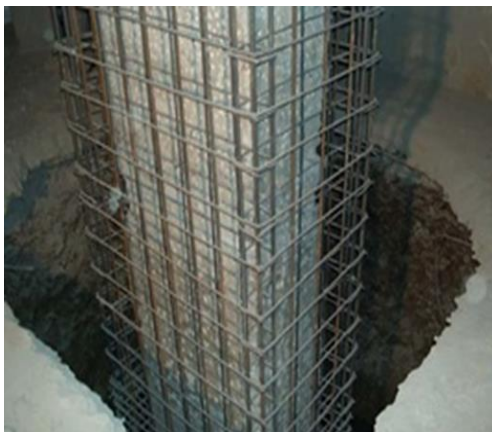
Fig. 1 Classical consolidation

For the protection and maintenance of historical monuments and heritage buildings, there are several classical methods applied such as: repairing with concrete seals the walls of the load-bearing walls, retailing the cracks of masonry areas by removing the joints between the elements, by replacing the damaged elements by inserting steel clips for fixing the masonry, repairing with reinforcing steel bars, by injection of cement mortars in the masonry, reinforcing the masonry walls with reinforced concrete piles and belts and reinforcing concrete.

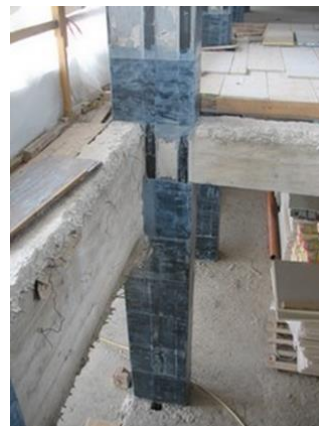
Fig. 2 Consolidation with composite systems

For the repair of historical monuments, modern methods of consolidation by means of shielding with fiber-reinforced polymeric composites are used lately due to the advantages offered by them. The main methods applied are: pre-tensioning and post-tensioning with polymerized composite strips systems, confinement with fiber-reinforced polymer composites, embedded composite bars and anchoring with fiber-reinforced polymer composites.

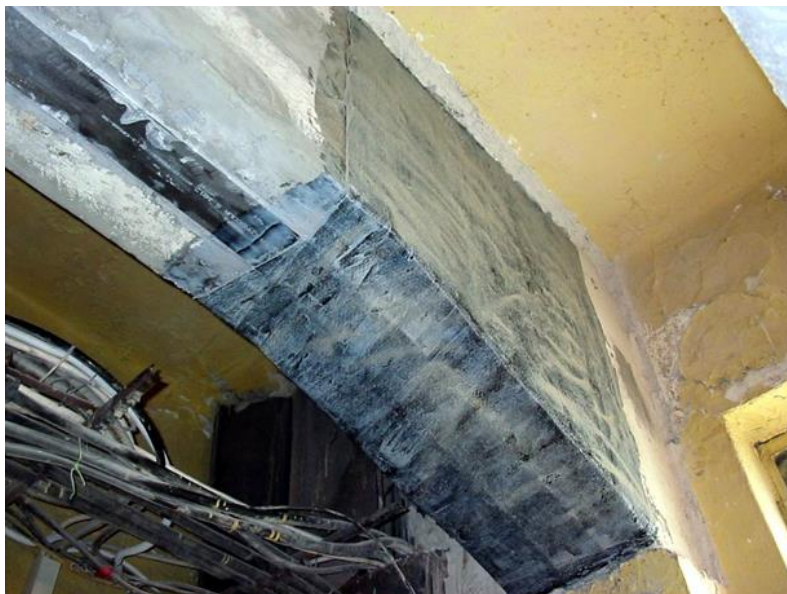
Fig. 3 Example of structural rehabilitation

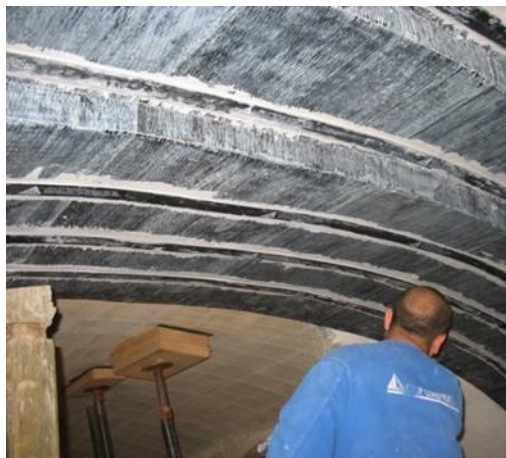
Fig. 4 Rehabilitation of arches with composite systems

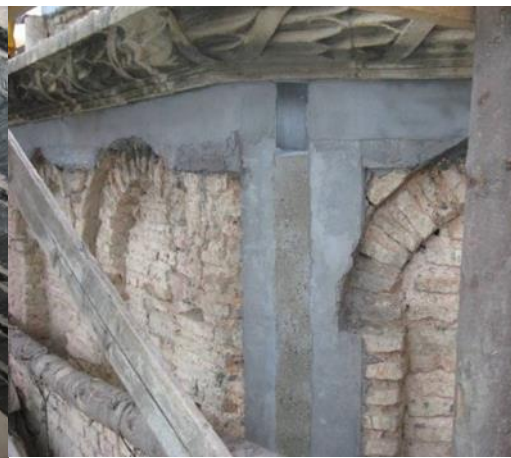
Fig. 5 Rehabilitation of masonry structure with composite systems

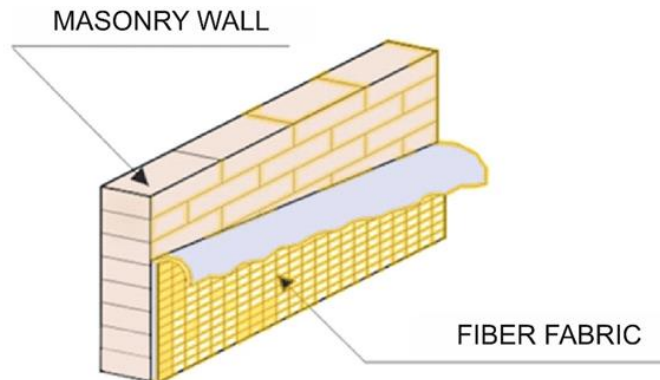
Fig. 6 Consolidation of non-reinforced masonry with composite membrane

All these disadvantages have influenced the search for alternative consolidation solutions. A first masonry consolidation solution with composite systems is in the form of a fiber fabric (glass, carbon or aramid) which is impregnated with a polymeric resin and bonded to the surface of the masonry which has been prepared.

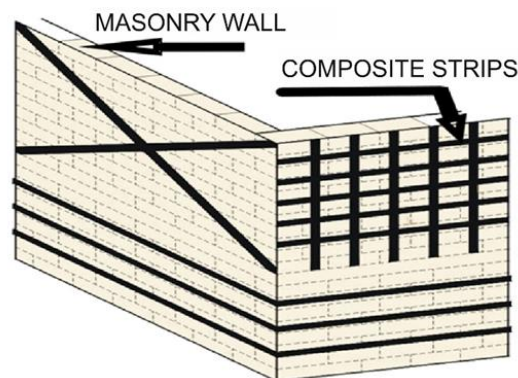
Fig. 7 Consolidation of brick walls with composite strips

It has been shown from the studies that the method of consolidation is more effective with narrow composite strips. Normal tensions can be much better overtaken by proper orientation of narrow composite strips than by fastening continuous fiber fabrics to the entire wall of the masonry. When the normal wall bending is the predominant load, it is necessary to use the horizontal composite strips to increase the bending capacity, and when the brick masonry is bent in its plane, it is recommended to fix the composite exterior reinforcement in the predominantly tensioned areas.

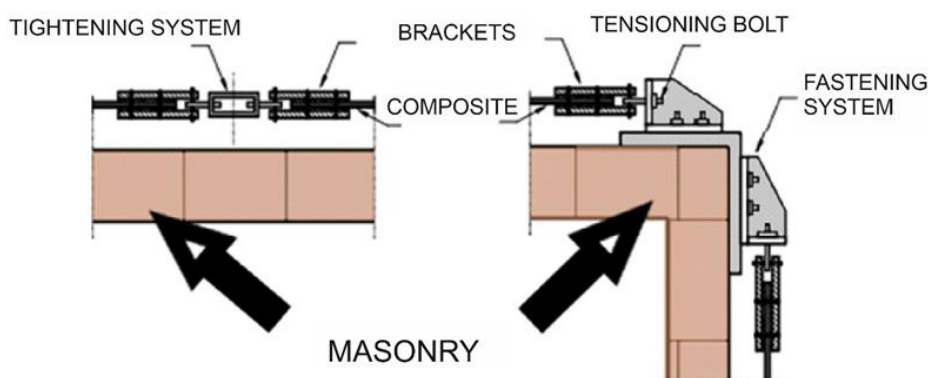
Fig. 8 Systems for fastening composite strips used to reinforce brick walls

Due to the fact that fiber-reinforced polymer composite lamellae cannot be bent at small angles, rods from composite systems can provide an appropriate anchorage only by means of metallic elements arranged at the corners. If it is necessary to tighten the composite rods, two brackets connected with a clamping system are used.

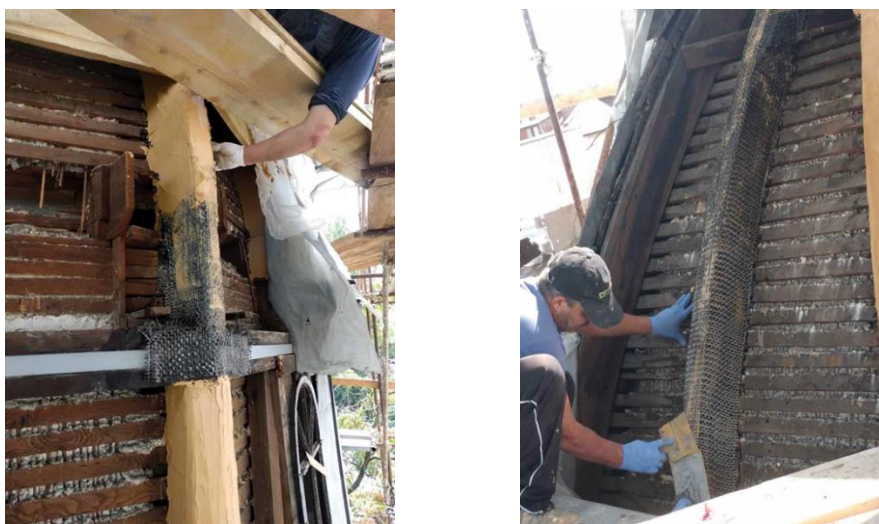
Fig. 9 Examples of consolidation of wood structures with composite systems

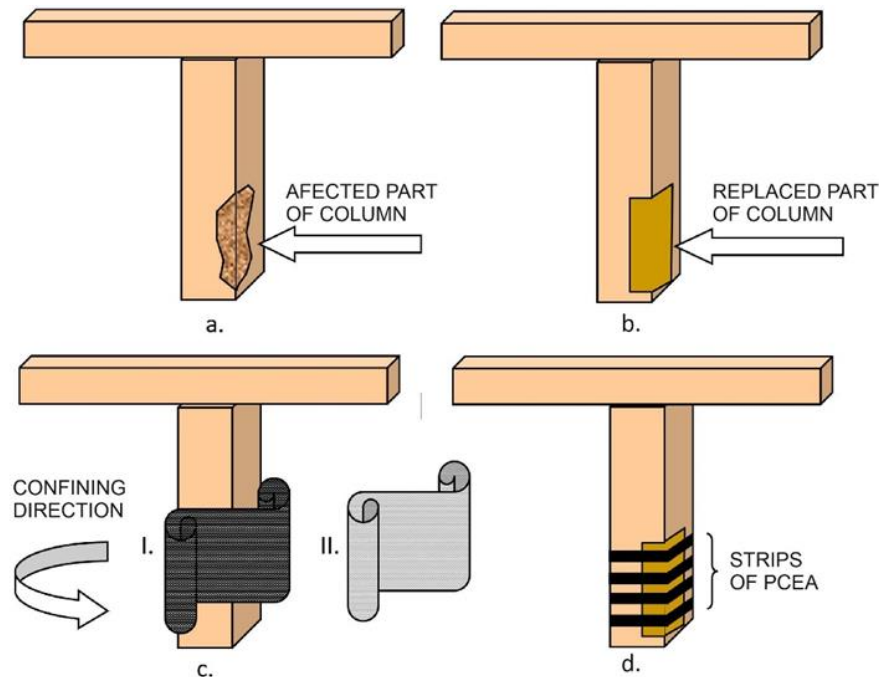
Fig. 10 Strengthening wooden columns with rectangular section:
a. column affected by rotting process; **b.** cutting the affected column portion and replacing the degraded part; **c.** confining the wooden column using carbon fiber (I) or glass (II) fibers impregnated with epoxy resins; **d.** strips of Polymeric Composites bonded with Epoxy Adhesive [9]

The following figure exemplifies a composite reinforcement of structural wood elements:
