PRODUCTION ENGINEERING ARCHIVES

The influence of the damaged reinforcing bars on the stress-strain state of the reinforced concrete beams

Zenoviy Blikharskyi¹, Taras Shnal¹, Roman Khmil¹

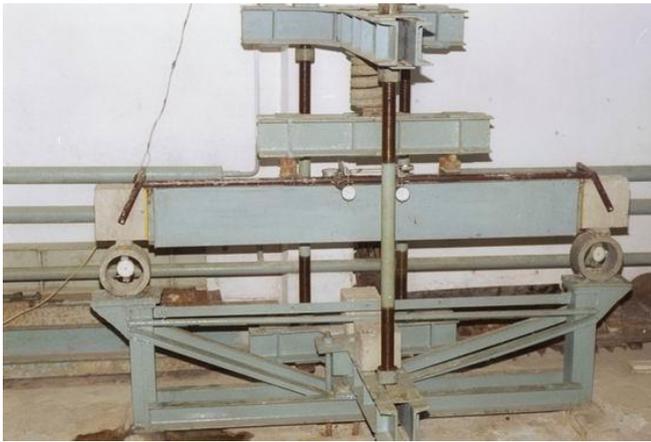
Fig. 1. The overall view of the beam during testing
Sources: (KHMIL R.Y. 2003)

facts, experimental researches was carried out within the laboratory work with the general amount of 22 reinforced concrete beams which were under the simultaneous influence of loading and aggressive environment (KHMIL R.Y. 2003, VASHKEVYCH R.V. 2005). Reinforced concrete beams were under the loading 0,3; 0,5; 0,7 from the limit load which corresponded to the maximal bearing capacity of beams. 10% sulfuric acid solution (H_2SO_4) has been used as an aggressive environment which has been placed in special containers of attached above beams. The loading has been applied in the third part of the beams' span in the form of two focused forces (Fig. 1, 2).

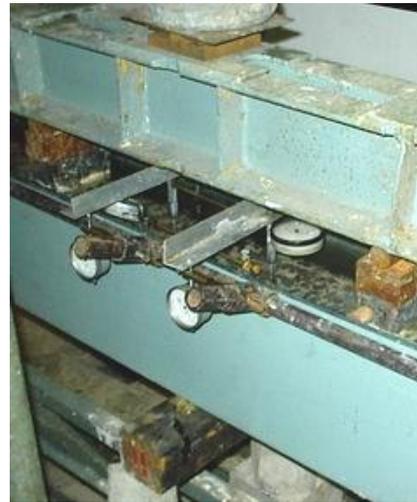
Fig. 3. Gauges position on of the beam during testing.

The deformations of concrete, armature and beams' deflections have been measured by gauges (Fig. 3).

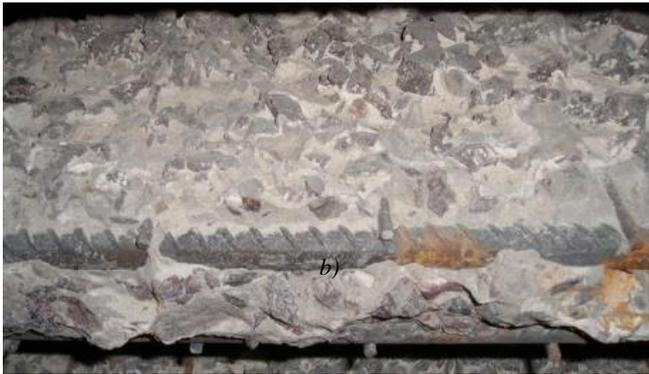
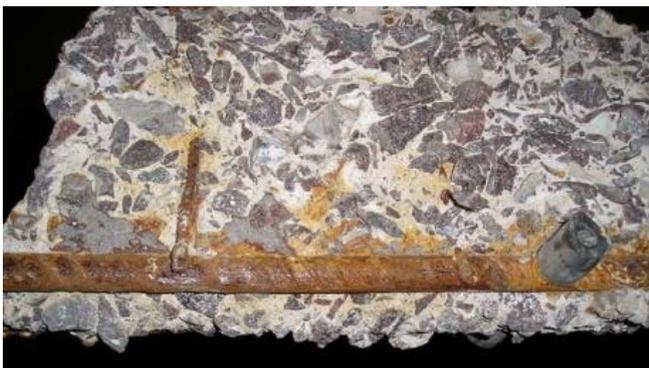
Fig. 6. The overall view of the armature corrosion:

a) a small corrosion intensity; b) a bigger corrosion intensity

its cross section was observed. This was accompanied by a significant increase of the beams' concrete and armature deformation and finally led to the exhaustion of their bearing capacity. Additionally, it is worth mentioning that the armature corrosion took place unequally (not simultaneously) along the perimeter – only from the side of the destroyed protective layer. From the inner side owing to the dense attachment of concrete the corrosion of armature did not take place (Fig. 6).
