IMPACT OF BIOCORROSION ON THE DURABILITY OF ETICS AND EMPIRICAL FINDINGS ABOUT THE PERIODOCITY OF MAINTENANCE

Nada ANTOŠOVÁ

ABSTRACT

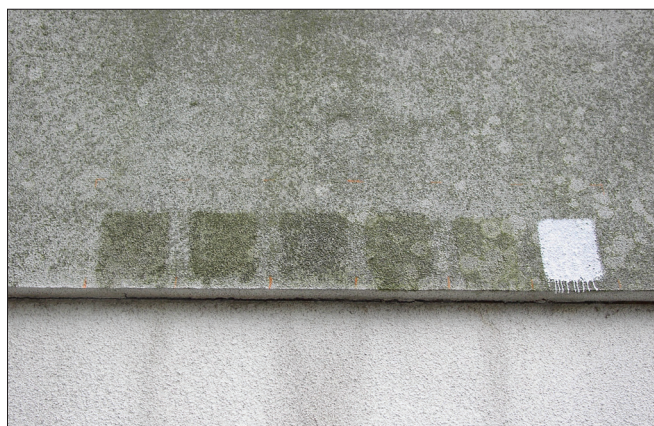
Fig. 1 Records of decontamination experiment on ETICS in 2005. Record created 7 days after the application of six different products. Noted decrease of new microorganisms, e.g., in Squares No. 1 and 2 (from the left) to half the amount (Antošová, N., 2007).

Technologies for the decontamination of ETICS with biocorrosion were experimentally tested in 2005. The effects of several freely available products on the market were observed, together with the amount of biological materials on the wall before and after the application of the biocide (during various time periods).

The results were satisfactory and clearly show the importance of maintenance. They present the issue of the periodicity of maintenance. The biological materials were decreased or even destroyed by the decontamination, depending on the type of product used and its lifespan. The timing of any new increases in biological materials on the surface of an ETICS was largely influenced by the surroundings, when only parts of the whole wall were chosen for the experiment. The surrounding parts of the wall were left in their original state. Therefore, the effectiveness of the

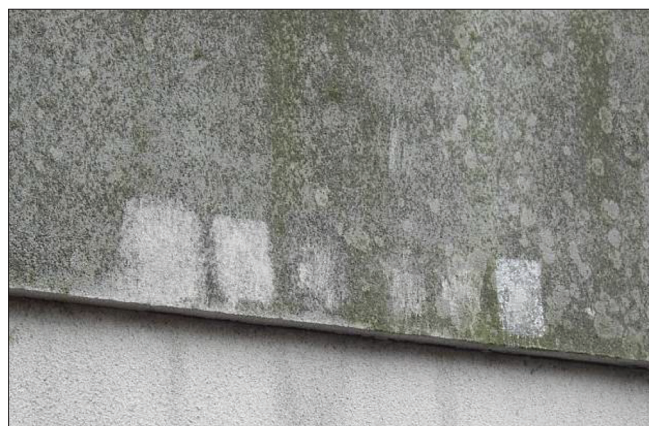
Fig. 2 Records of decontamination experiment on ETICS in 2006. Noted increase of new microorganisms, e.g., in Square No. 6 (from the left). Sample No. 1- destruction of microorganisms outside the designated area (Antošová, N., 2007).

product used is adversely affected by the surrounding parts of the wall, because algae and microorganisms developed quickly onto the tested parts.

If we consider the samples with a biocide of the best quantitative results in the destruction of biological materials on the top layer and its ability to destroy them after 4 years outside the designated area (Fig. 4), it is possible to consider maintenance every 5 to 7 years as the best option.

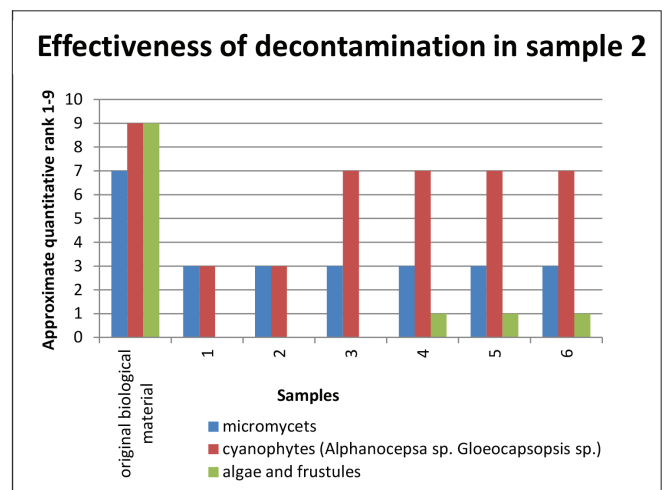
Fig. 3 Graphic representation of the effectiveness of biocide products when decontaminating an ETICS (results of experiment, samples taken 1-7 days after the application of biocides, samples taken 2-21 after the application of biocides, results of the author's experiment).

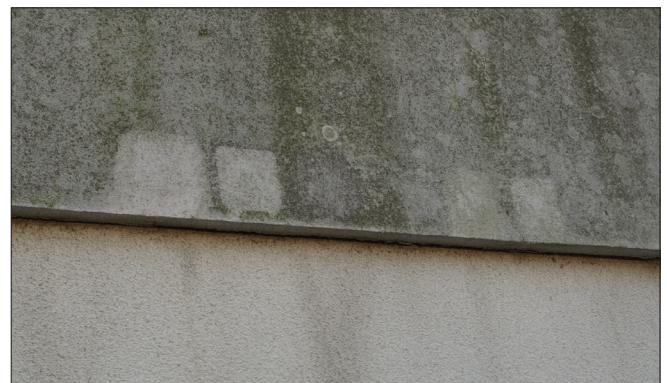
Fig. 4 Records of the decontamination experiment on ETICS in 2009. Note the increase in new microorganisms except in Square No. 1 (from the left). Sample No. 1- destruction of microorganisms outside the designated area (Picture from the archives of the author's experiment).

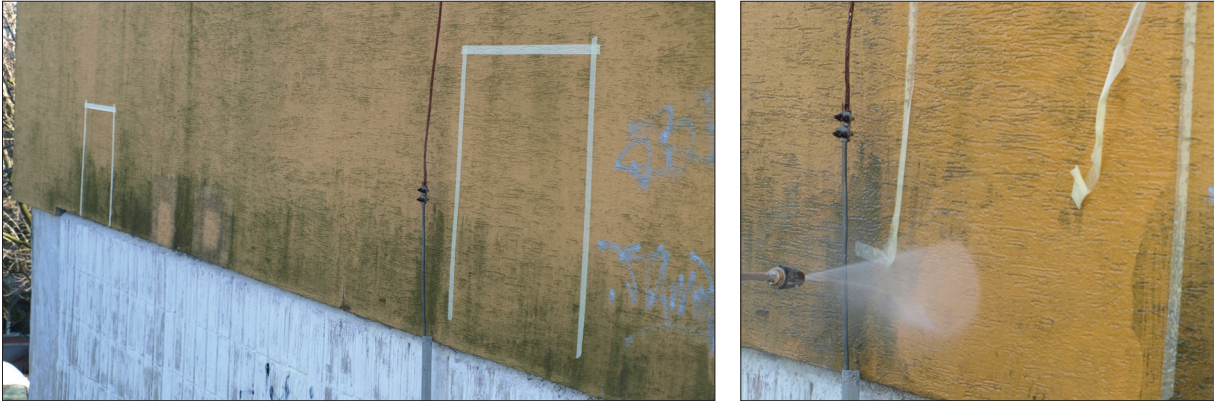
Fig. 5 Records of the decontamination experiment on ETICS in 2011. The state before the application – outlining the area. Cleaning with high-pressure water after 24 hours. (Picture from the archives of the author's experiment).

In 2011, the decontamination experiment was repeated on the ETICS with biocorrosion. The same chemical product dissolved in water and based on ammonia and aldehydes was used on two samples of ETICS. The difference was in the application technology. On the first sample, washing with high-pressure water was used after 24 hours; the second sample was not further treated. The samples were in the size of 120 x 80 cm. The lifespan of the chemical product was the same in this case. The surrounding areas of the sample were left untreated and with the original microorganisms.

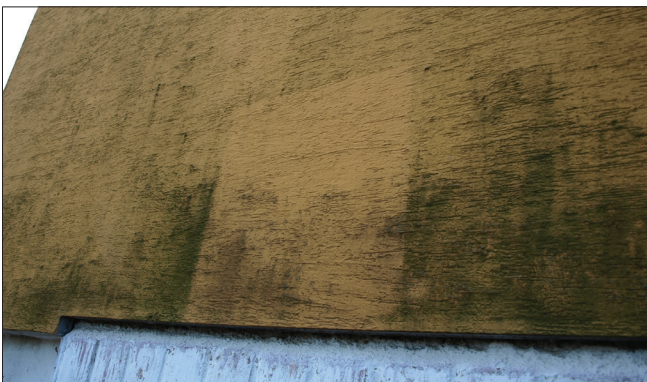
Fig. 6 Records of the decontamination experiment on ETICS. State of the sample in January 2012; this sample was not washed with water after the application of a biocide. (Picture from the archives of the author's experiment)

The results of the experiment were than less satisfactory. The first sample without washing showed the black marks of biological material after 2 years. The activity of the microorganisms was not observed. It is clearly visible with the naked eye that both samples of the ETICS were colonised by microorganisms after 3 years. The results were influenced by the chemical composition of the product used (low impact on the environment, dissolvable in water, low risk of soil contamination). The results show the importance of further maintenance after the application of the product to prolong the lifespan. The results also offer a comparison of the periodicity of maintenance with or without using high-pressure water. The microbiological results of effectively destroying the microorganisms have not yet been analysed.

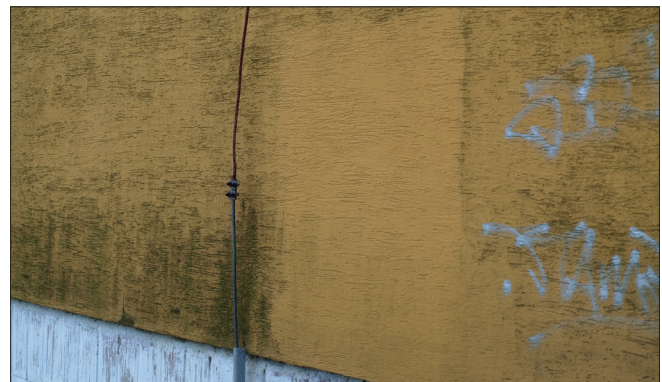
Fig. 7 Records of the decontamination experiment on the ETICS. State of the sample in January 2012; this sample was washed with water after the application of a biocide. (Picture from the archives of the author's experiment)

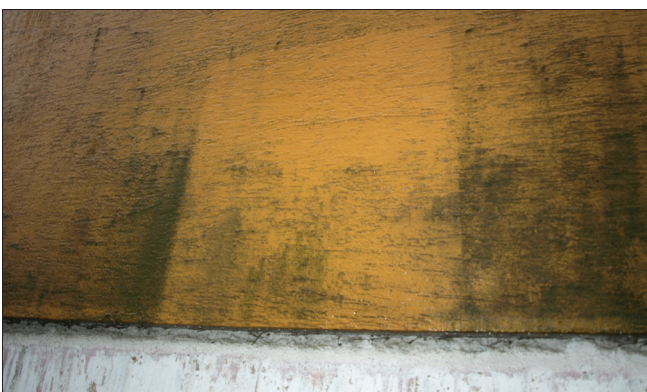
Fig. 8 Records of the decontamination experiment on the ETICS. State of the unwashed sample from Fig. 6, now in January 2013. (Picture from the archives of the author's experiment).

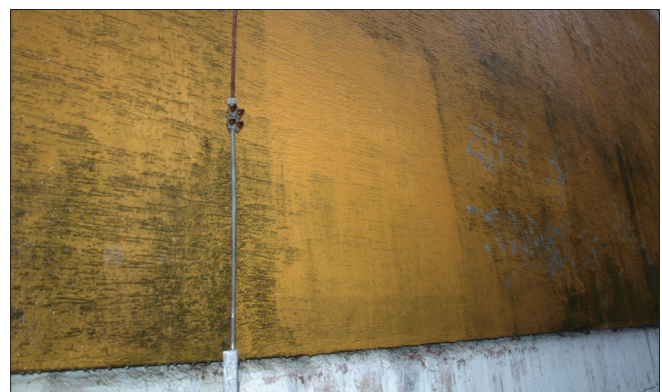
Fig. 9 Records of the decontamination experiment on the ETICS. State of the washed sample from Fig. 7, now in January 2013. (Picture from the archives of the author's experiment).
