PROVIDING LONGITUDINAL CONNECTION IN CASE OF CROSS SLUICING ON WATER BODIES IN BANAT HYDROGRAPHIC AREA

Diana HOANCA *, *Corina TODORESCU* * and *Alina ROȘU* *

DOI: 10.1515/trser-2015-0024

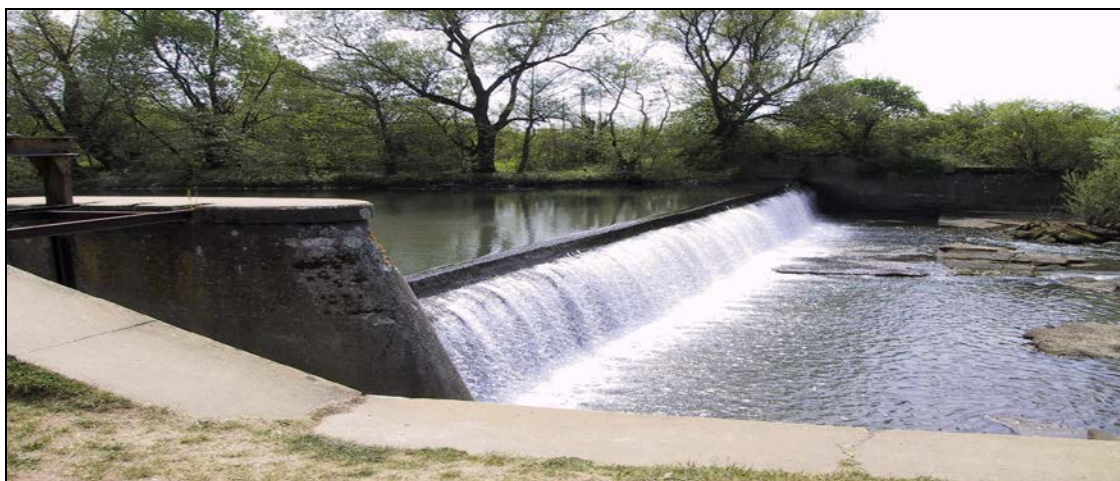
Figure 3: Balint Watermill sector.

Analysing the presented measures and taking into consideration the characteristics of the hydromorphological pressures on water bodies in the Banat HA, the following have been considered to ensure longitudinal connection: the creation of a bypass on Bega watercourse, at Balint Watermill - periodically functional and where there is a four meters high dam.

This measure is most suited on the left bank and its implementation eases the access of migratory ichthyofauna on medium distances.

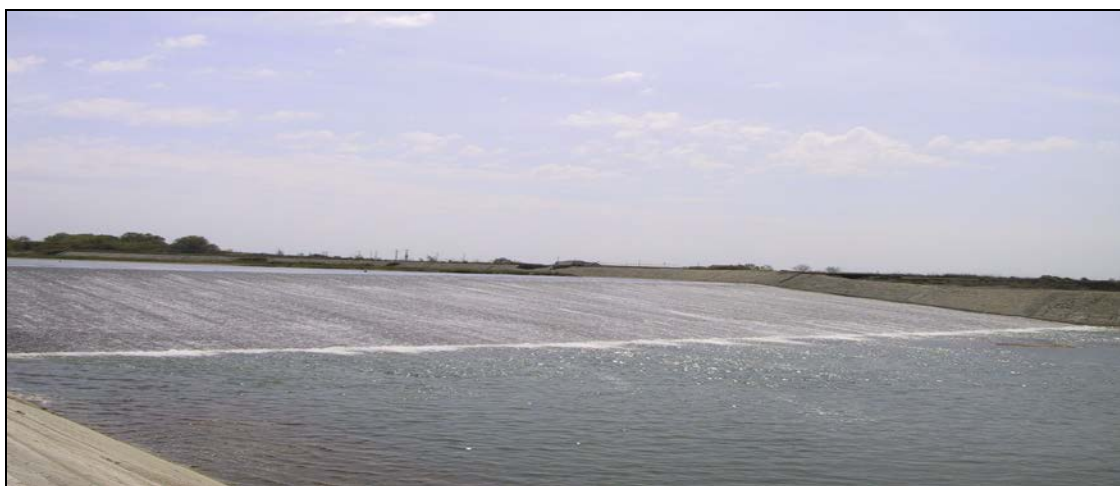
Figure 4: Hydrotechnic Knot in Coștei.

- the building of a fish passage on Timiș River at Coștei Hydrotechic Knot;
- the building of a fish ladder on both banks on Timiș River aligned against the crossings in Cotul Mic.

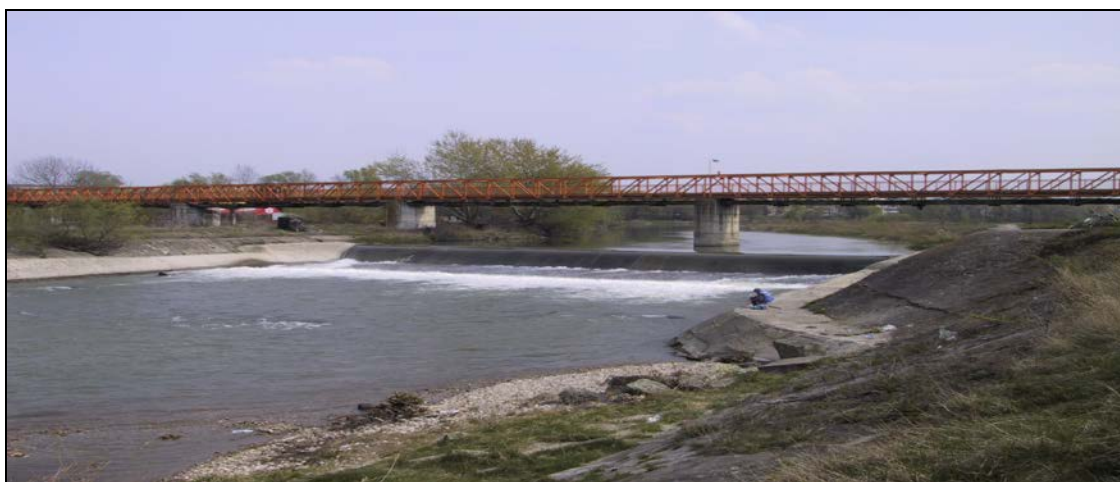
Figure 5: Crossing in Cotul Mic.
