DIAGNOSTICS OF WOODEN POLES SITUATED IN THE OPEN - AIR MUSEUM USING SONIC TOMOGRAPHY

Abstract

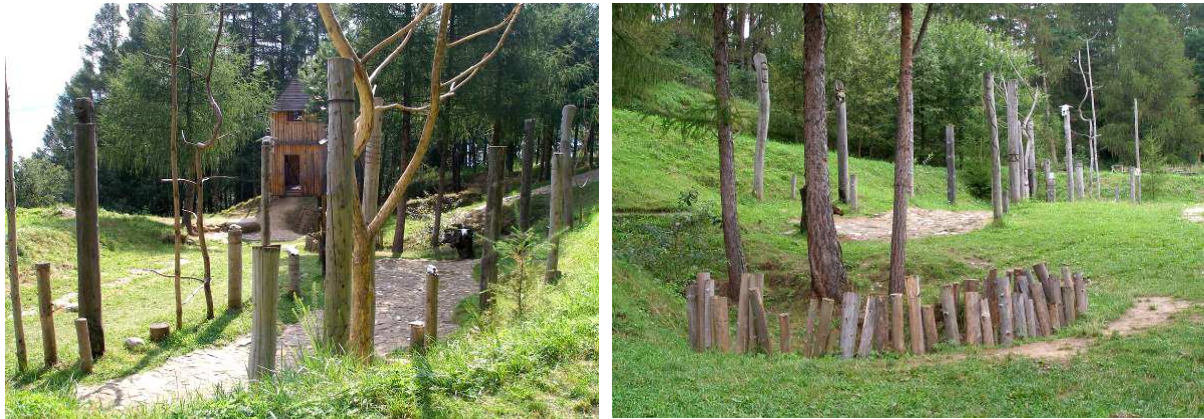
Extensive damage to the structures came 12 - 15 years later. It was caused by using an inadequate building material (a significant portion of poorly treated wood) and construction details (wooden poles fixed into the ground). The situation was worsened by unstable waterlogged mount slope situated in the landslide area. A considerable part of problems was managed to solve in 2002 - 2007, so the major part of the site could be restored (Figs. 1 and 2).

Fig. 1: View of the sacrifice site.

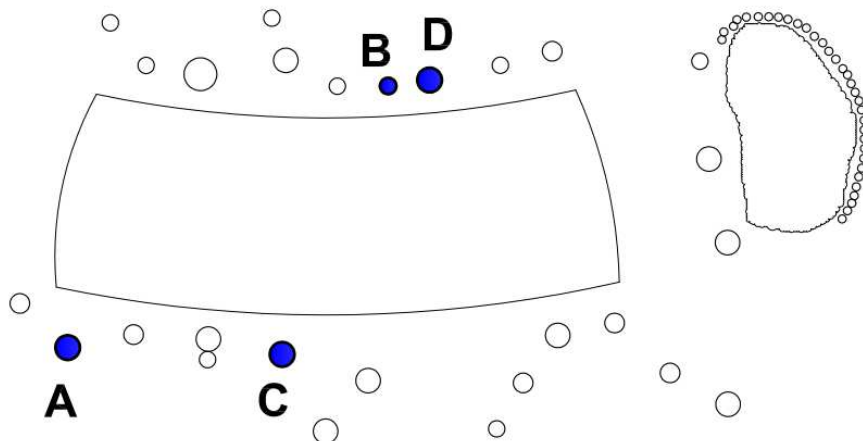
Fig. 2: Arrangement of wooden poles investigated in the sacrifice site.
