# EXPERIMENTAL CRACK PROPAGATION ANALYSIS OF THE COMPRESSOR BLADES WORKING IN HIGH CYCLE FATIGUE CONDITION

**Lucjan Witek**

*Rzeszów University of Technology  
Rzeszów, Poland*

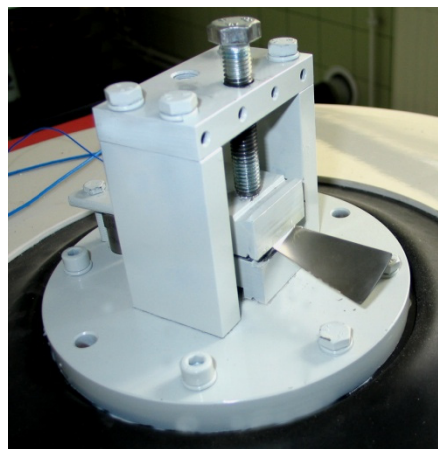
**Fig. 2. View of the blade mounted on the movable head of the vibrator.**

Before fatigue test, each blade was horizontally mounted on the movable head of vibrator (Fig. 2). After that, the head common with blade were entered into sinusoidal (harmonic) vibration. The

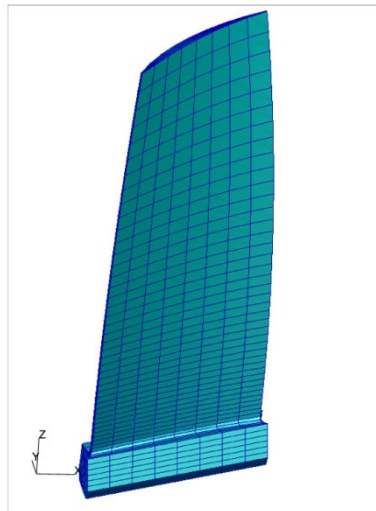
**Fig. 9 Finite element model of the compressor blade.**

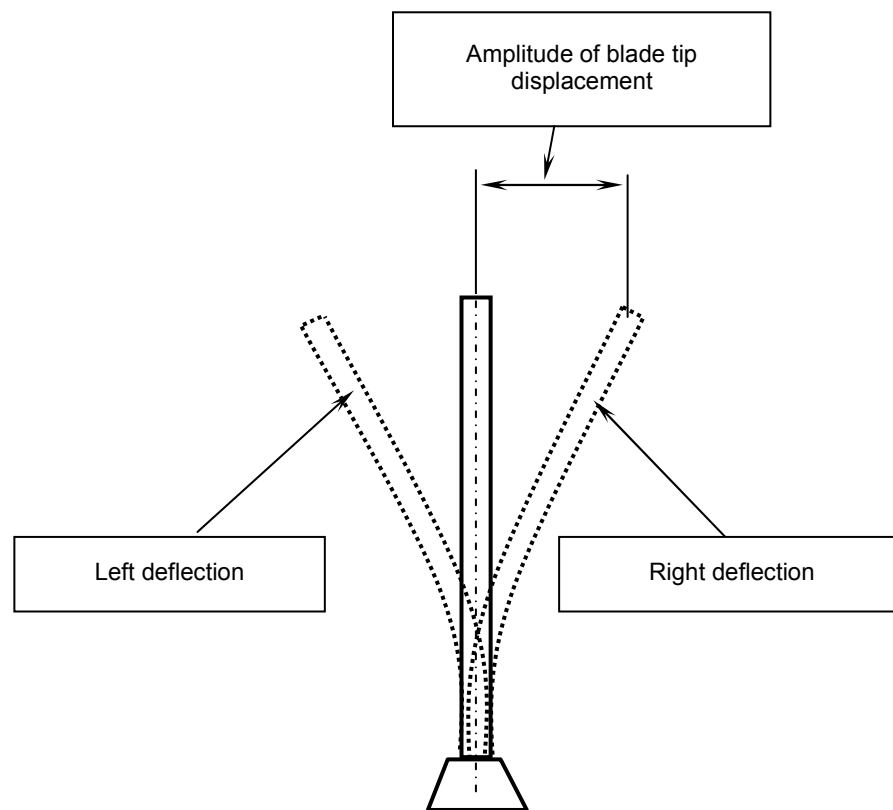
The blade under vibration is periodically bent in left and right side (Fig.10). Because of the fact that the cross-section of blade is non-symmetric, the stress levels under left and right deflection of blade will be quite different. In description of figures and results, the information about blade deflection will be placed. The blade for better visualization of numerical results will be shown in vertical position.

***Fig.10. Passing positions of blade under vibration.***
