DIAGNOSIS AND REPAIR TECHNOLOGY OF DAMAGED ELEMENTS OF CASA AIRCRAFT

The Polish military plane - CASA caught fire. The AFIT researchers have investigated the structure using the NDT methods and, together with specialists from WZL-3, have proposed the repair method.

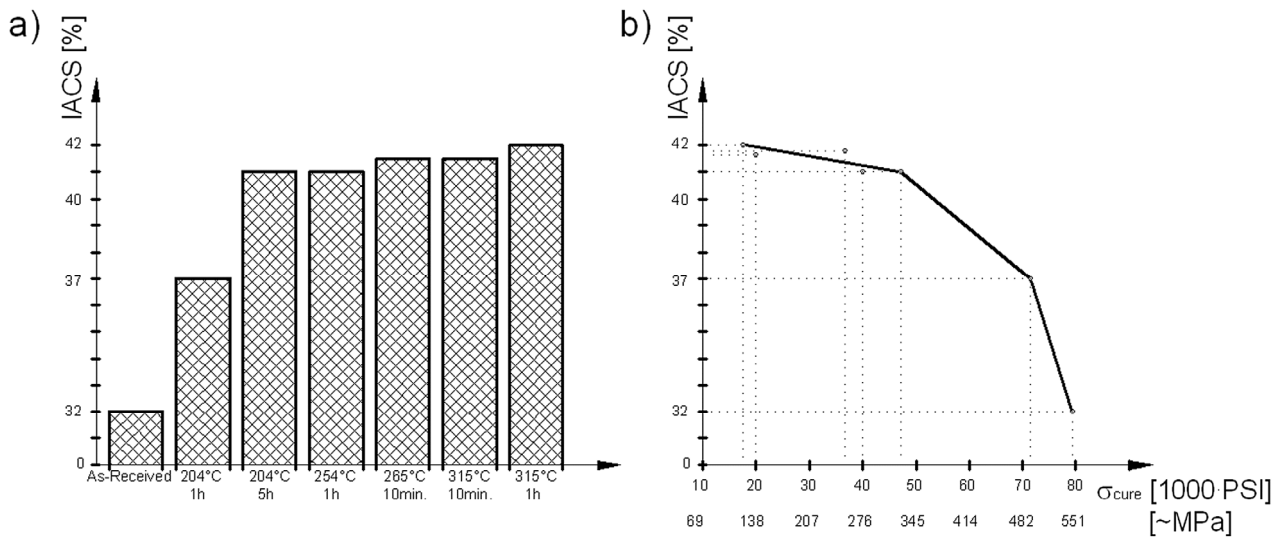
Fig. 2. The dependence aluminum alloy's conductive – module

There was discovered a relation between temperature and conductivity of aluminum alloy, as well as between conductivity and strength [3].

Based on NDT performance and the diagram (Fig. 2), the repair technology of riveting the alloy fastener to the longeron was developed. The properties of the alloy are same as those of the longeron (Fig. 11).

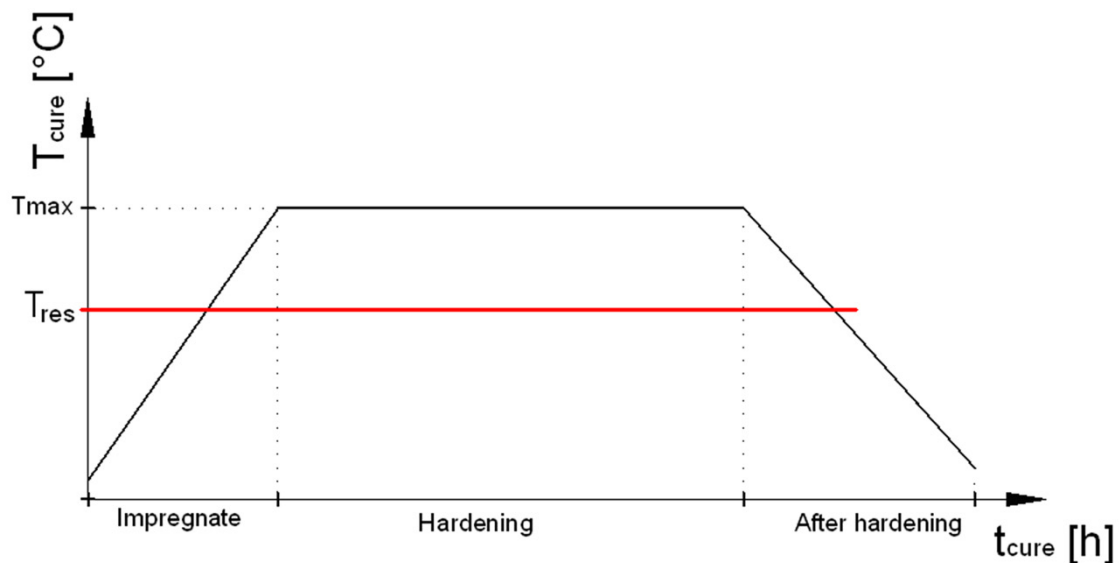
Fig. 6. Straight-ramp cure cycle

Sometimes prepregs contain other components which slow down chemical reaction. These components are deactivated at the maximum temperature during the cure. Immediate refrigeration of prepregs causes only the preliminary impregnation, the proper impregnation occurs during the first stage of the temperature cycle – in this first step of the cure: temperature grows and viscosity decreases. Next step is hardening, usually at constant high temperature, followed by cooling down.

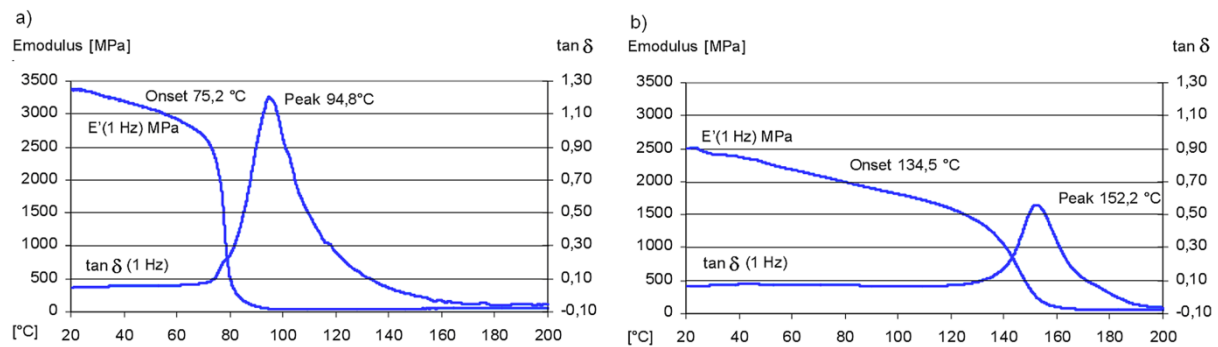
Fig. 7. Equivalent epoxy matrix's dynamic mechanic properties (data manufacturer):
 a) heat treatment 15h in 50°C, b) heat treatment 5h in 160°C

Based on the documentation, it is known that the panel's temperature resistance is 130°C, and that the prepreg's maximum cure temperature is 180°C.

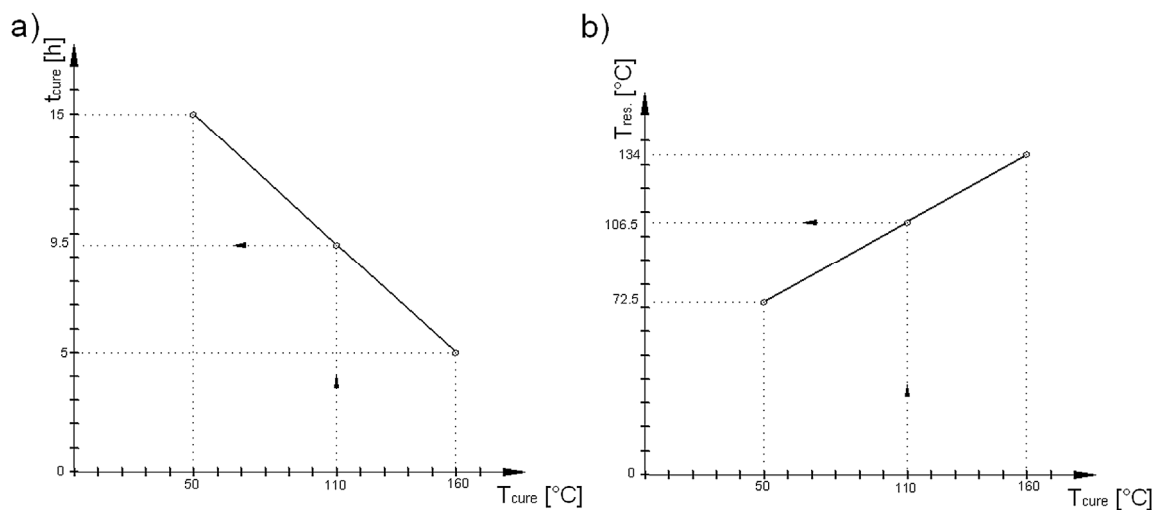
Fig. 8. Regress of parameters cure

Based on the above, it is possible to determine the temperature cycle parameters of the patch at the safe temperature.
