CRACK GROWTH ANALYSIS OF THE LANDING GEAR PULL ROD OF THE FIGHTER JET AIRCRAFT

Marcin Kurdelski
Andrzej Leski

*Air Force Institute of Technology,
Warsaw, Poland*

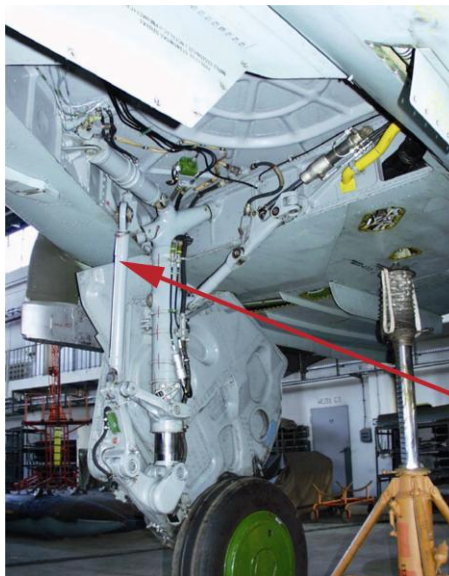
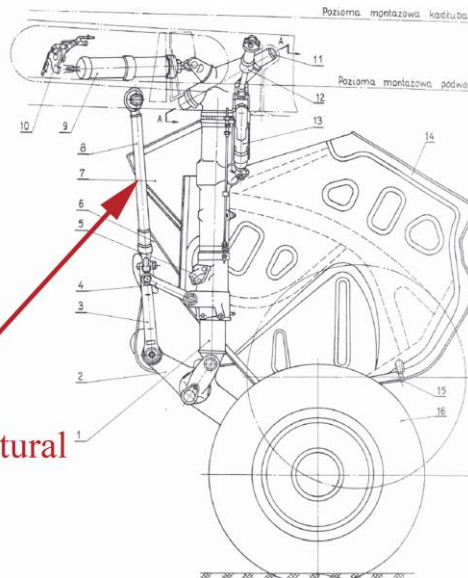
Fig. 2. Main landing gear schematics

**Pull-rod
Critical Structural
Element**

The pull rod is the member responsible for transmitting the load to the wing's strength members via the torsion links. It consists of two structural elements, the lower eye and the pull rod cylinder (tube). These two elements are joined by welding. The tube is fastened to the other (upper) eye with a threaded connection which permits regulation of the pull rod's length.
