EVALUATION OF DAMAGE AND DEFORMATION
OF RT-32 RADIO TELESCOPE

R. Joffe, N. Jēkabsons*, A. Bērziņš, M. Klapers, S. Upnere

Engineering Research Institute "Ventspils International Radio
Astronomy Centre" of Ventspils University College,
101 Inženieru Str., Ventspils, LV-3601, LATVIA
*e-mail: normundsj@venta.lv

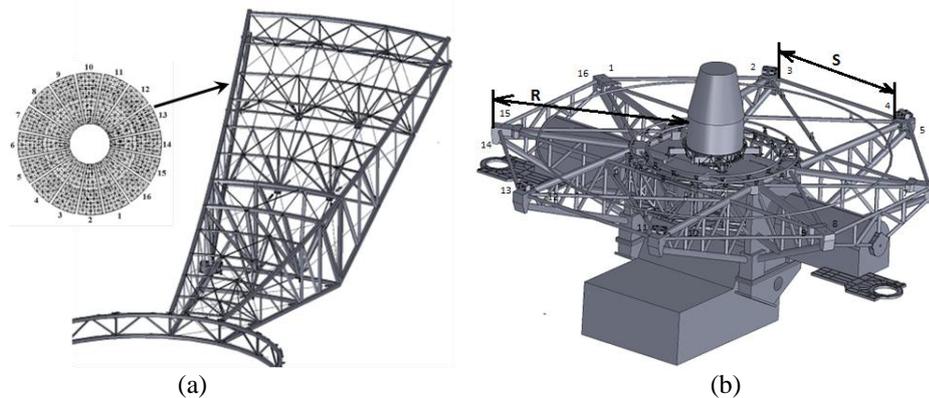
Fig.1. Segment of the mirror supporting structure (a) and base substructure (b).

The load carrying substructure of the antenna contains a large number of individual beams. For the mapping of beam damage the whole substructure is divided into segments (total 16). A segment of the supporting substructure for the antenna mirror is shown schematically in Fig. 1a, while the base substructure – in Fig. 1b.

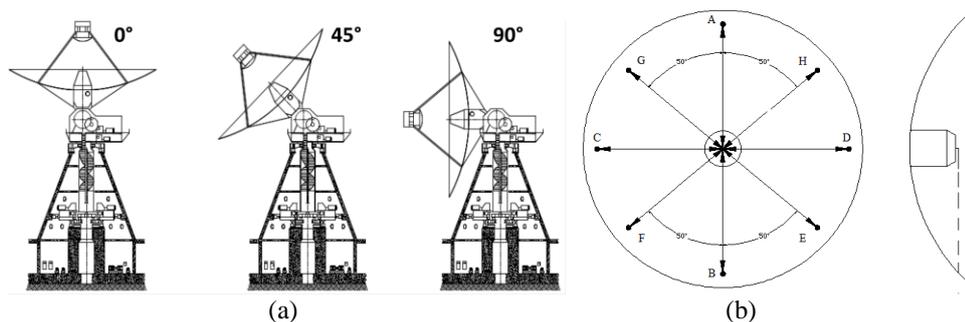
Fig. 5. Different RT-32 antenna orientations (a); locations on the dish circumference where measurements of “apparent” radius were made (b).

The relative changes in the dimensions of antenna surface were estimated based on the results of measurements at the chosen points on the middle cone of the dish to its edge on the circumference. These points are always the same for different orientations of the antenna. This so-called “apparent radius” was measured for three orientations (0°, 45° and 90°) of the antenna (Fig. 5a) and for eight different locations on the dish (Fig. 5b). For each of these points the antenna was balanced and levelled (see Fig. 5b) separately for every measurement in order to minimize error. For each point, multiple measurements (six to ten repetitions) were made. The average values along with standard deviations are presented in Table 2, where also the real values (in mm) of the apparent radius and relative changes (in %) at reorientation are given.

The geometrical changes of the substructure (schematically shown in Fig. 1b) were also measured at different antenna orientations – in the same manner as for the mirror supporting structure, see Fig. 5a. Two parameters were measured: 1) length, S , of the side of the octagon around the base substructure (see Fig. 1b); 2) “apparent” diagonal of the octagon, R (i.e. distance from a side of the central cone to the corresponding corner of the octagon, as shown in Fig. 1b). Also in this case, the measurements at different orientations of the antenna were made between the same points chosen on the base substructure. Multiple (three to five) measurements for each point were performed in order to minimize error.

The results presented in Fig. 7 show the total displacement within 2.5... 4 mm; there is no significant difference between the displacements of antenna edges in the cases with and without damage. The largest differences are observed around point D (270°) on the dish (Fig. 5b), which corresponds to sectors 13 and 14 of the antenna (see Fig. 1). As the results presented above (Table 1) show, these sectors had the largest number of damaged elements.
