# PRODUCTION ENGINEERING ARCHIVES

## An analysis of the causes of track twist at high speed of driving

Andrzej Pacana<sup>1</sup>, Dominika Siwiec<sup>2</sup>

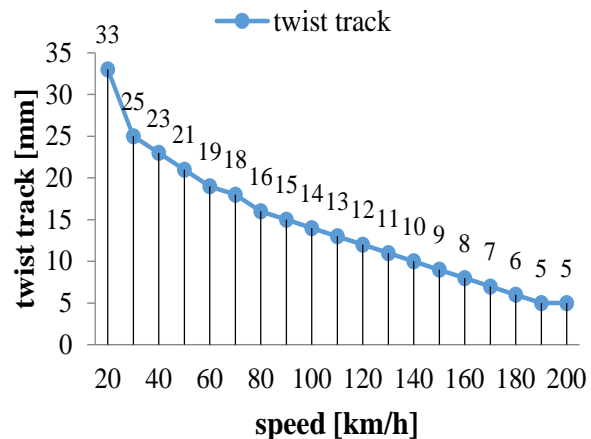
**Fig. 2.** The values of admissible deviations for the track twist in relation to the speed of the rail vehicle. Own study based on the instruction, 2005.

During the analysis of the track twist according to the norm PN-EN 13848-5:2017-10 it was assumed that the value of admissible deviations for the track twist is 6 mm by the speed of 160 km/h  $< V \leq 200$  km/h) (Horodecka et al., 2017; PN-EN 13848-5:2017-10).
