## THE SUPPORT OF UNDERWATER WORKS WITH THE USE OF REMOTELY OPERATED VEHICLES ON THE EXAMPLE OF WORKS CONDUCTED ON THE WRECK OF THE FISHING BOAT WŁA-127

Marek Dawidziuk<sup>1)</sup>, Adam Olejnik<sup>2)</sup>

### ABSTRACT

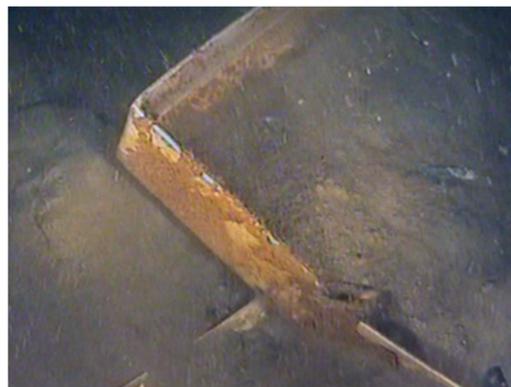
Fig. 3. The object located near the site of the wreck (own studies).

The first stage of work for the ROV operators was to familiarise themselves with the work area, and, in particular conduct an analysis of the collected sonograms for the presence of hazards to the ROV vehicle – such as fishing nets, and a general characterisation of the seabed with the objects present on it (Fig. 3).
