## EXAMPLE BUILDING DAMAGE CAUSED BY MINING EXPLOITATION IN DISTURBED ROCK MASS

LUCYNA FLORKOWSKA

The Strata Mechanics Research Institute of the Polish Academy of Sciences,  
ul. W. Reymonta 27, 30-059 Kraków, Poland.

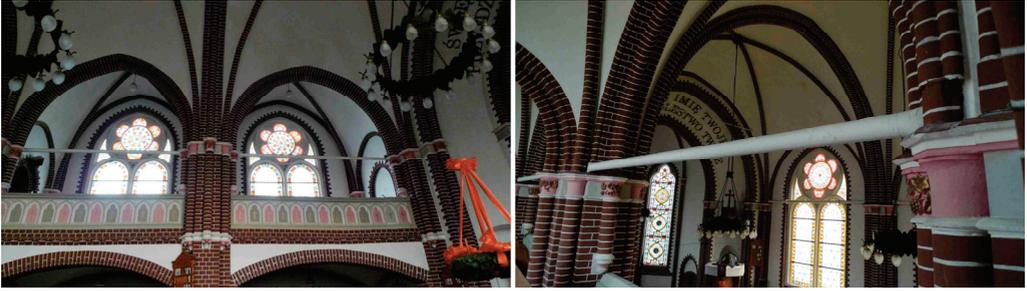
The system of tie-beams comprises: RC tie-beams, 60 cm below ground level, external steel tie-beams, 40 cm below parapets (mounted into wall chases) and presented in Fig. 3 and 4 steel tie-beams inside the church, in level with pillars' capitals. Steel tie-beams holding the structure from outside are circumferential (apart from low-installed fragments each side of presbytery housing the vestry) and anchored in the walls. Additional transverse anchoring is provided by steel tie-beam separating main nave from presbytery. The steeple is protected by steel anchor in Western wall and steel stretcher in Northern wall.

Fig. 4. Steel tie-beams protecting against mining damage
