## Long-term Influence of Concrete Surface and Crack Orientation on Self-healing and Ingress in Cracks – Field Observations

This paper presents results from investigations on the long-term influence of concrete surface and crack orientation on ingress in cracks. Five reinforced concrete structures from Norway exposed to either de-icing salts or seawater have been investigated. Concrete cores were taken with and without cracks from surfaces with vertical and horizontal orientation. Carbonation in cracks was found on all de-iced structures, and a crack on a completely horizontal surface appeared to facilitate chloride ingress. Ingress of substances from seawater was found in all cracks from marine exposure. However, the impact of cracks on chloride ingress was unclear. Horizontal cracks on vertical surfaces appeared to facilitate self-healing.

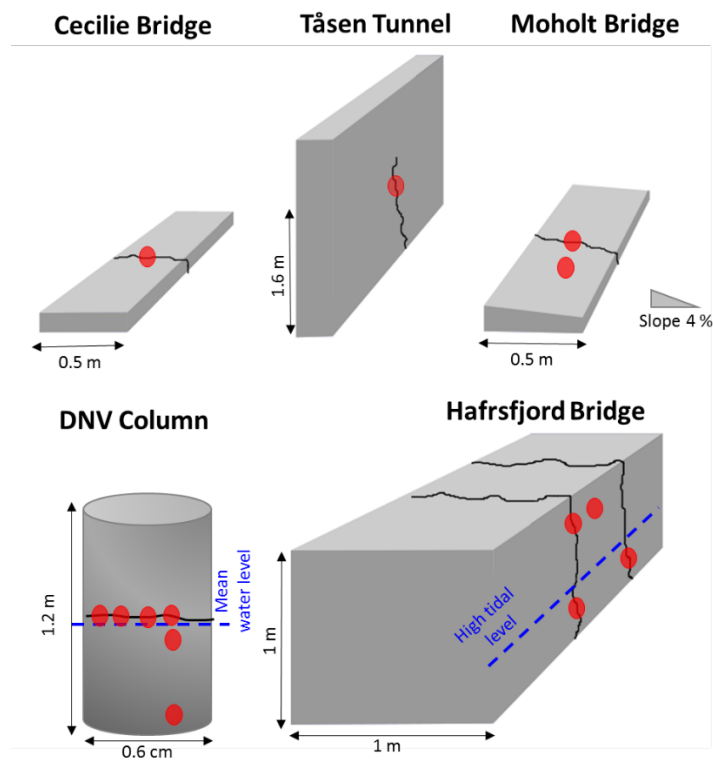
Figure 2 illustrates the investigated structural parts showing the different orientation of the investigated concrete surfaces and the orientation of the investigated cracks. The red circles indicate locations of coring. Concrete cores were taken from horizontal and vertical surfaces. The edge beam from Cecilie Bridge was the only completely horizontal surface of all investigated structural parts. The edge beam from Moholt Bridge had a slope of about 4 %. From Tåsen Tunnel, the DNV column and the foundation of Hafrsfjord Bridge, cores were taken on vertical surfaces.

Figure 2 - Illustration of the investigated structural parts showing the concrete surface and crack orientation. Locations where cores were taken are illustrated in red.

While the Tåsen Tunnel and Hafrsfjord Bridge had vertical cracks, the DNV column had a crack with horizontal orientation. Except for the DNV column, it is expected that the investigated cracks are due to early drying shrinkage or thermal restraint. The investigated crack from the DNV column derives from dynamic loading [15]. None of the structures allowed cores to be taken from different surfaces or crack orientations.

For all structures it was tried to drill concrete cores through reinforcement with crack width above and below 0.3 mm [2]. Additionally, reference cores next to the cracks were taken when possible. Table 4 gives an overview of the drilled concrete cores from the investigated field structures. The approximate location of concrete cores is illustrated in Figure 2.

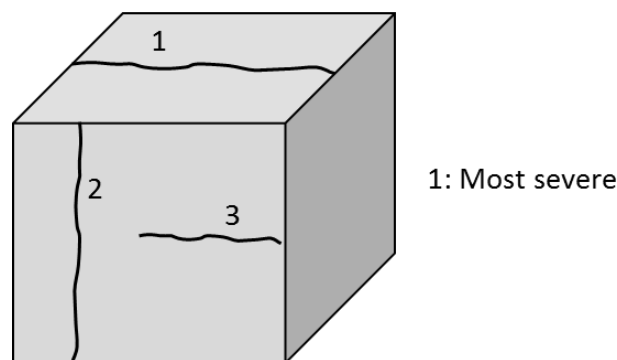
marine exposed DNV column seem to favour self-healing, and complete self-healing of cracks was only observed in the cores taken from the DNV column. In contrast, the vertical crack on the Hafrsfjord Bridge was not self-healed. This might be explained by a horizontal crack being wet for longer time, as seawater might stay longer inside the crack after it is filled. In a vertical crack the water can move more freely out of the crack.

Figure 9 illustrates the observed long-term influence of concrete surface and crack orientation on ingress in cracks. A crack on a horizontal top surface (1) appears to represent the most severe condition with regard to ingress. This supports the guidelines given in the *fib* model code for service life design (MC-SLD) [3]. A crack on a vertical surface is less severe. The potential for self-healing of a crack in marine exposure seems to be facilitated with a horizontal crack, i.e. vertical cracks (2) appears more severe than horizontal cracks (3).

Figure 9 - Illustration of the observed long-term influence of concrete surface and crack orientation on ingress in cracks.
