Stanislav Smugala, Darja Kubečková*, František Indra The impact of changes in the geological conditions of road bedrock layers while the road was in use

DOI 10.2478/otmcj-2019-0008 Received May 13, 2019; accepted September 27, 2019

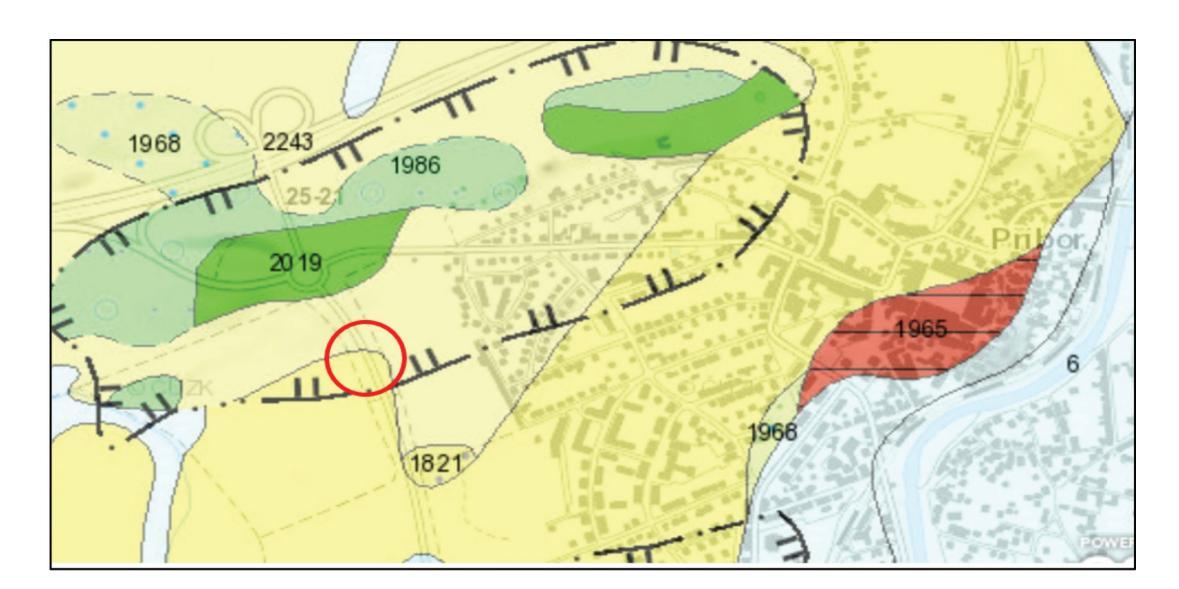
Fig. 2: Area according to the geological map [explanation of geological structures (the structures themselves relate only to the bold geological structure) is as follows: 19 light yellow-loess clay, genesis-eolic sediment, system-Bohemian Massif-covering formations, formation-quaternary, era-kenozoic, Pleistocene department; 2,243 ocher to pink-eluvial sediments (weathered mantle) stone-sand-clayey eluvia of sedimentary rocks, system-Carpathians, formation-quaternary to neogene, era-kenozoic, department Pleistocene; 1,821 ocher-yellow-marinated sediments, calcareous clay (tégl), in places with sand system-Carpathian Foredeep, formation-neogene, era-kenozoic, department-miocene, grade-Baden; 2,019 green-volcanites, cucumber, picrit, tuff, tuffite, system-Carpathians, area-flysch zone, region-outer group of nappes, regional unit-Silesian, formation-chalk, era-mesozoic, department-lower chalk, degree-berrias, Valangin, Hauteriv, Barrem, Apt, Formation-Volcanicities of the Ashtree Association; 1,986 bluish-marinated, sandstone, conglomerate, claystone, limestone, system-Carpathians, area-flysch zone, region-outer group of nappes, regional unit-Silesian, formation-rešín-Hradiště; 1,968 grey-yellow with blue dots-marinated, claystone, sandstone, conglomerate, system-Carpathians, area-flysch zone, region-outer group of nappes, regional unit-ždánice unit, sub-Silesian unit, formation-chalk to paleogene, era-mesozoic to kenozoic, department-Upper Cretaceous to Paleocene, degree-Turon, Coniak, Santon, Campan, Maastricht, Formation-Frýdek].

conducted in situ. Area for geological surveys and geological structures is shown in Figure 2.

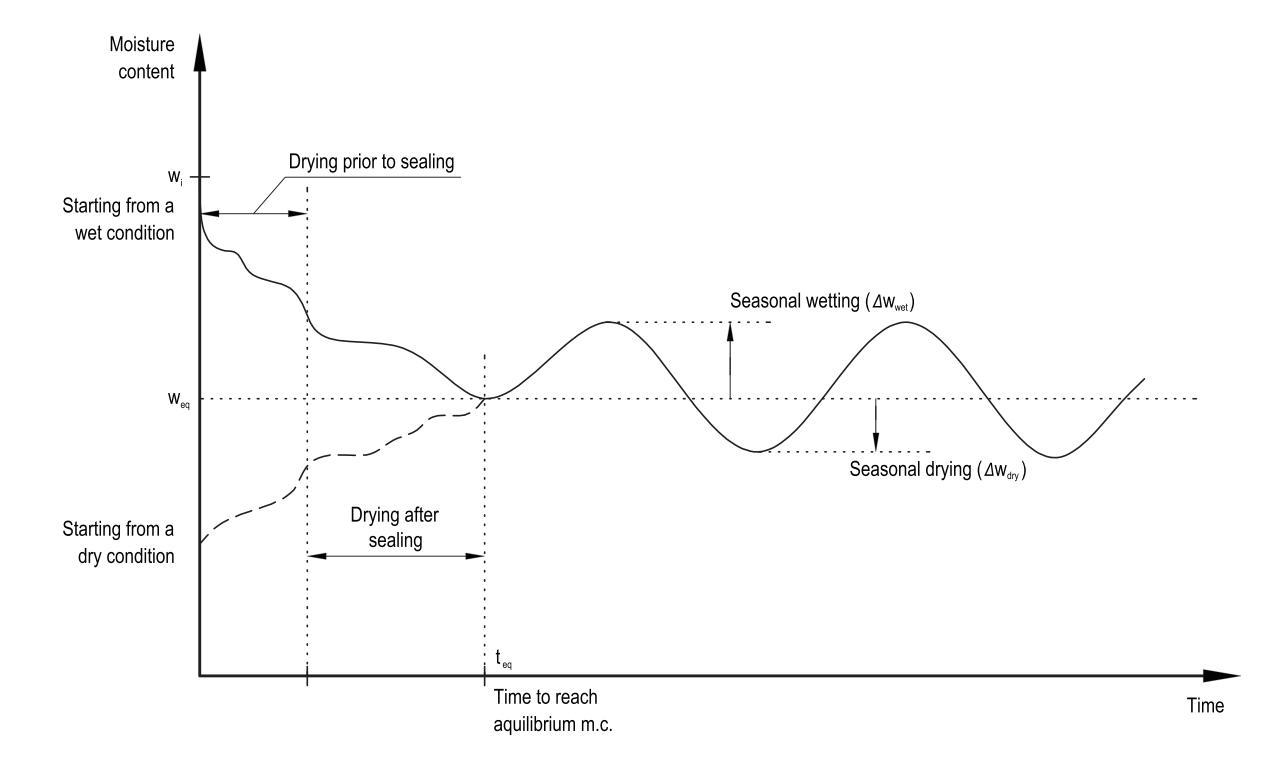
Fig. 7: Moisture content as work is conducted.
