PESD, VOL. 11, no. 2, 2017

ANALYSIS OF THE HYDROCLIMATIC RISK PARAMETERS AT THE HIGH LEVEL OF THE TAZLĂUL SĂRAT RIVER IN 2016 YEAR

Mihail Luca¹, Mihaela Avram²

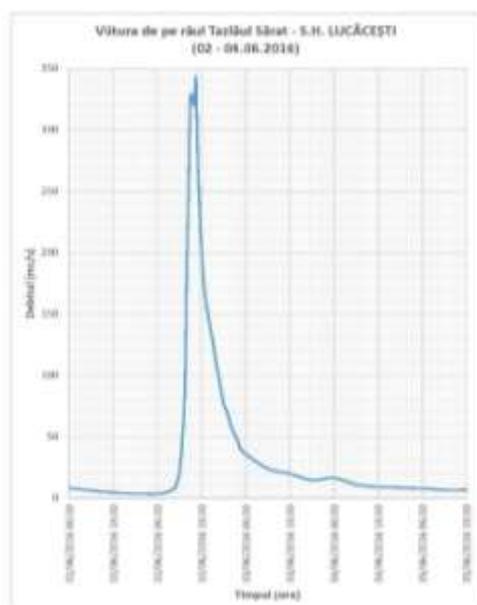
The flood on the Tazlăul Sărat River started on 02.06.2016, at 10.00, with a 69 cm share and a flow of 6.70 m³/s. The peak of the flood was recorded on 02.06.2016, at 16.30, where the quota reached 360 cm and a maximum flow of 342m³/s. The 2.73 m flood gauge has overtaken the banks and has caused major

Fig. 2. The flood level hydrograph on the Tazlăul Sărat river, the Lucăcești H.S.
