The influence of mining activities on the Church of St. Cross in Bytom–Miechowice

Tomasz Lipecki^{1*}, Hanna Ligarska¹ and Małgorzata Zawadzka¹

Abstract

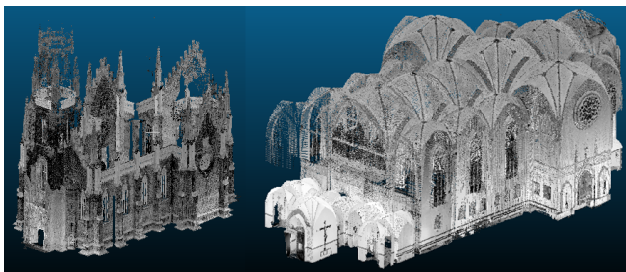
Figure 7. The view of the outer and inner part of the church – point cloud view

After removing unnecessary points and so-called “noise” in CloudCompare, point clouds containing only the outer and inner parts of the church were obtained (Fig. 7). The individual elements are then analyzed, among others: pillars, church steeple, attic, side walls, edges of window openings (Fig. 1 and 7).

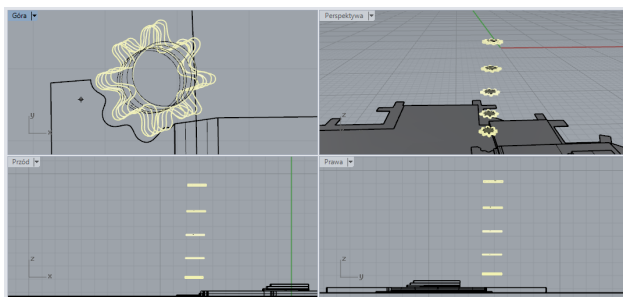
**Figure 11.** Example of modeled sections of pillars for analysis

Because the analysis described above does not speak of the segmental values of declination of the entire pillar height, a detailed analysis of each pillar was performed, by modelling 5 intersections cut-off from the cloud point and reading the fit in each modelled profile of the circles (Fig. 11). Due to this analysis, the values, directions and indirect distortion of each pillar declinations were received (Fig. 12) The maximum declination of the pillars now stands at 29.0 ‰ (Tab. 3). Before the coal exploitation in 2014 it was 25.6 ‰ (Słowik et al., 2015) which

means that as a result of the exploitation, the condition of the church's structural components continues to deteriorate.

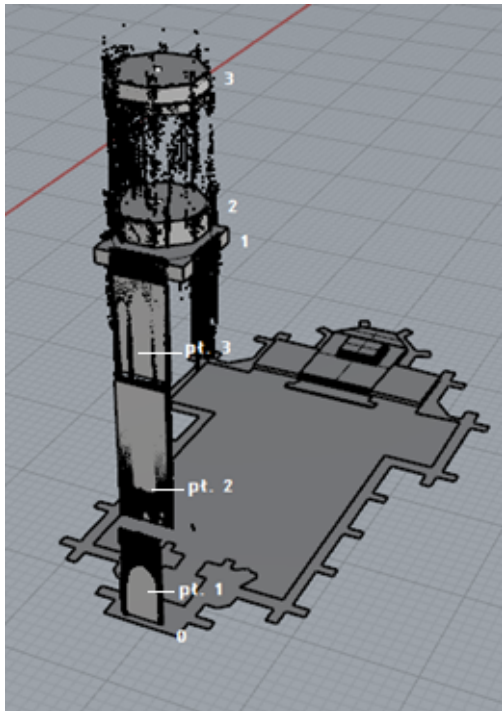
Figure 16. Modeled parts of the church tower

[g]	Inclination			total [mm]	direction	Total height [m]
		[%]	[‰]	[mm/m]			
attic	2.661	4.18	41.8	41.818	1200	N-E	28.70
whole tower	1.7552	2.76	27.6	27.578	1028	N-E	37.28
upper part of the tower	2.0101	3.16	31.6	31.585	370	N-E	11.77

The analysis of the church tower's verticality was much more difficult as the lower parts of the tower were heavily built by other construction elements, so it was impossible to fit the solid into the cloud of points precisely. Therefore, the lower parts of the tower are represented by planes 1÷3 (Fig. 16), while the rest of the tower is already represented by solids. Delimitation of every single element was measured and summed. For lower parts delimitation was determined only in the east direction, while for the upper part it was possible to determine the centre coordinates of circles adjusted in blocks. Delimitation was calculated for the whole tower and separately for the upper and lower parts (Tab. 4) because of accuracy of adjustment.
