TECHNICAL NOTE

EXAMPLE OF THE APPLICATION OF JET GROUTING TO THE NEUTRALISATION OF GEOTECHNICAL HAZARD IN SHAFT STRUCTURES

PIOTR DYBĘŁ, DANIEL WAŁACH, JUSTYNA JASKOWSKA-LEMAŃSKA

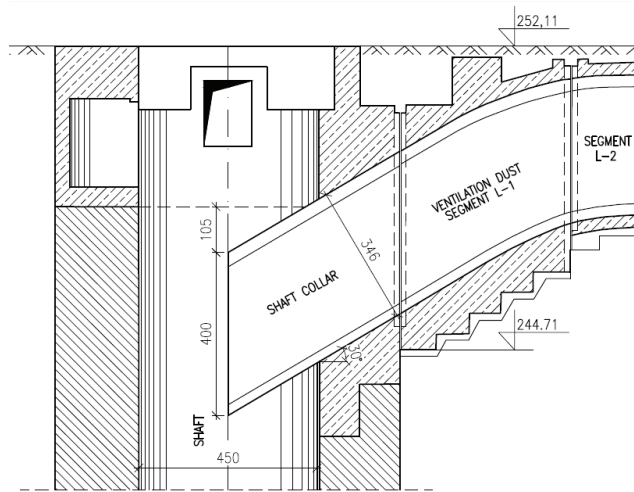
Fig. 1. Longitudinal section drawing of the ventilation duct and shaft collar

After the dislocation of the ventilation duct, a site inspection was performed, including the immediate area around the shaft, ventilation duct and the shaft top building. As a result of the displacement of the first segment of the ventilation duct in relation to the shaft collar, a possibility of additional loads affecting the shaft lining was found. These loads were not taken into account in the initial design. The research conducted by the authors included the analysis of the current condition as well as control static and strength calculations helped to assess the real hazard to shaft structures and infrastructure. It was shown that further subsidence of the ventilation duct may lead to damaging the shaft structures. Immediate protection of the
