## Bird mortality on medium-voltage power lines in the Czech Republic

Vlasta ŠKORPÍKOVÁ, Václav HLAVÁČ & Milan KRÁPEK

**Abstract:** In 2015–2016, 6,429 km medium-voltage power lines with 76,430 pylons were checked for bird mortality in the Czech Republic. 1,326 bird victims of power lines were found, 156 of which died after collisions, and 1,170 birds were electrocuted. They belonged to 60 species from 12 orders, and birds of prey made up almost half of all victims. Steel pylons bearing several cross-arms including upper and crosswise jumpers were identified as most dangerous from the electrocution point of view. On the other hand, pylons in straight lines with Pařát cross-arms (triangular arrangement of conductors without any horizontal bar) were among the least dangerous, and when they had a simple perch fitted below the cross-arm, no mortality was recorded. But these pylons are new in practice and despite becoming widely used recently, they form less than one tenth of all pylons in the Czech Republic. On other pylons various types of mitigation measures have been installed. Commonly used plastic covers and plastic strips have proved to be especially effective, but only in case

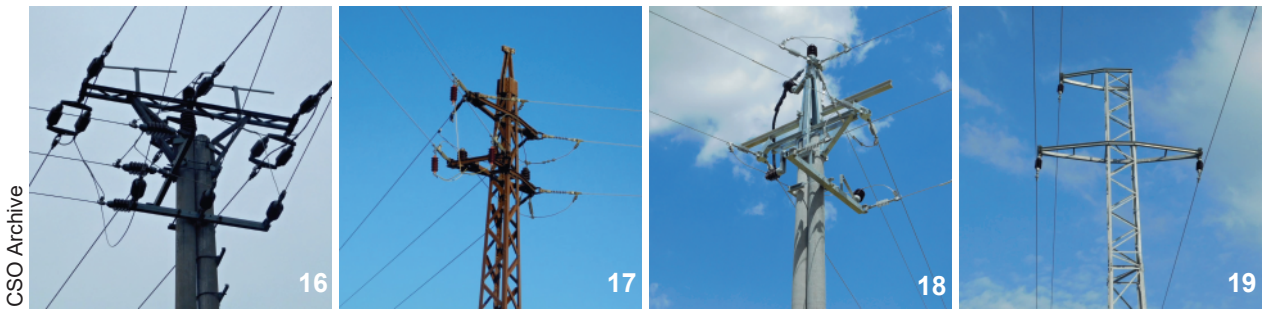
**Fig. 16–19.** A concrete branch pylon with three horizontal cross-arms, upper, lower and crosswise jumpers and two benches (16), a steel branch pylon with two horizontal cross-arms (17), on which extremely high mortality was found. It was replaced with the pylon in Fig. 18; a concrete pylon with Pařát and horizontal cross-arms and more bird-protection measures: a horizontal plastic element as a safe perch, a jumper insulation and perch discouragers on the horizontal cross-arm (18); a steel pylon with two cable levels and suspended insulators (19).
