**A. Komorek<sup>1</sup>, D. Grygiel<sup>1</sup>, R. Bieńczak<sup>1</sup>, J. Godzimirski<sup>2</sup>**

## THE POSSIBILITY OF A VISUAL ANALYSIS OF THE FAILURE OF BUTT ADHESIVE JOINTS MADE WITH DIFFERENT GLUES

**Keywords:** *adhesive joint, butt sample, visual analysis*

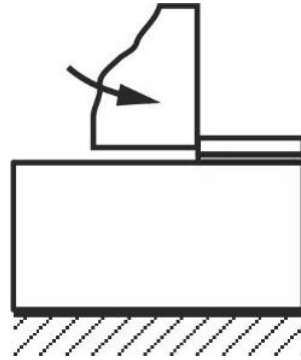
Fig. 1. Diagram of examining impact strength in block samples

strength of adhesive block samples used to determine the comparative impact strength of adhesives is significantly dependent upon the adhesive strength of glued joints. This is due to the fact that in this type of impact loaded joints (Fig. 1), the highest values are obtained by normal stresses, which are perpendicular to the connected surfaces, and these stresses are typically associated with the adhesive strength of joints.

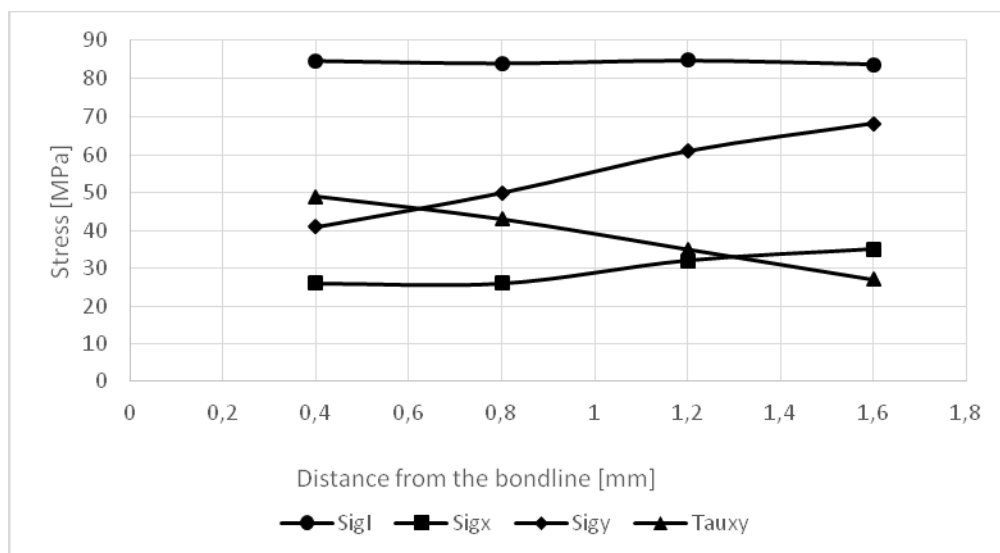
Fig. 2. The dependence between stresses in joints and the distance of the impactor's edge to the surface of the joint ( $\sigma_I$  - Max Principal Stresses,  $\sigma_x$  - normal stresses perpendicular to the surface of the joint,  $\tau_{xy}$  - tangential stresses in the direction of impact loading)

It is also worth noticing that with the height of applying the load over the joint equal to 0.8 mm (height being in accordance with the requirements of Standard PN-EN ISO 9653) the normal stress values are close to the tangential static values, which seem to prevail with the assumed manner of the load application. While increasing the distance between the impactor and the joint, the value of the tangential stresses falls and of the normal ones, it rises (Fig. 2).

This is due to increasing the value of the bending moment of the impacted upper element. A highly significant effect of adhesion in the adhesive joint resulted in conducting an investigation of this parameter in adhesive joints made with different glues, of different coefficients of the elastic modulus. It was assumed that such glues may be characterized by different adhesive properties, which should affect the impact strength of adhesive joints, made with them.

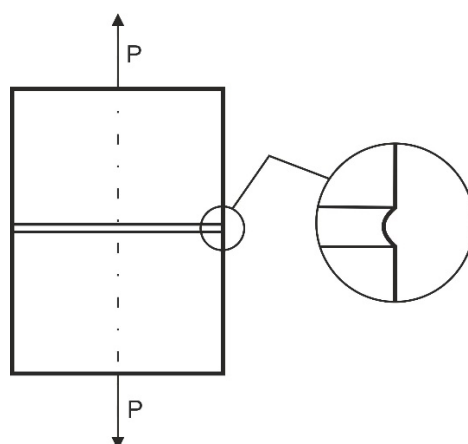
**Fig. 3.** Model of an adhesive joint impact loaded for tear-off [3]

In the study the authors used butt adhesive joints, in which the joints are loaded for tear-off. In such a joint, the glue layers which are immediately adjacent to the bonded surfaces cannot be subject to regular deformation in the joint plane (radial). The remainder of the joint layers undergo such deformations with loading combined with axial forces. The walls of the adhesive joints of butt connections become concave in their shape (Fig. 3), which proves the occurrence of tangential stresses [11].

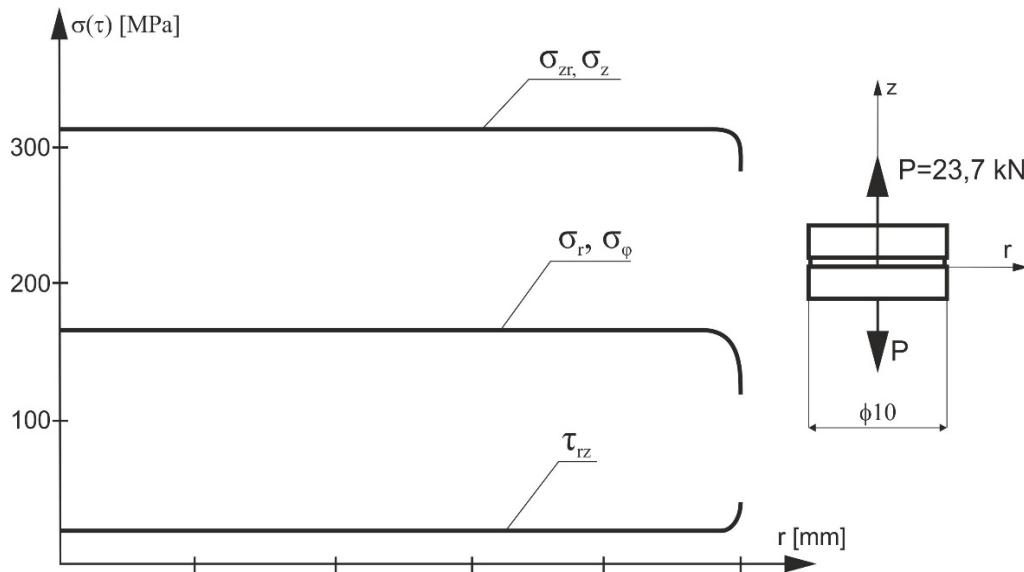
**Fig. 4.** Stress distribution in the joint layer which is immediately adjacent to the butt connection, axially-symmetrically extended :  $\sigma_r, \sigma_\phi, \sigma_z$  -normal stress,  $\sigma_{rz}$  -reduced stress,  $\tau_{rz}$  -tangential stress,  $r$  - radius of the joint [4]

Using the FEM, the authors determined the distribution of stresses in the joint of such connections [12] and assessed their influence on the strength of the joint. The analysis of the stress distribution in the adhesive joint depicted in Fig. 4 leads to a conclusion that the maximum tangential stresses occurring in the joint are smaller, by an order of magnitude smaller, than in case of normal stresses and exert hardly any effect on the extent of the joint subjected to tension.

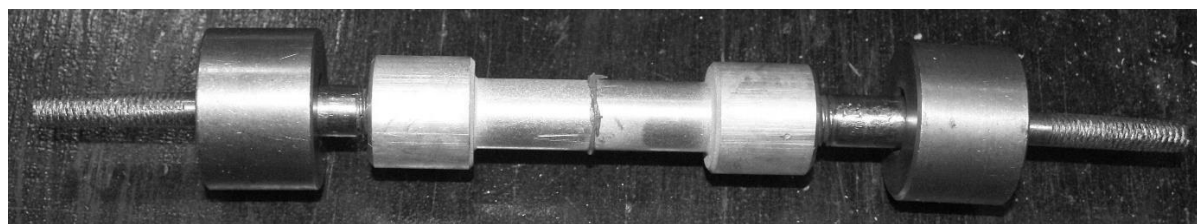
**Fig. 5.** The butt joint prepared for testing

The surfaces for joining were prepared by means of abrasive blasting, and the abrasive agent was copper slag. Due to the conducted treatment, the authors obtained the mean arithmetic profile deviation from the average line  $R_a = 3.90 \mu\text{m}$ . Before bonding the surfaces of the samples were degreased by means of gasoline extraction, which was evaporated in the chamber of the laboratory dryer. After applying the adhesive onto the bonded surfaces, the elements of the samples were assembled and left to harden for a period of 7 days. The obtained average thickness of the joints was equal to  $g_k = 0.05 \text{ mm}$ . Each series included 5 specimens. Prior to the examination, the authors performed an inspection by removing the bond excess. Due to the need to obtain the load alignment, the research used self-aligning brackets and samples which were dedicated to them (Fig. 5).

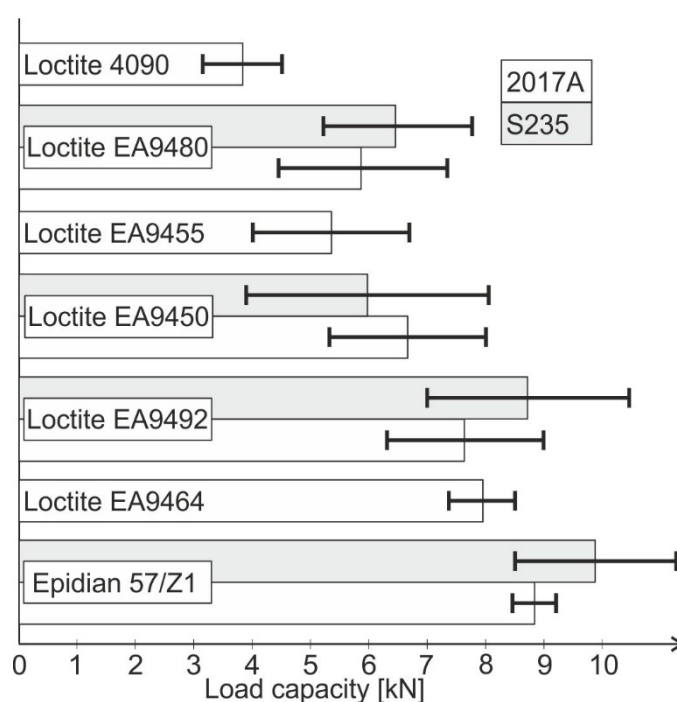
**Fig. 6.** The destructive force of the samples made with aluminium alloy 2017A or steel S235 adherends joined with different adhesives

The obtained findings have been presented in Fig. 6.

The highest destructive force was obtained with Epidian 57/Z1 glue, regardless of the type of the bonded material. The lowest value of the destructive force was registered for joints made with hybrid glue. With the applied manner of preparing the surface of the adherends, the higher average strength was characterised by duralumin elements (with the exception of Loctite EA9480), however the large discrepancy among the findings does not allow making a clear comparison of the obtained results. The lack of a clear difference between the destructive force of steel or duralumin joints points to similar adhesive properties of the joined materials, undergoing abrasive blasting or cohesive damage of joints, which the authors attempted at proving in the examination of failures of the investigated joints.

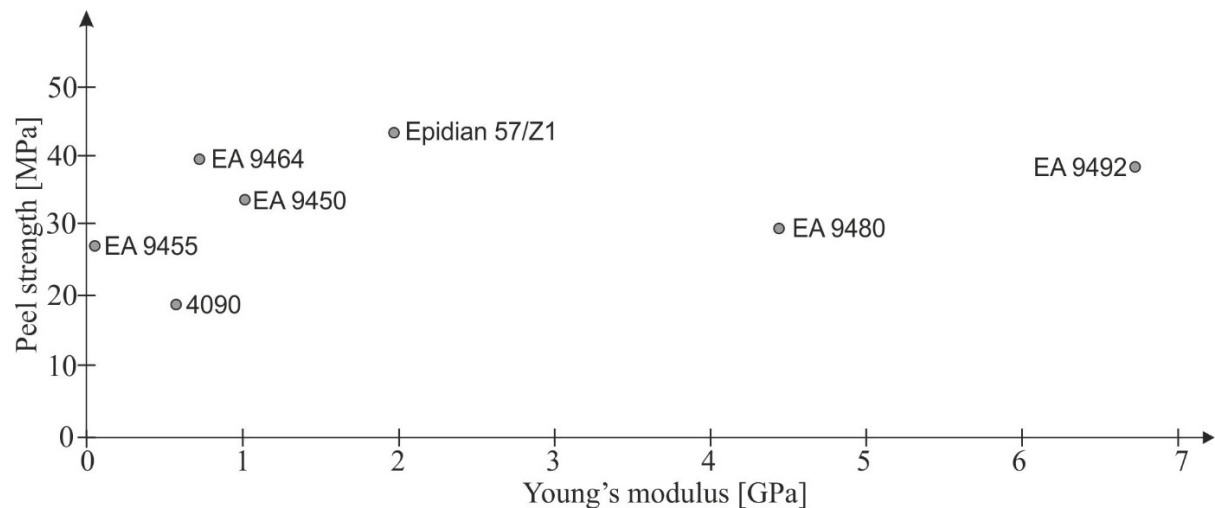
**Fig. 7.** Peel strength of the butt joints made of the aluminium alloy 2017A and Young's modulus of the examined adhesives

The generalized diagram, as seen in Fig. 7, points to the lack of a relationship between the peel strength of butt joints and the elasticity modulus of the adhesive, therefore the value of Young's modulus of the glue cannot be used as a basis for predicting the peel strength of butt joints.

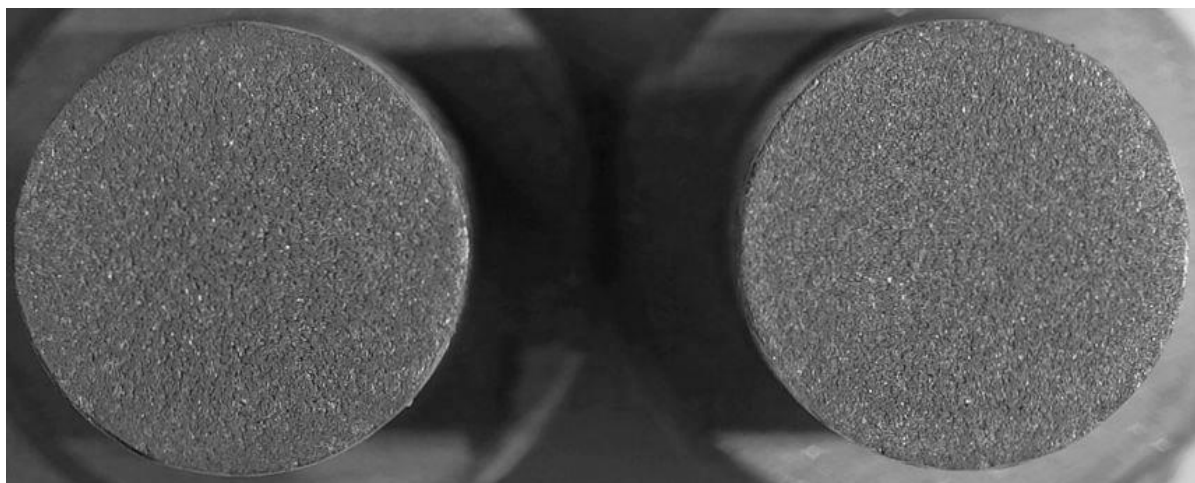
**Fig.8.** Failure of the aluminium-alloy 2017A elements made of transparent adhesive Loctite EA 9455, inspected visually

The analysis of the nature of the damage was conducted with three methods: a visual inspection [13, 14], with an optical microscope [15, 16] and with often used [17, 18] electron microscope. The visual analysis made with the naked eye, due to a small thickness of the adhesive joint and low contrast with a metal or transparency of certain adhesives is, in a number of cases, hampered and does not prove certain as for the nature of the damage (Fig. 8). Nevertheless, it appears that most of the damage is cohesive in its character, with little (several per cent) share of adhesive damage.

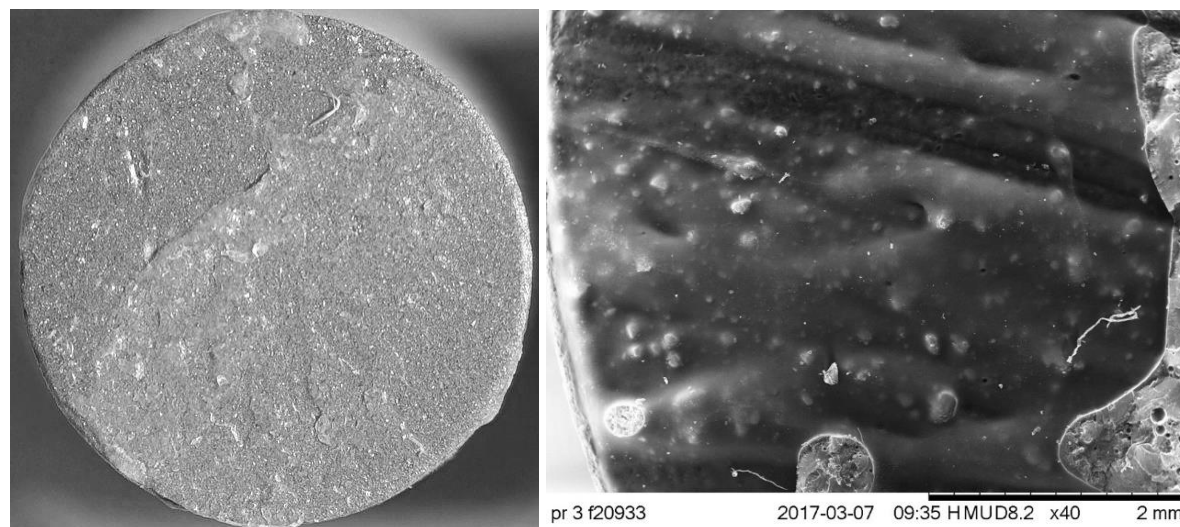
**Fig. 9.** Failure of the steel S235 joint, made with the adhesive Loctite 4090, a) optical microscope, Magn. x7.5, b) electron microscope. Magn. x40

The exception is joints made of adhesive Loctite 4090, where, regardless of the glued material, in the case of a few samples, one can observe traces indicating lack of bonding of glue layers applied on all the bonded elements (Fig. 9).

The damage is not adhesive in its character, resulting from very rapid curing of the joint, made with this adhesive.

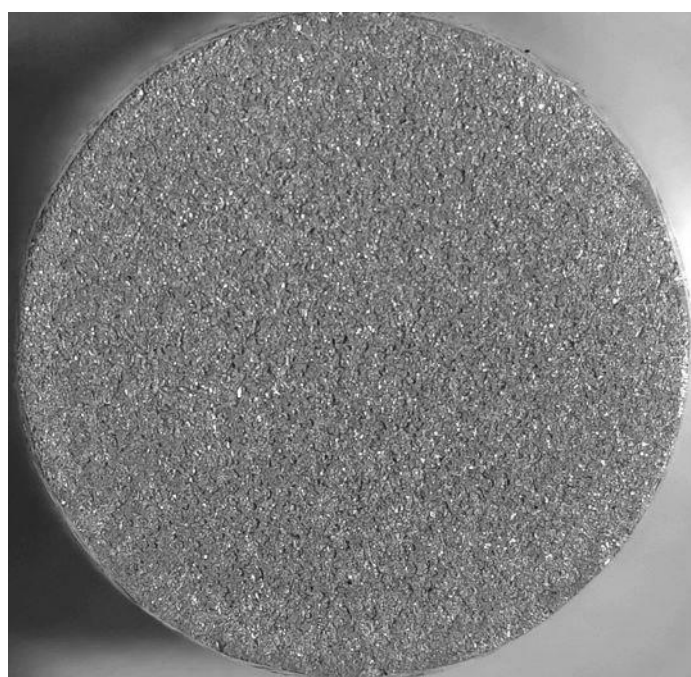
**Fig. 10.** Failure of the aluminium-alloy 2017A elements made with Loctite EA 9455. Optical microscope. Magn. x7.5

Observations of failures using an optical microscope give much more reliable results (Fig. 10), however even in this case, in some areas it was difficult to find definitely the presence of residues of glue on the bonded elements. The observations made by optical microscope, on the whole, confirm conclusions stemming from visual inspections.

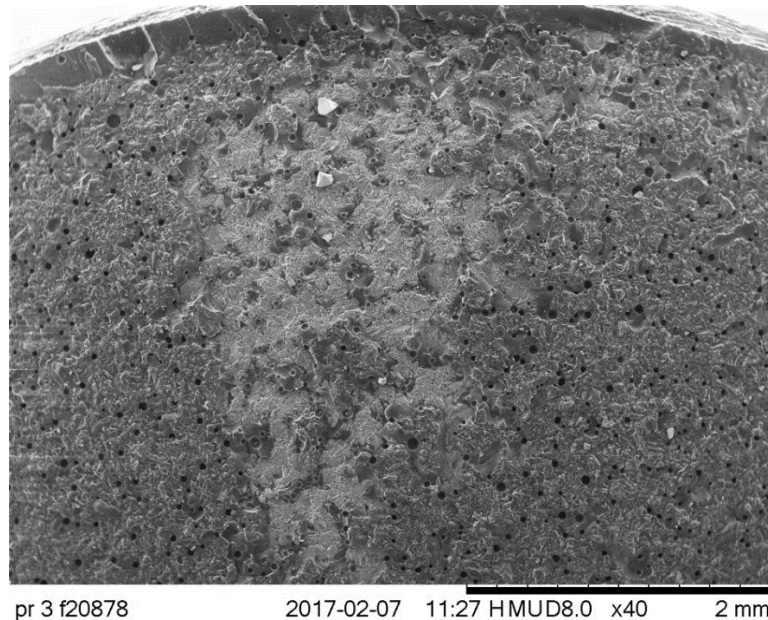
**Fig. 11.** Failure of the aluminium-alloy 2017A elements made with Loctite EA 9455. Optical microscope. Magn. x 40

The observations with the use of an electron microscope confirm the dominant, cohesive nature of the damage (Fig. 11), making it possible to clarify the uncertainties. However, it should be noted that in the areas considered as adhesive damage in the optical methods, it is also possible to notice glue residues, thus it seems that when assessing the nature of the damage of the joint, one also needs to specify the manner of conducting the observation and the used magnification.
