## ANALYSIS OF TECHNICAL CONDITION ASSESSMENT OF GAS TURBINE BLADES WITH NON-DESTRUCTIVE METHODS

**Abstract:** Structural components of gas turbines, particularly the blades, sustain a variety of damages during the operation process. The most frequent cause of these damages are the overheating and thermal fatigue of the material. A primary technique to assess condition of the blades is the metallographic examination. In spite of the fact that metallographic analysis delivers much more information on the structure of examined blade material, it is a type of destructive test resulting in the destruction of the blade which makes further utilization of the item impossible. The paper has been intended to discuss non-destructive testing methods and to present capabilities of applying them to diagnose objectively changes in the microstructure of a turbine blade with computer software engaged to assist with the analyses. The following techniques are discussed: a visual method, based on the processing of images of the material surface in visible light, active thermography, based on the detection of infrared radiation, and the X-ray computed tomography. All these are new non-destructive met

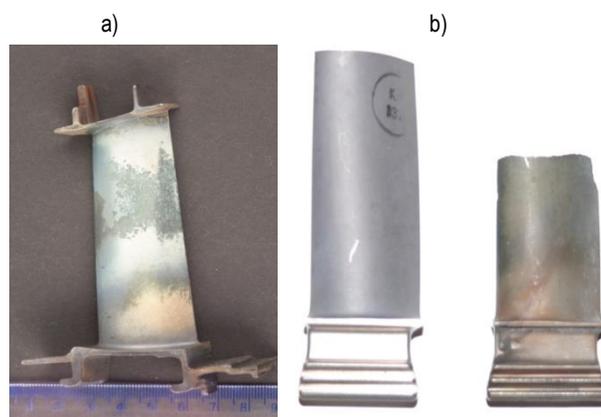
**Fig. 1.** a) – a vane with overheated area, b) – an image of the blade clipped due to overheating (Błachnio and Kułasza, 2009; Błachnio, 2011)

in which it is embedded. The main causes of a gas turbine's damages are its overheating and thermal fatigue (Fig. 1).

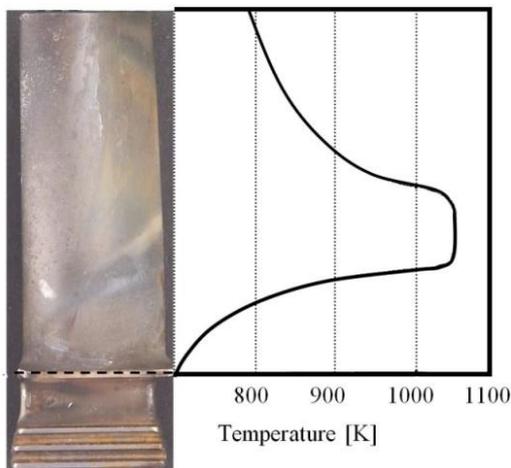
Fig. 2. A diagram of the typical temperature distribution along the gas turbine blade feather (Błachnio, 2011)

maximum temperature on a given blade. A typical temperature distribution along the blade feather is very uneven (Fig. 2). Damages to the first (central) stages of a turbine are usually caused by the impact of high temperature of exhaust, whereas damages to the last, (peripheral) stages (turbines with the longest blades) originate mainly from the effects of mechanical strain (vibration, centrifugal force) (Błachnio, 2011; Karczewski, 2008; Szczepanik and Rządowski, 2012; Marsh, 2013).

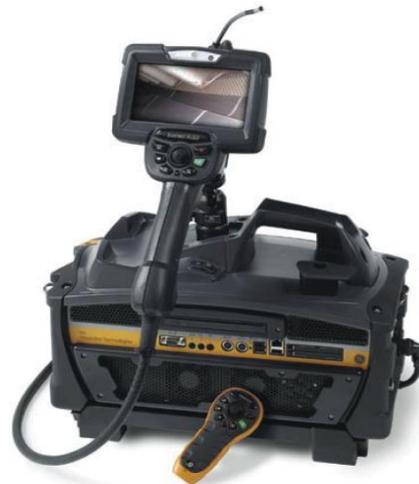
Fig. 3. Optoelectronic device – videoscope (EVEREST XLG3-Video Probe. 2006)

Illuminated surface of the blade can be recognized by a light-sensitive detector (CCD matrix with an optical system – optoelectronic system) through a secondary source of light from its surface. CCD matrix counts incident photons, energy of the light rays incident on each pixel. In the case of a computer vision system the image is obtained from ambient by means of an optoelectronic device – videoscope (Fig. 3). This enables indirect method of diagnosis of the object through the processing and analysis of data collected in the form of digital images.

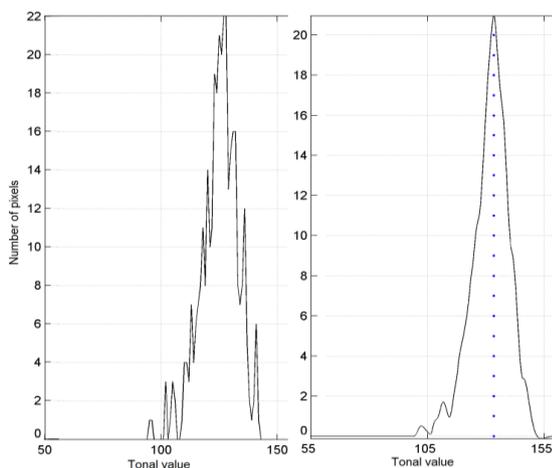
Fig. 4. Exemplary spectral analysis of the image of blade surface (Blachnio and Bogdan, 2010)

Parametric description of histograms is to determine the position of the maximum value of the amplitude, i.e. the number of pixels (ordinate axis) for the values of saturation of grayscale or RGB (abscissa axis) - Fig. 4. In order to extract diagnostic information the examined waveforms of the changes of the maximum amplitude values in the function of temperature are approximated by polynomials.

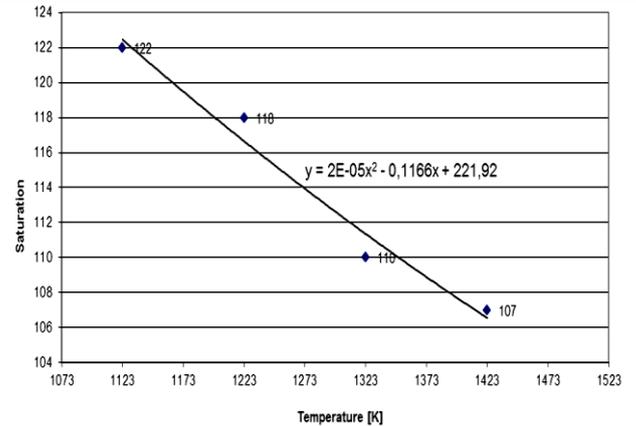
Fig. 5. The values of the position of the maximum amplitude of grayscale saturation of blade surfaces annealed in conditions similar to realistic (Blachnio and Bogdan, 2010)

Acquisition by videoscope and computer analysis of images of the surface samples of the blades made of superalloy EI-867 WD were performed before and after heating in a furnace in realistic conditions. Studies of the first order statistics (parametric

description of histograms) of images of blades surfaces showed a monotonic decrease of values of the amplitude of grayscale saturation (Fig. 5).

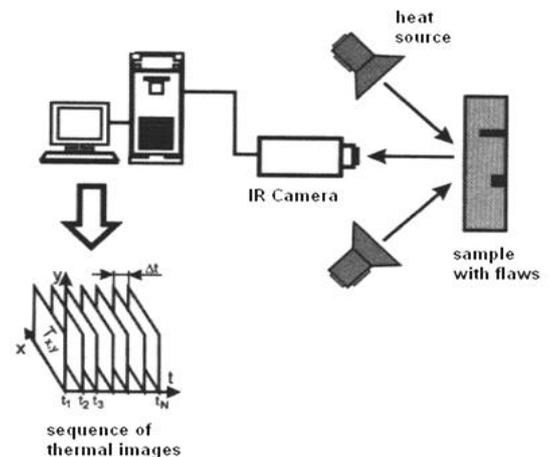
Fig. 6. Application diagram for the pulsed thermography (Oliferuk, 2008)

Active thermography is based on the detection of infrared radiation. The essence of the study is to analyze the thermal response of the material to external impulse heat stimulation. If a certain amount of energy is delivered to the surface of the material, for example in the form of a heat pulse, after its expiry the surface temperature will start changing rapidly. Due to thermal diffusion, thermal front will move into the material. The presence of areas with different thermal properties (including defects) compared with areas without defects causes a change in the diffusion rate. Thus, by monitoring the temperature field on the surface of the cooling sample, it is possible to reveal position of the defects. Depending on the stimulation method, there are a few types of active thermography, namely, pulsed thermography, lock-in thermography with modulated heating and pulsed phase thermography (Oliferuk, 2008; Holland, 2011). Pulsed thermography is considered to be a relatively simple kind of active thermography. It depends on the determination and analysis of the temperature distribution in the study area during its cooling down after prior uniform heating with the use of thermal pulse (Fig. 6).

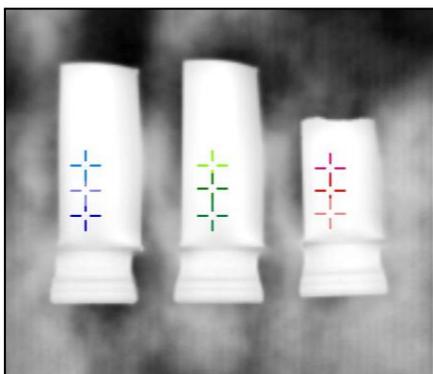
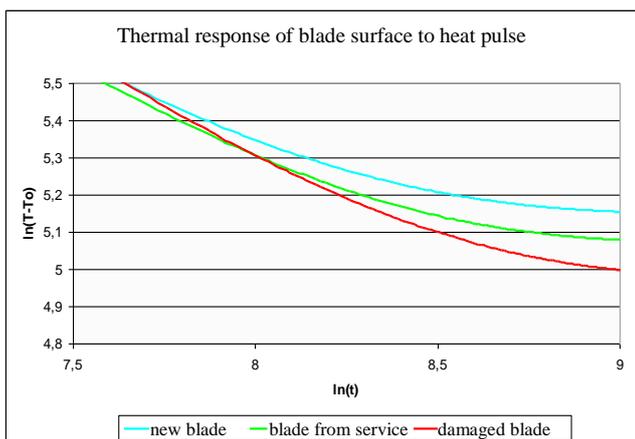
**Fig. 7.** Blades thermograph and changes of dependence of the parameter  $\ln(T-T_0)$  of the thermographic signal at selected points of the blade surfaces (Kulaszka et al., 2011)

Thermographic examinations covered the turbine blades made of alloy EL-867WD, classified into various categories: new, used - fit and damaged during turbine engine operation. The obtained results confirmed changes of parameter dependence of thermal response of the examined blade materials to stimulating heat pulse (Fig. 7).

While on the basis of the analysis of the response to the heat pulse of the blade material classified as "unfit", it was possible to determine areas clearly deviating from the average value. These areas coincided with areas visually assessed as overheated which, combined with the results of the tests conducted on sam-

ples (Fig. 7) allows to draw conclusions on superheated structure of the material.

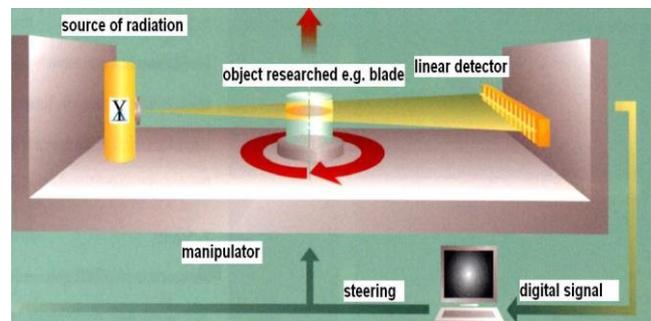
**Fig. 8.** The example of a tomography investigation with use of a linear detector (Electronic Instrument CT-X-ray, 2011)

Tomography is the collective name for the diagnostic methods aimed at obtaining a spatial image of the machine element. In the technical diagnosis, a method of computed tomography (called CT) has been widely applied (The research report, 2011). It is a kind of X-ray tomography allowing for obtaining spatial images (3D) from the radiograph scanning of the object performed from different directions (Fig. 8).

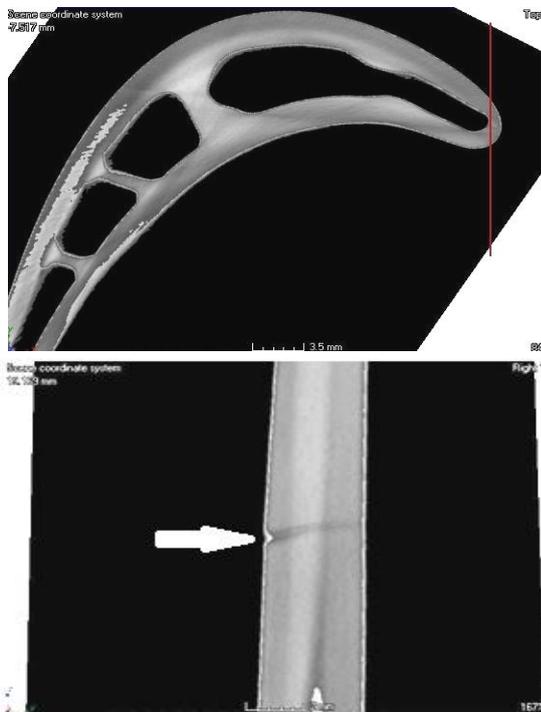
**Fig. 9.** Tomogram of a turbine blade with a visible crack at the leading edge (Chalimoniuk et al., 2013)

Computer radiography applied to turbine blades allows the observation of actual thickness of the inner, invisible walls (Chalimoniuk et al., 2010). An image of the object can be represented in the colours and the shape of the inner wall can be determined in the appropriate scale, e.g., the size and location of the defect. Also, the geometry of the internal components can be accurately measured and the tolerance of their actual dimensions be assessed. Thus, CT scan allows to verify the correctness of realization of the component with a very high degree of accuracy and diagnose internal damages, for example, cracks, blade canals blockage, etc. (Fig. 9).
