## MONITORING OF CRACK GROWTH IN A STRUCTURE UNDER A COMPOSITE PATCH

**Michał Salaciński**  
**Piotr Synaszko**  
**Michał Stefaniuk**  
**Krzysztof Dragan**

*Air Force Institute of Technology,  
Warsaw, Poland*

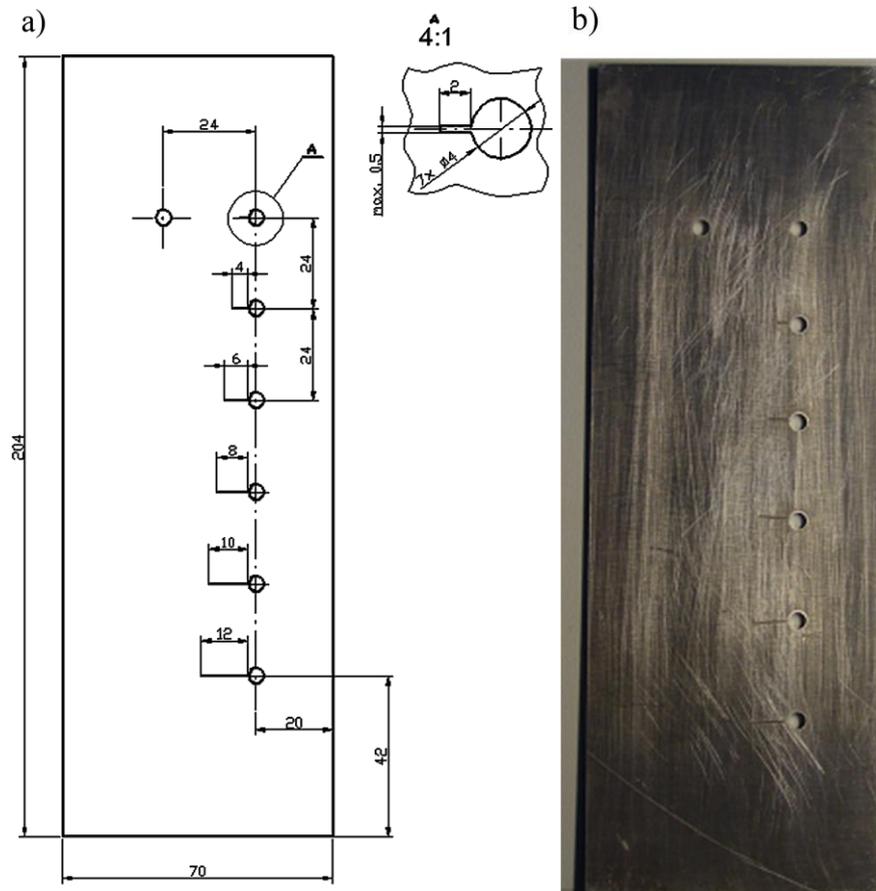
Four identical metal plate specimens were made (2024-T3 steel). The damage was modeled in the form of fatigue cracks of different sizes, initiated on holes in each of the specimens (fig 1).

**Fig. 1. Metal specimens with cracks modeled: a) crack model dimensions, b) actual specimens**

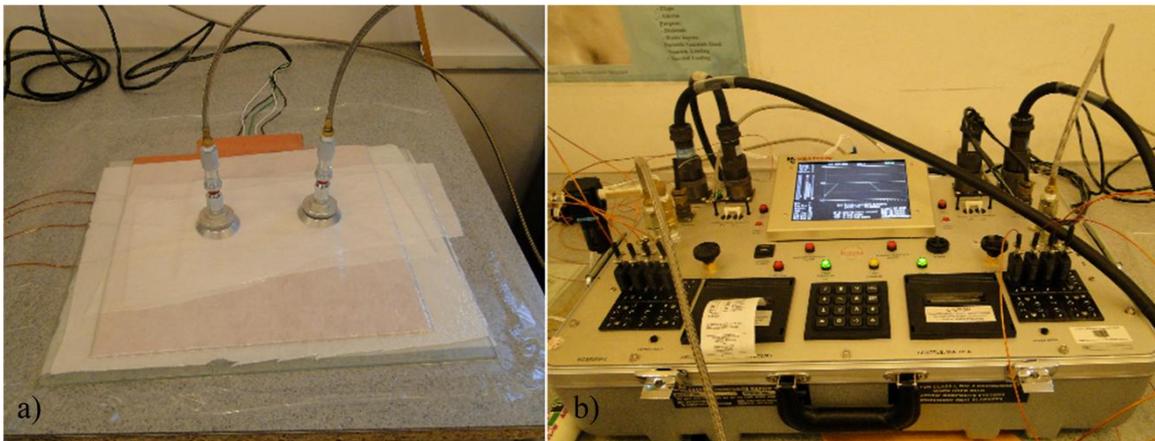
**Fig. 2. Cure cycle by hot bonder: a) vacuum bag with hot bonder, b) control unit**

The test repairs were performed using prepreg materials, in accordance to existing standards [5-7]. Metal specimens' surface was degreased, sandblasted and subsequently covered by anti-corrosion and adhesion-improving compound. The composite patch was bonded to the repaired structure using an adhesive epoxy film. The repair operation was performed in a single step (using a single heat cycle).

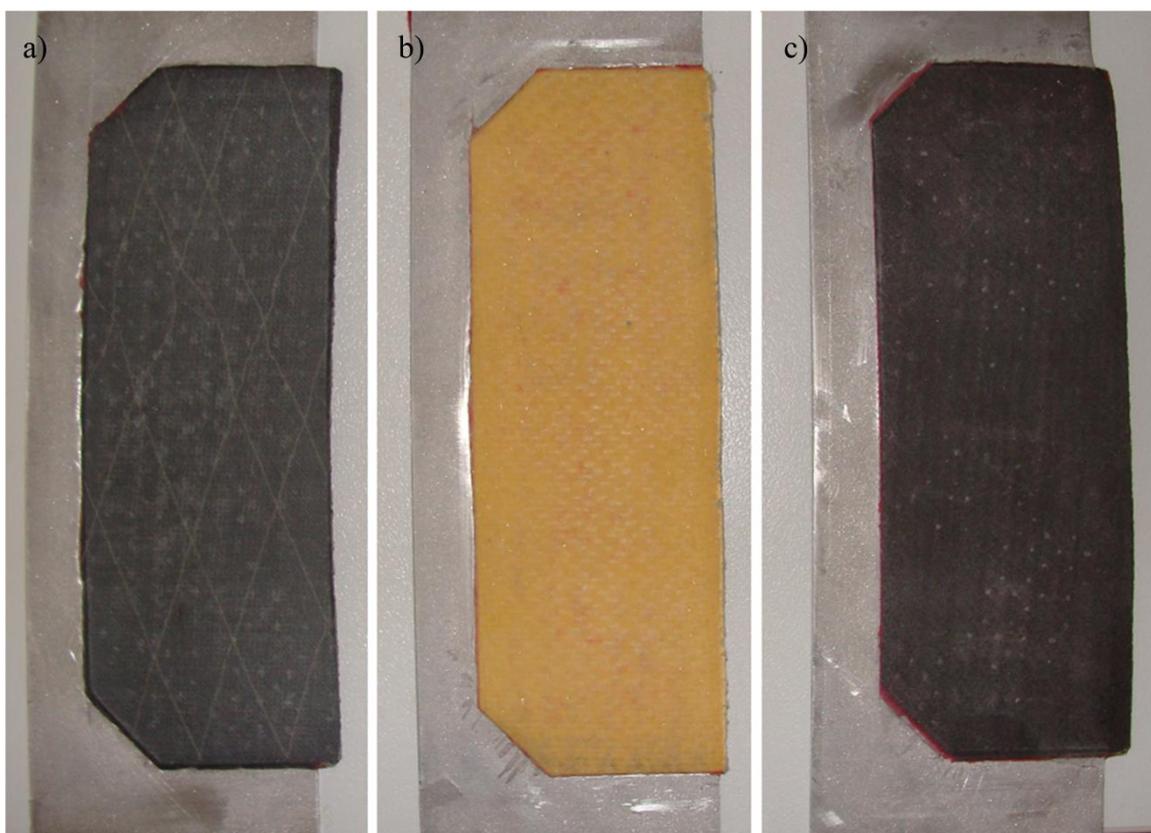
In the AFIT laboratory, CBR was performed on three of the specimens with the use of Carbon (CFRP), Aramide (ARFP) and Boron (bfrP) fiber reinforced polymer patches.

**Fig. 3. The specimens after CBR: a) specimen repaired by CFRP patch, b) specimen repaired by ARFRP patch, c) specimen repaired by BFRP patch**

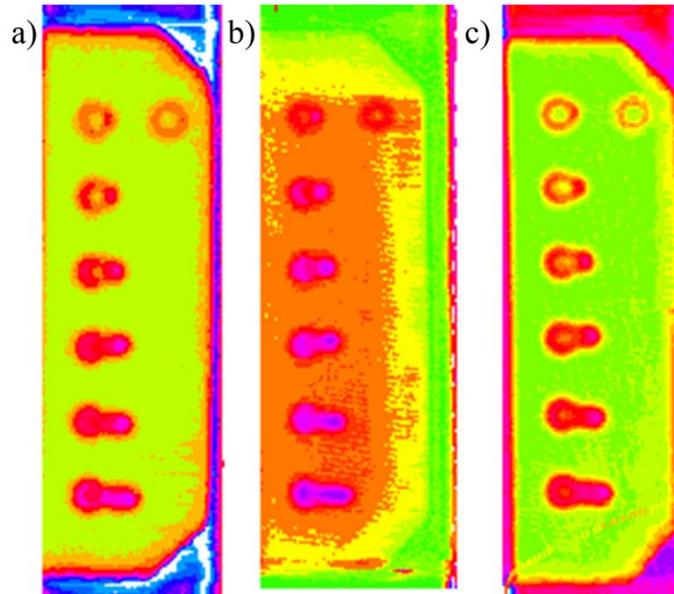
The ET investigation was performed with the use of a MAUS V system and with a MOI device. The authors conducted a series of tests with different test frequencies. These frequencies were chosen by way of earlier research. The results indicated that the frequency of 10kHz gives the clearest image of damage for all types of composite patches, equally for the MAUS system and for the MOI. The best visualization, regardless of the patch's material, was obtained with MAUS system's C-scan imaging (fig. 4), even for the smallest crack (2mm model).

**Fig. 4. MAUS's C-scan: a) specimen repaired by CFRP patch, b) specimen repaired by ARFRP patch, c) specimen repaired by BFRP patch**

- The ET method can be employed for the inspection of repaired metal structures. The use of experimentally chosen 10 kHz eddy current frequency filters out only the interesting response signal in metal alloys.

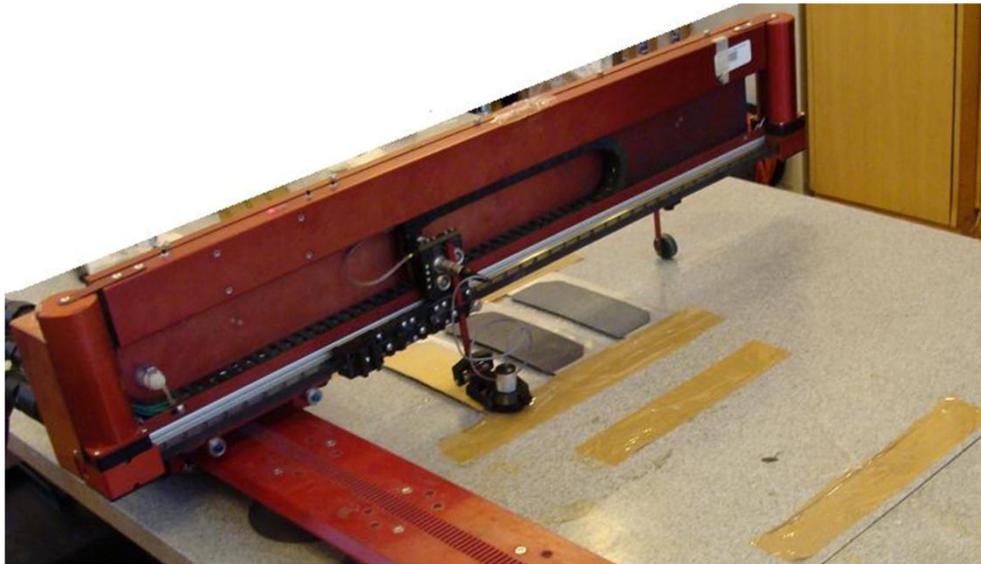
The automated MAUS system enables the examination of flat as well as of highly curved surfaces. However, access to the tested objects is limited by large dimensions of the sensor. Because of that, the system can only be applied to larger and easily accessible areas of aircraft skin or to particular components, de-installed from the craft.

**Fig. 5. MAUS V during work**

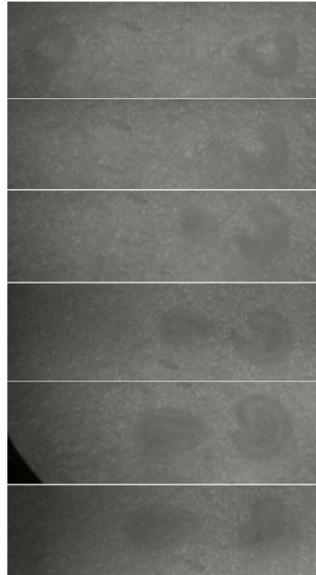
**Fig. 6. Test results for the specimen repaired with the BFRP patch**

For the MOI system, the resulting images' clarity and definition vary with the patch material. The best results were obtained for the BFRP specimens.

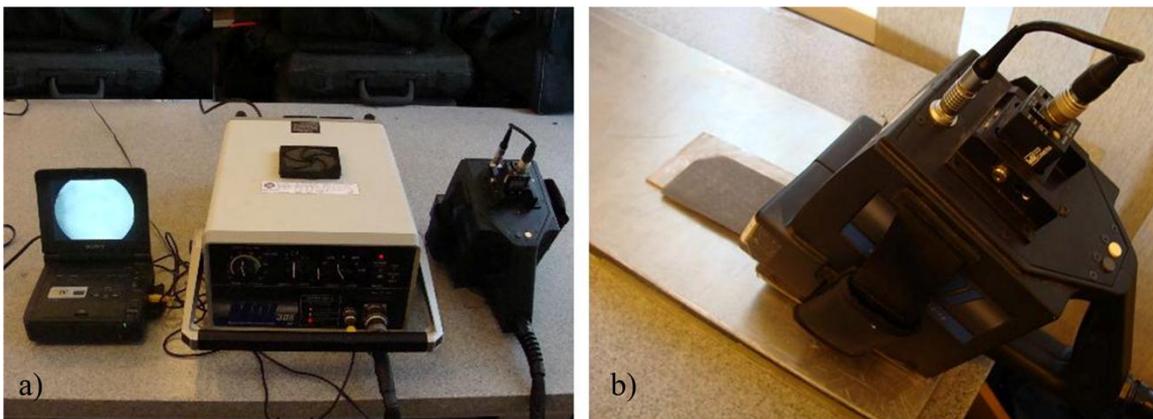
Operating principle of the MOI involves the ET method, as well as the Faraday effect (magneto-optic effect), in which the polarization plane of linearly polarized light ray is rotated by a certain angle while propagating through a medium in which magnetic field is present [11].

**Fig. 7. MOI system: a) control unit, sensor, video recorder, b) sensor during work**

One of the advantages of the MOI device is the capability to record and also to monitor in real-time the structure's condition. This property may be used for on-line observation of the crack propagation during a fatigue test.

Disadvantages of the MOI are the limited access to the examined object due to the sensor's large size, as well as the fact that the system's sensor must remain in contact with the surface inspected – therefore the object's surface should be flat or of low curvature.

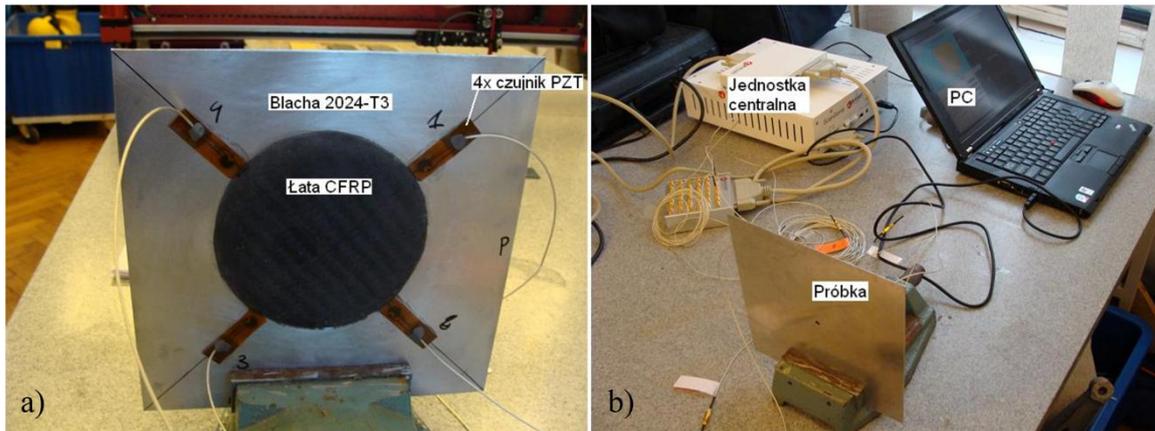
The use of PZT sensors is a modern approach in the field of structural monitoring. Some initial research on the application of such sensors for the monitoring of composite patch covered metal structures had been carried out at the IWTL. For this purpose, the commercially-available Accellent instrumentation system was used. The system includes the PZT sensor suite and a central unit containing an impulse generator and a measurement card. The system is controlled by PC-installed software.

**Fig. 8. The test system: a) specimens with PZT, b) Acecent equipment**

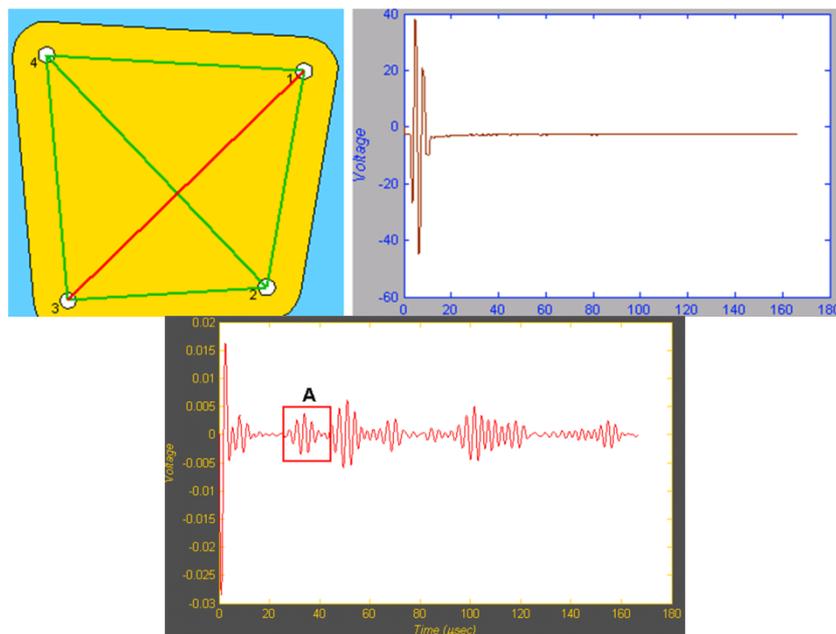
The sensors' location coordinates are input into the software and the baseline condition of the structure is captured by registering the structure's response to an impulse generated by each of the PZT units.

**Fig. 9. Baseline: a) sensor locations, b) signal generated (300 kHz), c) baseline structure response**

The PZTs serve both as sensors and generators. In this research a three-peak sine-burst signal has been used. The software, by taking into account the recorded baseline result, the sensors' coordinates, and the form of the crack, computes the crack's location. The baseline structure used for the PZT research had the form of a 6mm diameter hole. The 1.3 mm, 5 mm, 10 mm, 15 and 20 mm incisions (crack models) were used in the series of tests.

mm	Structure condition	Suitable, window A (FIGURE 9c) Transition 1-3	FFT Transition 1-3	Visualization
0				
1.3				
5				
10				
15				
20

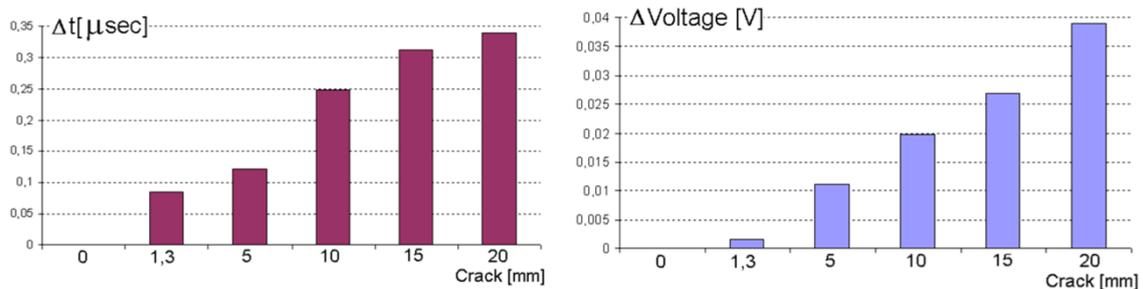
The recorded response signal is used for evaluating the crack's influence on amplitude loss and phase shift (when compared to signal responses of the baseline). The occurring phase shift may be explained by the increase of the shortest wave path between the generating and receiving unit (sensor). The increase occurs because of the interaction between the crack and the generated wave. This interaction leads to a deflection of the wave.

The diagrams show that the signal's measured electrical parameters and the crack length are related.

**Fig. 10. Researches results: a) time delay (phase shift), b) amplitude loss**
