ANALYSIS OF THE POSSIBILITY TO ASSESS THE OCCURRENCE OF HIDDEN CORROSION IN LAP JOINTS USING ACTIVE THERMOGRAPHY

Lukasz Kornas
Krzysztof Dragan

*Air Force Institute of Technology,
Warsaw, Poland*

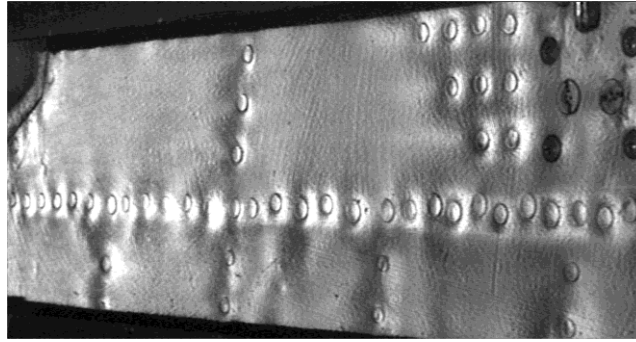
Fig. 1. Hidden corrosion (pillowing), the result of test with the use of DAIS system[1]

Corrosivity is a very important phenomenon unfavourably affecting materials used in aviation. Corrosivity necessitates continuous aircraft surveillance during operation. The effect of corrosion processes is the damage of the material observed mainly on the surface of the material in the form of an accumulation of solid compounds such as oxides, rust and scale resulting from chemical reactions. These chemical reactions are caused by changing weather conditions, increased humidity and the working environment such as contact with sea water. In many cases, the aircraft structural component exposed to corrosion is the plated area of the lap riveted joints. As a result of the difference in potential at the interface between two materials, oxidation of the material occurs creating corrosion products in the form of metal oxides. In the case of aircraft structures made of light alloys (usually aluminium alloys), these are mostly aluminium oxides $\text{Al}_2\text{O}_3 \cdot 3\text{H}_2\text{O}$, whose molar volume is greater than that of pure aluminium. They accumulate between adjacent materials, causing local surface deformations. Continuous process of creating metal oxide contributes to fatigue. Ignoring this phenomenon may lead to deterioration in strength properties of joined materials as well as damage of the rivet connecting them. It is a kind of hidden corrosion called pillowing.

The DAIS system measures the degree of surface deformation caused by the presence of solid metal compounds at the boundary between two materials. Using a number of different test techniques enables better verification of the research results. The authors used a pulsed thermography technique, which allows the registration of changes in infrared radiation emitted by the material. Based on the fundamental thermal coefficients (table. 1) for specific materials, the authors conducted preliminary tests to confirm the presented thesis.

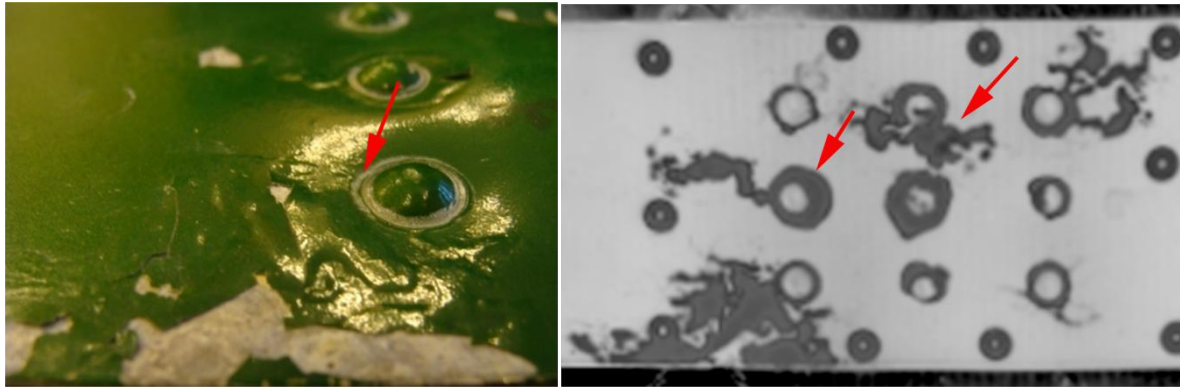
**Fig.2. a) damaged anti-corrosion paint coating,
b) thermograph of damaged anti-corrosion paint coating**

While performing preliminary tests, samples with the damaged anti-corrosion coating from the wing flap of Su-22 aircraft were used (Fig.2). The tests were carried out with pulsed thermography using EchoTherm. Hidden corrosion can manifest itself through the paint coating damage such as cracks, blowholes, etc. This causes the varnish layer flaking due to lack of adhesion to the surface. Anti-corrosion coating damage is caused by adverse external factors such as humidity, exposure to sea water or by contaminants introduced during the production stage. Thermographic results of the damaged paint coating are shown on the thermograph below (Fig. 2).
