Heat load and deuterium plasma effects on SPS and WSP tungsten

Monika Vilémová, Jiří Matějíček, Barbara Nevrlá, Maryna Chernyshova, Pawel Gasior, Ewa Kowalska-Strzeciwilk, Aleš Jäger

Abstract. Tungsten is a prime choice for armor material in future nuclear fusion devices. For the realization of fusion, it is necessary to address issues related to the plasma–armor interactions. In this work, several types of tungsten material were studied, i.e. tungsten prepared by spark plasma sintering (SPS) and by water stabilized plasma spraying (WSP) technique. An intended surface porosity was created in the samples to model hydrogen/helium bubbles. The samples were subjected to a laser heat loading and a radiation loading of deuterium plasma to simulate edge plasma conditions of a nuclear fusion device (power density of 10⁸ W/cm² and 10⁷ W/cm², respectively, in the pulse intervals up to 200 ns). Thermally induced changes in the morphology and the damage to the studied surfaces are described. Possible consequences for the fusion device operation are pointed out.

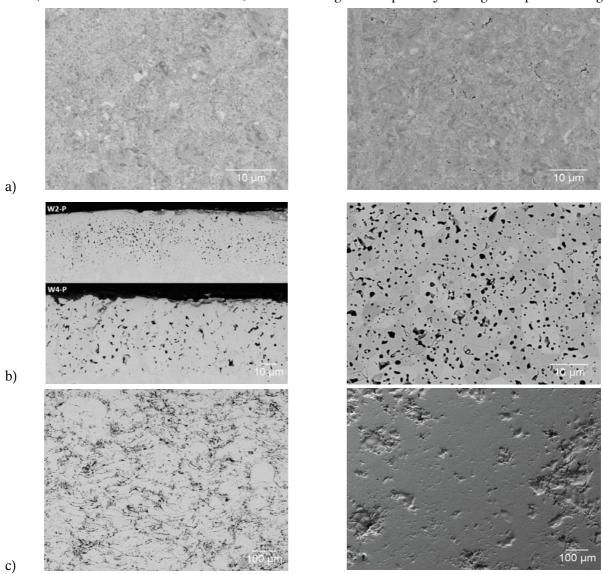
Fig. 1. The microstructure of the tungsten samples. a) W2: the cross section (left) and the polished surface (right); b) W2-P, W4-P: the cross section (left) and the polished surface of W2-P (right); c) W-WSPH: the cross section (left) and the polished surface (right).

A microstructural overview of the tungsten samples is presented in Fig. 1. The sintered tungsten samples, i.e. W2 and W4, showed no apparent difference in the microstructure, thus only W2 sample is documented. Microstructure of the W2/W4 samples consists of fine tungsten grains. The different gray level areas in the micrograph can be attributed to the different grain orientation. The structure is dense, only minor residual porosity remains in the vicinity of the surface (Fig. 1a, right). The porosity was determined to be 0.2% and 0.3% for the W2 and W4 samples, respectively.

Figure 1b shows W2-P and W4-P sample containing surface porosity. The figure depicts the original

thickness of the layer with pores; however, for the irradiation experiments, the thickness was polished down to few microns to create islands of porosity on the sample surface. Thus, a direct comparison of the irradiation effect on the tungsten surface with and without porosity is made possible. The surface layers of the W2-P and W4-P contain pores mainly in the micron and submicron range. It is apparent that the density of the pores is lower for W4-P than W2-P; however, the average pore size is larger for W4-P. The porosity aims to model the bubble structure observed after irradiation of a material with hydrogen or helium. The size, shape and density of the pores are very close to the commonly reported values for helium bubbles [9].

The microstructure of the W-WSPH sample represents a characteristic structure of plasma-sprayed coating on the cross section consisting of flattened particles ('splats'), intersplat boundaries/cracks/ pores and intrasplat cracks/pores. The relief of the coatings surface (Fig. 1c, right) is an artifact of the polishing process that removed weakly bonded splats

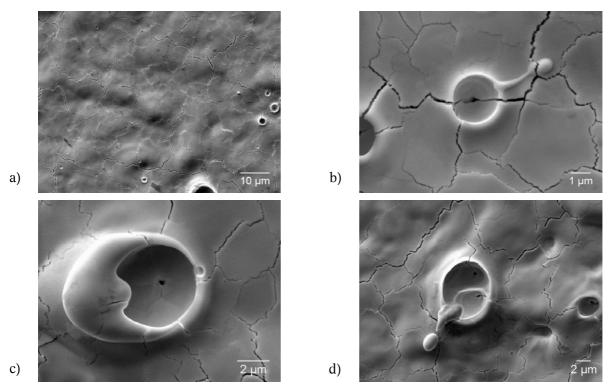
Fig. 10. Surface morphology of the W2 sample after a laser irradiation (1 shot) and details of craters formed after a bubble burst: a) surface after heat loading by laser; b), c) and d) the crater on the surface.

Besides a number of cracks and roughening, features resembling craters formed by bursting of a bubble were observed on the surfaces of the sintered samples (Fig. 10). Their origin is not clear. Although their appearance was very similar to that previously reported in literature [17], it seem unlikely that the craters result from boiling bubbles. Again, the only impurity expected in the samples is tungsten trioxide. However, the oxide content is very low and is expected to be uniformly distributed as no evidence of oxidized areas was found in the microstructure. Thus, the localized impurity melting would not be the case. Moreover, for all observed craters a small hole was found at their bottom (Fig. 10b-d). Thus it seems the hole was an outlet for a gas entrapped in the material during production/sintering process. The gas was expanding through the molten layer towards the surface where the bubble burst. An analysis of selected craters using the FIB method revealed a void underneath the craters connected

to the surface via a hole (Fig. 11), supporting the hypothesis of the hot gas expansion from a closed void/pore. Thus, the presence of closed micropores in plasma facing materials represents another potential source of surface erosion (Figs. 10b–d) and fusion plasma contamination by the escaping gases and by the ablated material.

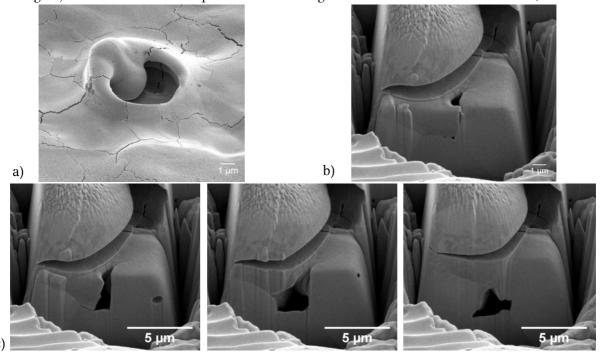
Fig. 11. A void underneath the bottom of a crater found on the surface of the W2 sample after laser irradiation: the crater (a), a hole found in the bottom of the crater (b), the size and the shape of the void revealed by the FIB method (c).
