EVALUATION OF IMPACT DAMAGE IN COMPOSITE STRUCTURES USING ULTRASONIC TESTING

Abstract

Keywords: impact damage, composite structures, non-destructive testing, ultrasonic testing, image analysis

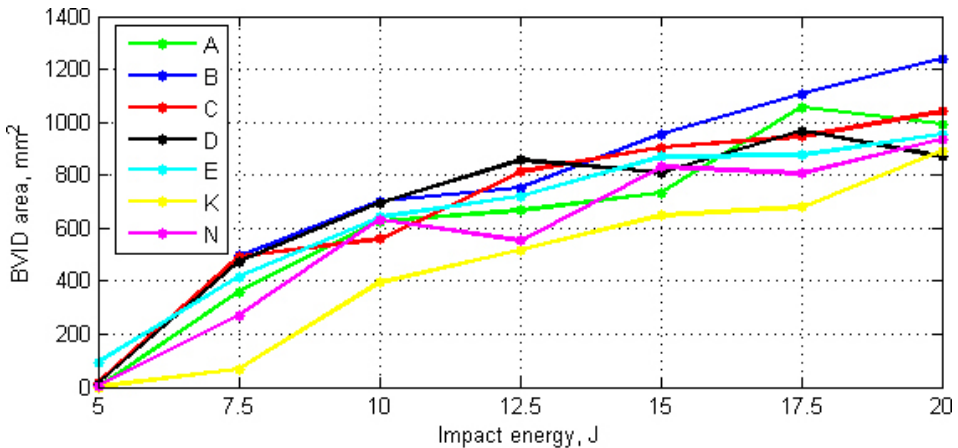
Fig. 6. Calculated BVID areas for the specimens impacted with variable energy values and impactor shapes (given in the legend of colours)

All the C-Scans obtained were processed using the presented image analysis algorithm. The summary of the total area surfaces of the BVID is presented in Fig. 6.

These results revealed that in the case of the impactors with the granite stones the more flat impactor *K* caused less damage for all the impact energy cases than the impactor *N* with the sharp ending. This was due to different types of stress distributions obtained when impacted with various shapes of impactor endings (flat solids caused mainly shear stress distribution whereas sharp shapes caused tension stress in the composite fibres and penetrated the matrix during the impact

[17]). For the cases impacted with the hemispherical impactors it was noted that the BVID produced by the impactor A was less than in the case of the impactor with a smaller radius B for all the impact energies, whereas for the remaining impactors with the decreased radius no clear dependency was observable.
