# Characterization of AZ31-NbC surface composite fabricated by friction stir processing

Muralimanokar M.<sup>1</sup>, Vaira Vignesh R.<sup>1</sup>, Padmanaban R.<sup>1</sup>, Suganya Priyadharshini G.<sup>2</sup>

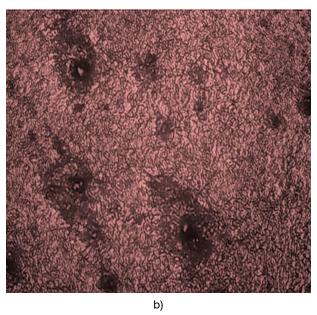
Fig. 1. AZ31-NbC surface composite: a) un-etched; b) etched

Figure 1a shows the un-etched microstructure of developed surface composite that shows the NbC reinforcement embedded in the matrix. The Figure 1b (etched) shows the dispersed  $\beta$ -Mg<sub>17</sub>Al<sub>12</sub> ( $\beta$ -phase), and fine grains in the developed surface composite. The dark patches show the fine distribution of NbC. No characteristic agglomeration of NbC was observed in the developed surface composite.

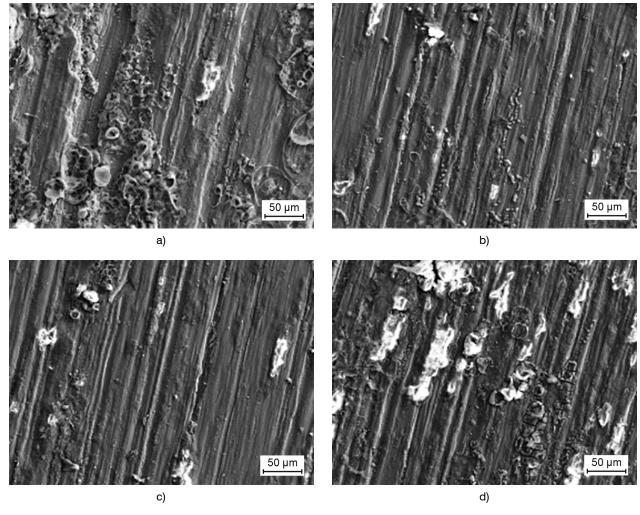
Fig. 3. Surface morphology of B03 specimen

Figure 3 indicates the worn surface morphology of the specimen B03 that was worn at a load of 2 kg. Formation of wear debris in a clustered manner and minor cracks were observed, as shown in in Figure 3a. Deep grooves and cracks on the worn surface, as shown in Figure 3b, were created by the concentration of load in a localized spot. Figure 3c displays the furrows, mild cracks and scratches. Removal of material as a cut pieces lead to delamination, as shown in Figure 3d. Besides, ploughing phenomenon, which is caused by the dragging of debris in the course of the wear, was prevalent on the worn surface of the specimen. The results indicated

a combined adhesive and abrasive wear phenomenon in the specimen B03. Figure 4 shows the worn surface morphology of the specimen F03 that was worn at a load of 2 kg. Figure 4a shows the spalling on the worn surface that was chanced by the ejection of material in the form of small particles. Figure 4b picturizes the wear debris and Figure 4c shows the localized forms of wear (furrows and scratches). Shallow grooves and wear debris were observed in the Figure 4d. The specimen F03 exhibited comparatively lesser abrasive features than that of the specimen B03 that was slid at same load. Figure 5 shows the surface morphology of the worn specimen F01 that was worn at a load of 1 kg. Figure 5a shows pits and mild scratches. Some traces of wear debris are observed in Figure 5b. Material removal in the form of small piece of coatings and chips can be seen in the Figure 5c. Figure 5d clearly shows the wear debris, scratches. The wear mechanism of the developed surface compoiste was in the region of mild wear at low load and in the region of transition zone (adhesive wear and abrasive wear) at high loads.

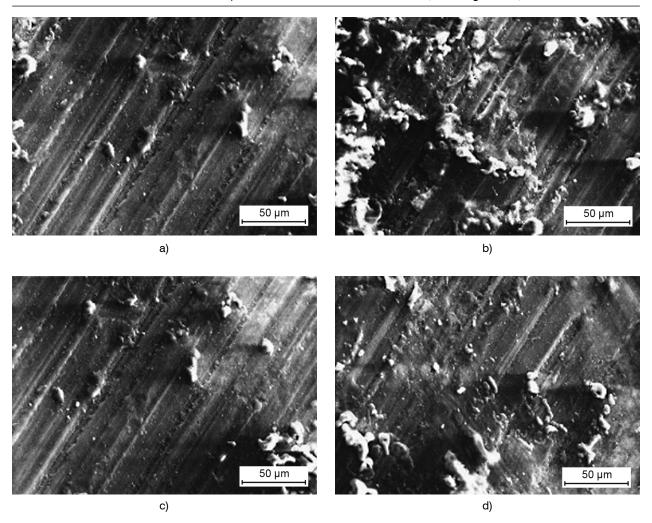
Fig. 4. Surface morphology of F03 specimen

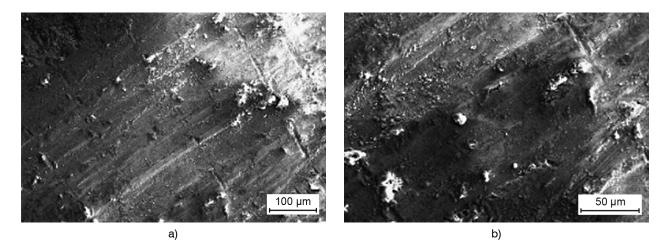
Fig. 5. Surface morphology of F01 specimen (continue on next page)

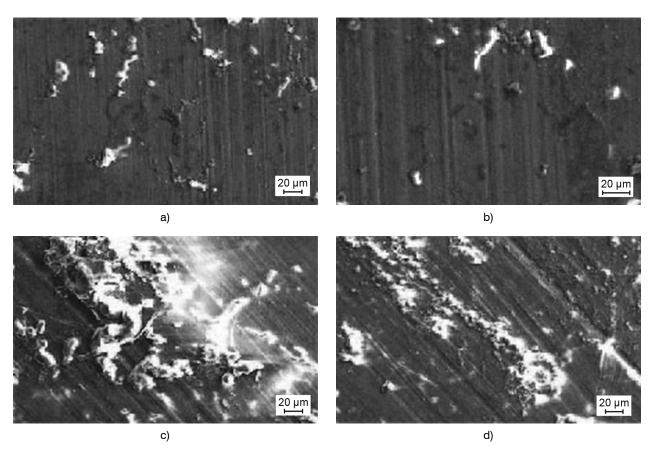
Fig. 10. Corroded surface morphology of the base material and developed surface composite (continue on next page)

Fig. 10. Corroded surface morphology of the base material and developed surface composite

Figure 10a and 10b displays the surface morphology of developed surface composite AZ31-NbC alloy after 24 hours of corrosion test. Figure 10c and 10d shows the surface morphology of developed surface composite

AZ31-NbC alloy tested for 48 hours of corrosion test. Figure 10e and 10f indicates the surface morphology of base material after 96 hours of corrosion test. In the surface morphology of the corroded specimen, the white patches correspond to the corrosion products. The overall analysis reveals the absence of pitting phenomena in the corroded specimen.
