P. Grzywna, D. Kukla

*Institute of Fundamental Technological Research Polish Academy of Sciences,
Department of Strength of Materials, Warsaw, Poland
pgrzywna@ippt.pan.pl*

EVALUATION OF STRAIN DISTRIBUTION FOR THE P91 STEEL UNDER STATIC LOAD USING ESPI SYSTEM

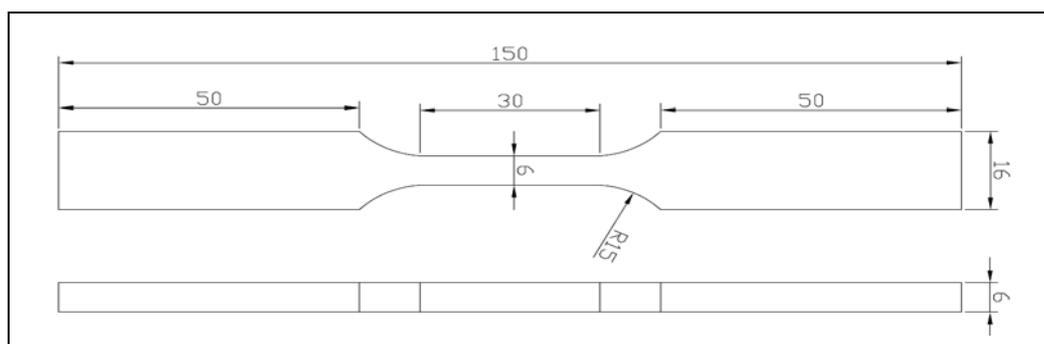
Fig. 1. Geometry of specimen for tensile test and measurement of stress/strain using ESPI method

Flat specimens of a geometry designed for observation of field distribution were made of high temperature creep resistant alloy steel X1-CrMoVNb9-1 (Fig. 1), some specimens were cut from a initial material, the rest from an exploited one. One specimen from each stock was used for tensile test in order to measure mechanical properties and determine a yield stress, which was necessary for estimation a load program for field stress characterization [1].

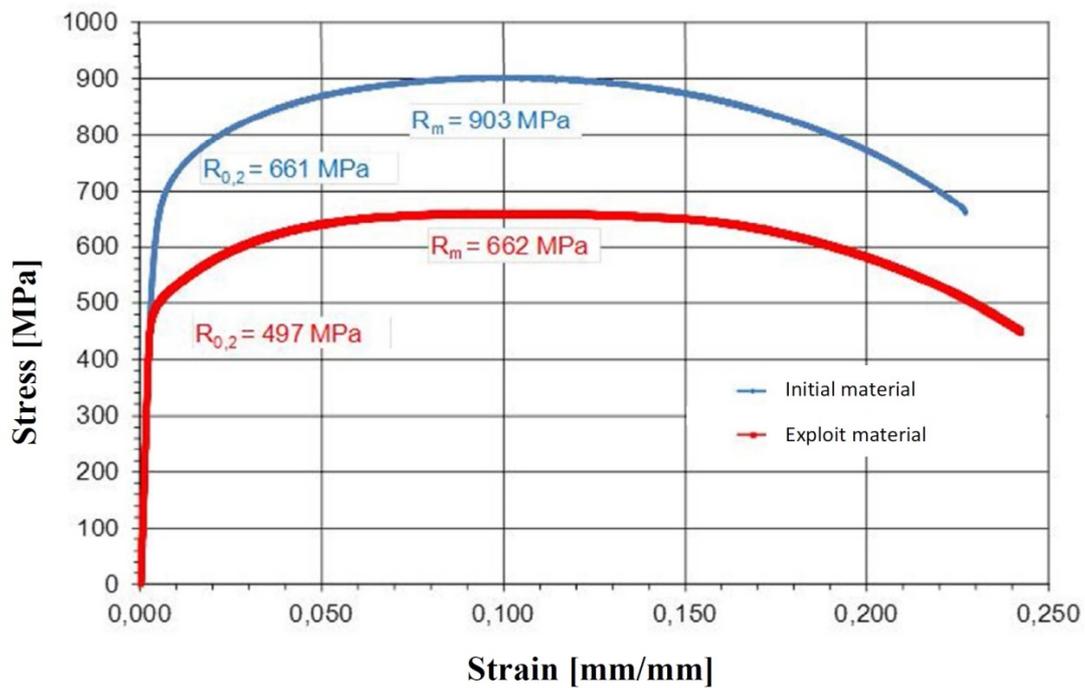
Fig. 2. Stress-strain curve for tested steel specimens in the state of delivery and after exploitation

Mechanical strength properties of P91 steel before and after exploitation were determined on the basis of static tensile test result. The results are presented in the Table 2 and Fig. 2.

R_m [MPa]	R_e [MPa]	A [%]
P91 delivery state „0”	903	661	23
P91 state „80 000 h”	662	497	24,5
PN: 10216-2:2004	630-830	>450	17-19

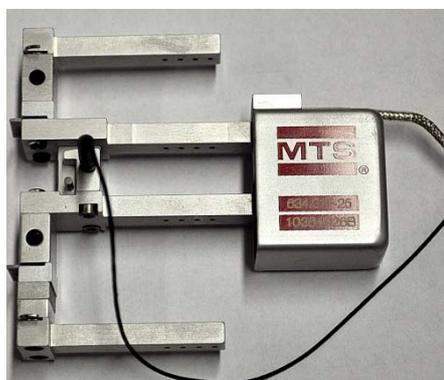
Fig. 3. Extensometer for measuring displacement

Measurements of stress pattern distributions were done with the use of the Electronic Speckle Pattern Interferometry (ESPI). The program of applying the load to specimens was executed in five steps from 0 to 2.5KN. Load step of 500 N was maximal for preserving the stability of interference fringes which enabled measurement of displacements. Global strain was measured by extensometer produced by the MTS company with gauge length 30 mm (Fig. 3.)

Strain measurement with the use of extensometer enabled verification of the results obtained with the use of ESPI technique in axial direction (Y). According to the previous description, the strain measurement with ESPI camera is based on displacement measurements. Displacement according to the local changes of the intensity of speckled images emerged as a result of chaotic dissipation of highly coherent radiation on specially prepared coarse surface of a specimen. Fig. 4 presents the scheme of creating a strain map in the ESPI measurement system [2,3].

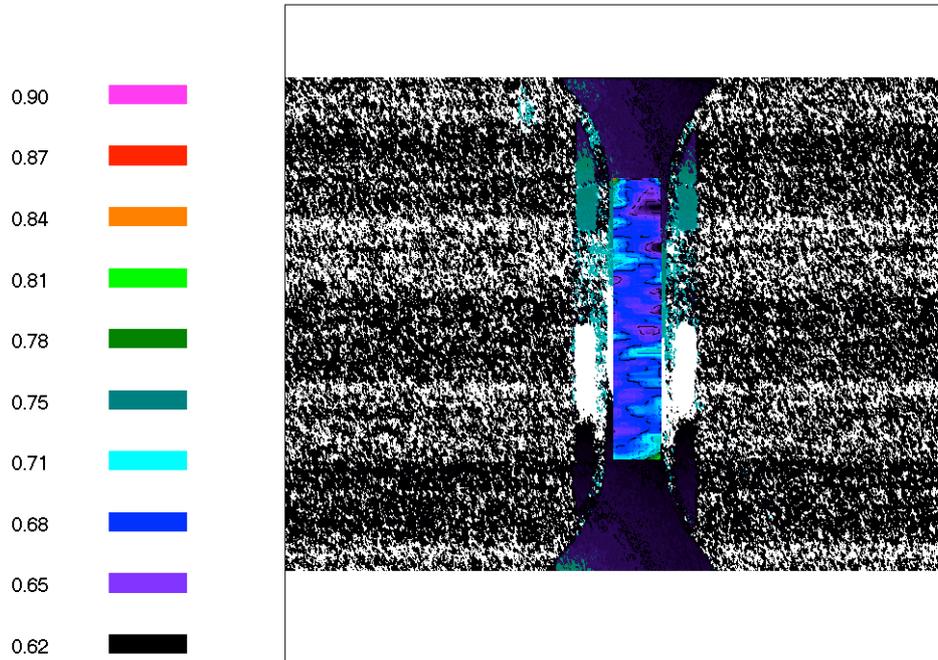
Fig. 4. Phase map with a layer of strain map in the measured section of the specimen generated by the ESPI system

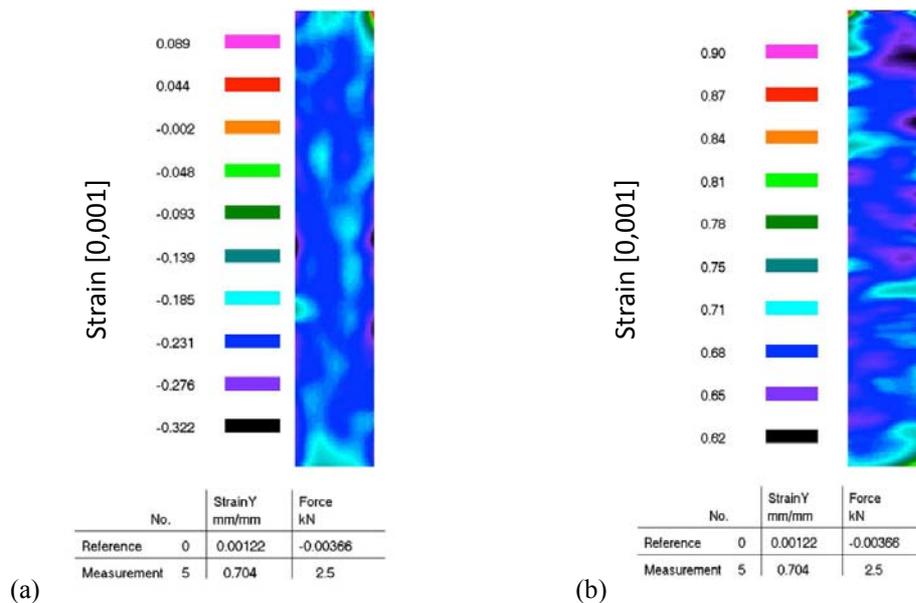
Fig. 5. Strain pattern distribution towards the X direction transversal to the direction of stress loading (a) and towards the Y direction consistent with the stress direction (b) for the NP91_1 specimen

NP91_1 and NP1_2 specimens have represented steel in the delivery condition without the preliminary load. In both cases deformation is homogeneous, with no clear localisations.

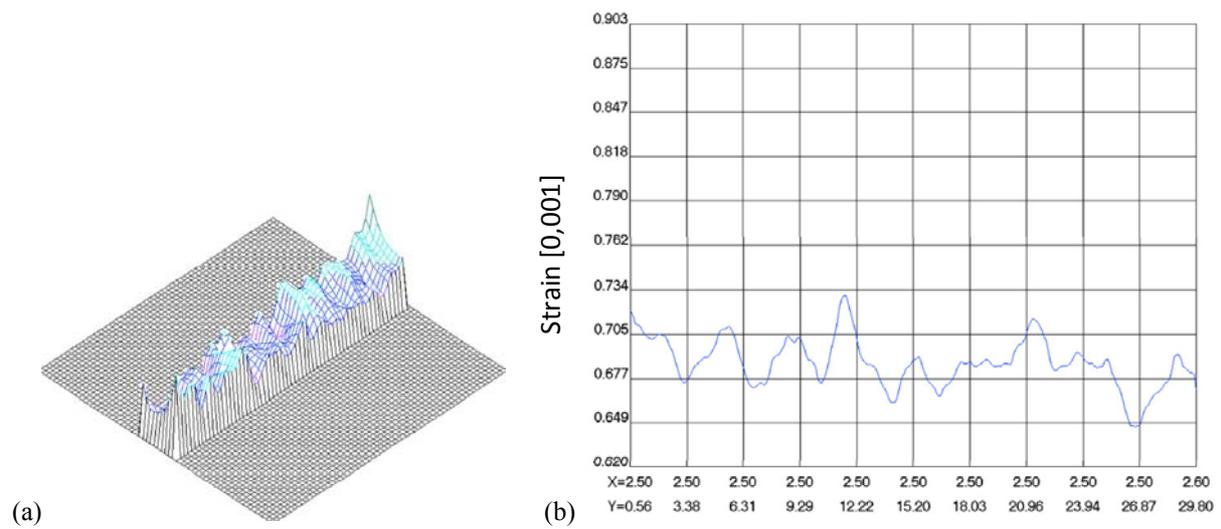
Fig. 6. 3D strain profile in the direction of tensile (a) and line graph in the axis of the main NP91_1 specimen (b)

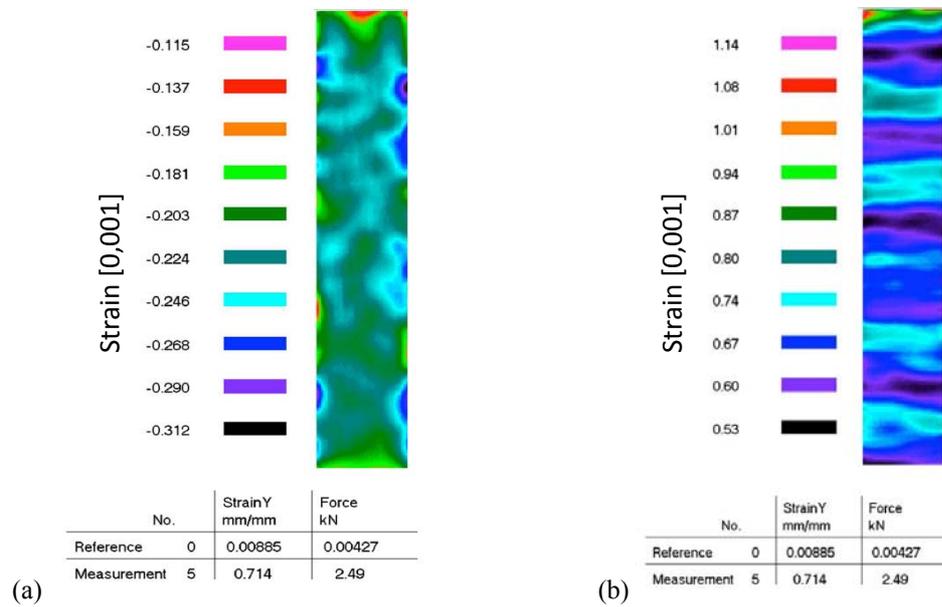
Fig. 7. Field strain distribution towards the X direction transversal to the direction of stress (a) and towards the Y direction consistent with the direction of stress (b) for the NP91_2 specimen

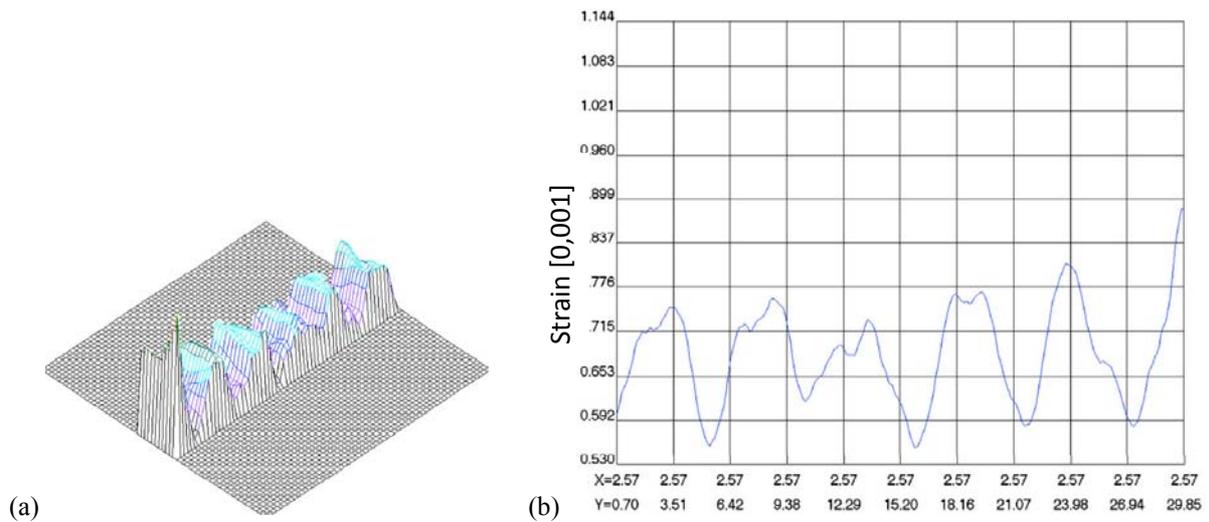
Fig. 8. The 3D strain profile towards the tensile direction (a) and the linear profile in the axis of the main NP91_2 specimen (b)

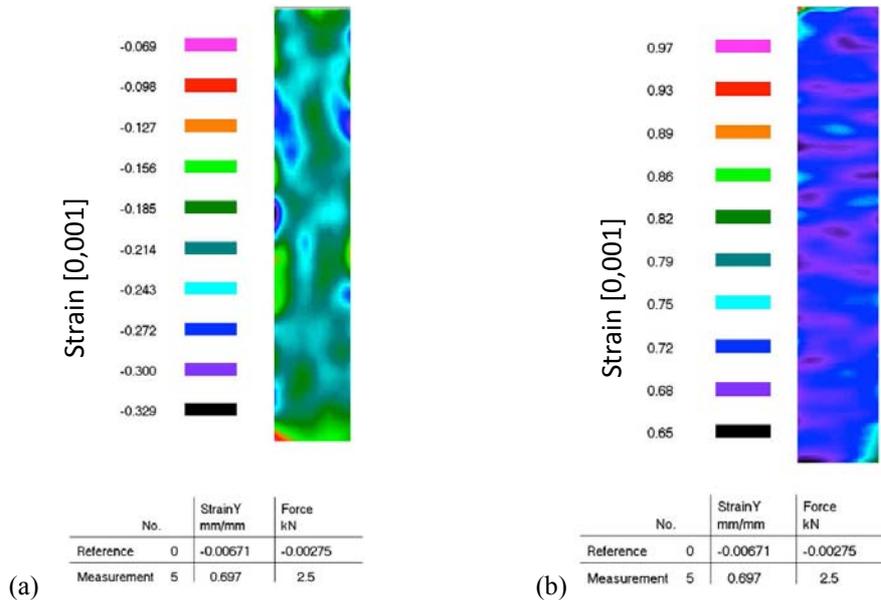
Fig. 9. The field strain distribution towards the X direction transverse to the stress direction (a) and towards the Y direction compatible with the stress direction (b) for the EP91_1 specimen

Exploited specimens and new specimens reveal a similar character of deformation evolution in the same scope of loading. Results indicate that the strain distribution is homogeneous on the whole surface of the measured part of the specimen, and the statistical dispersion does not go beyond 0.035%.

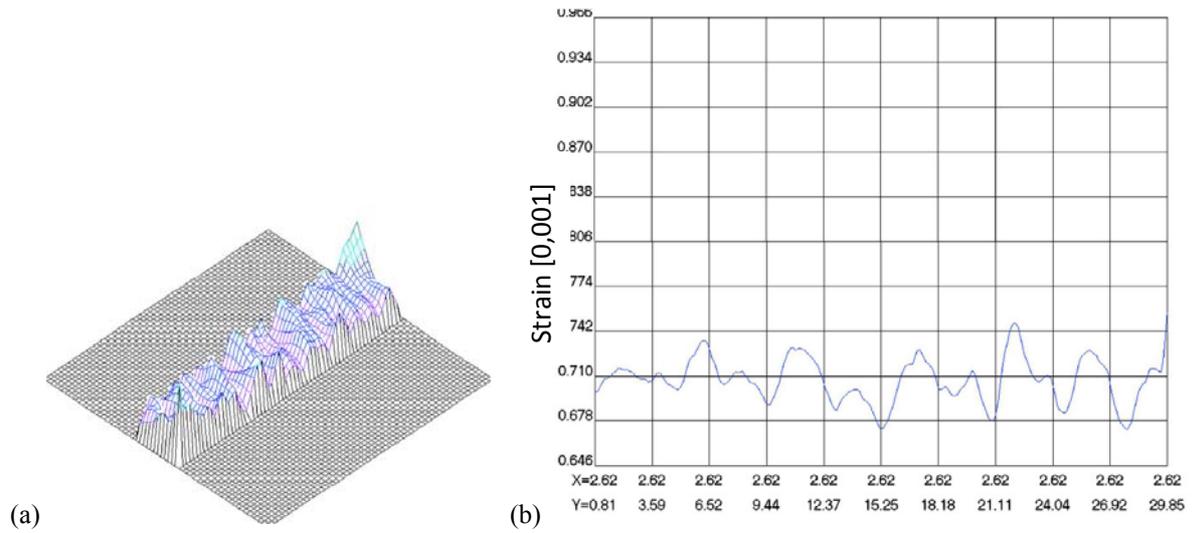
Fig. 10. The 3D strain profile towards tensile direction (a) and a linear profile in the axis of the main EP91_1 specimen (b)

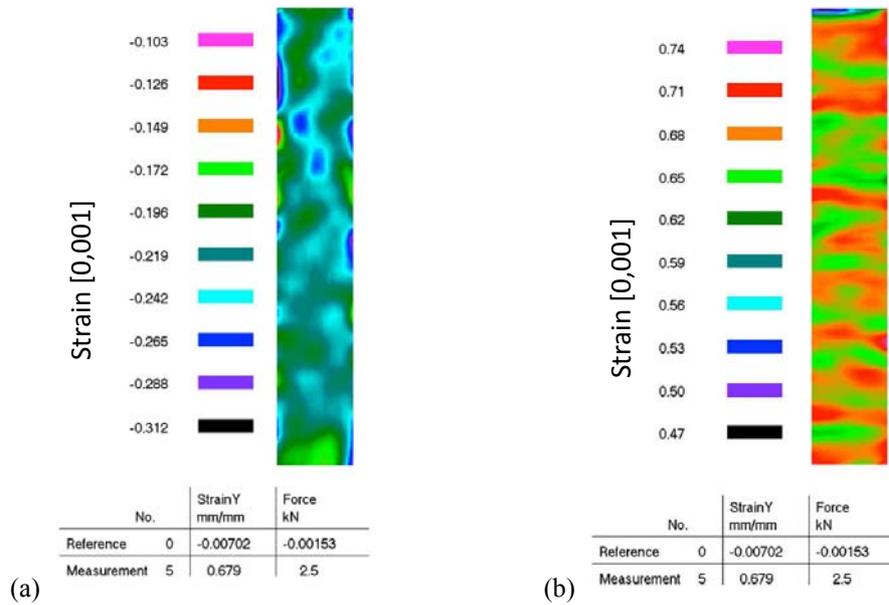
Fig. 11. The field strain distribution towards X direction transverse to the stress direction (a) and towards Y direction compatible with the stress direction (b) for the EP91_2 specimen

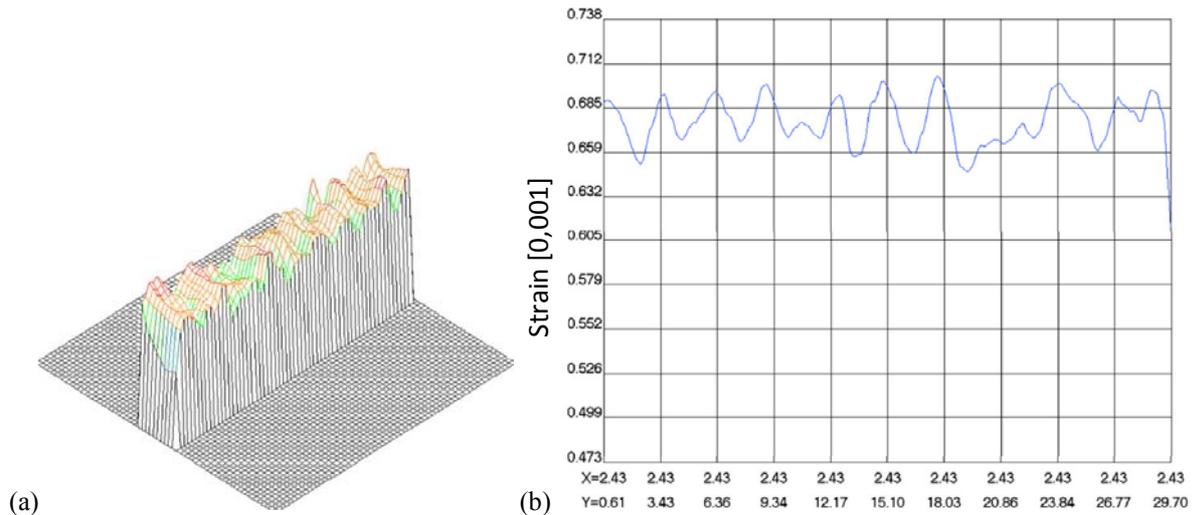
Fig. 12. The 3D strain profile towards tensile direction (a) and the linear profile in the axis of the main EP91_2 specimen (b)

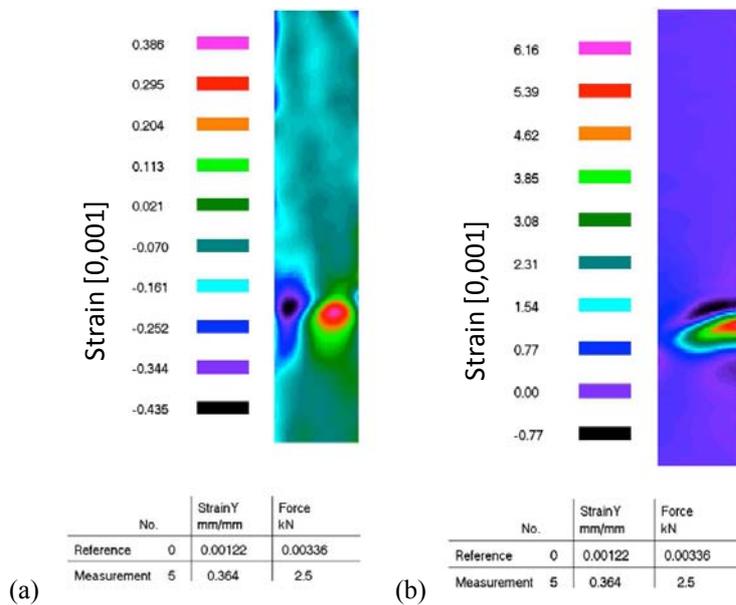
Fig. 13. The field strain distribution towards X direction transverse to the stress direction (a) and Y direction compatible with the stress direction (b) for the NP91_1FC specimen

NP91_1FC and NP91_2FC specimens have undergone fatigue tests in the scope of cycle tensile stress with amplitude of 370 and 350 MPa, until the occurrence of a crack, but before losing the integrity of the specimen [4]. With the same values of applied force, but with twice less stress than in the case of the earlier specimens the increase of the deformation localised directly around a crack is almost tenfold.

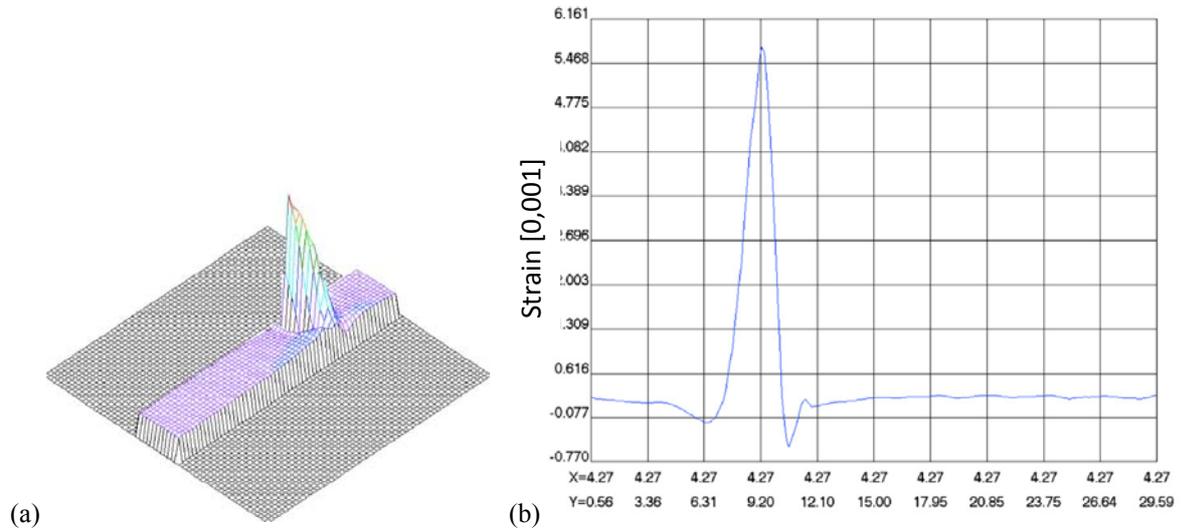
Fig. 14. The 3D strain profile towards the tensile direction (a) and the linear profile in the axis of the main NP91_1FC specimen (b)

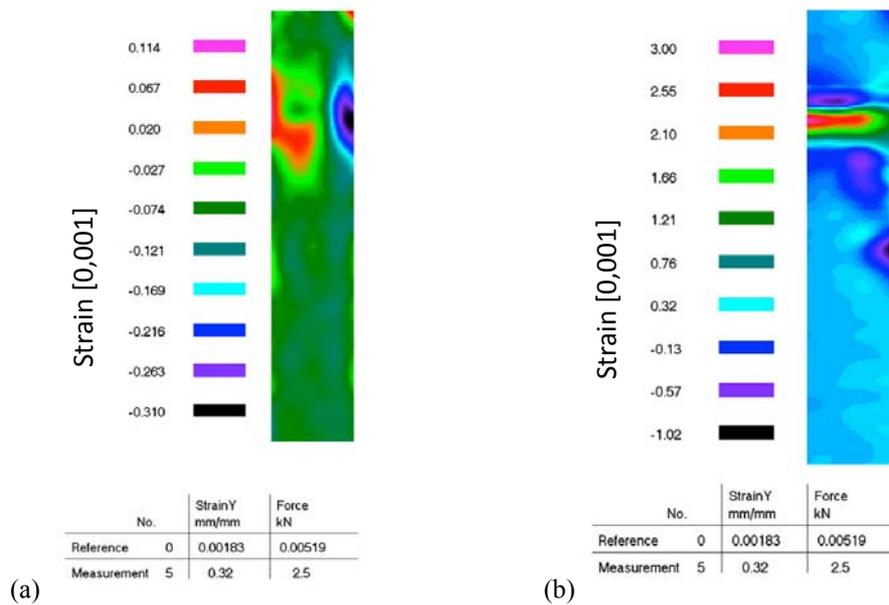
Fig. 15. The field strain distribution towards X direction transverse to the stress direction (a) and towards Y direction compatible with the stress direction (b) for the NP91_2FC specimen

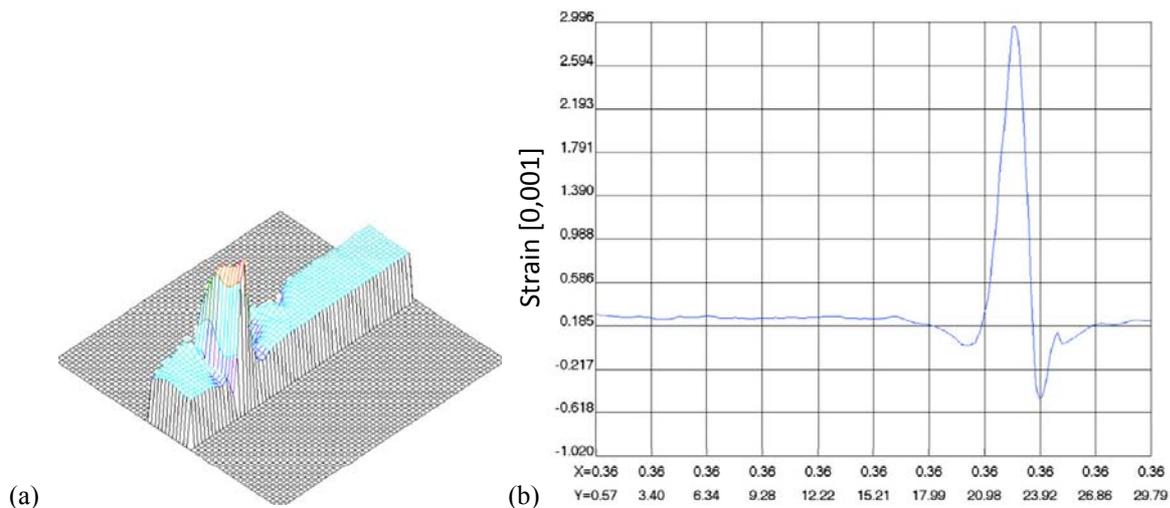
Fig. 16. The 3D strain profile towards the tensile direction (a) and the linear profile in the axis of the main NP91_2FC specimen (b)
