The impact of the health condition of oaks from the Krotoszyn Plateau on the mechanical properties of timber structures

ABSTRACT

The study was conducted to perform a comparative analysis of the mechanical properties of wood samples derived from oaks in the Krotoszyn Plateau, which depend on the health state of the trees. Strength parameters of oak wood were calculated for selected diseased and healthy trees (according to the Roloff classification). The study was conducted by a modified method described in the standard Polish Norm PN EN 408+ A1: 2012. For testing, prior selection of wood samples showed that more wood samples of diseased trees compared with those of healthy oaks did not fulfil the Polish standard requirements. According to the method used, the average results of strength tests of timber structures from healthy oaks exhibited higher strength parameters than those of the diseased trees.

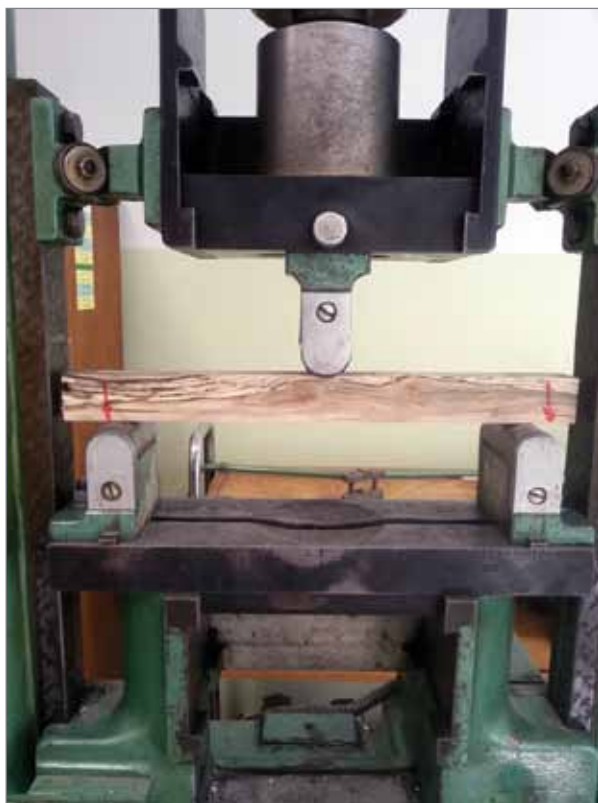
Figure 1. Static outline of sample support and load

analyses. The analyses consisted of the attempt to bend prepared laboratory samples until obtaining a decline in the strength indicated on the machine manometer, that is, material destruction of individual test samples. Sample load was presented in Figure 1. The study was conducted in the laboratory room with air temperature of 24.4°C and relative air humidity of 52.0%. Before carrying out the test, geometrical parameters and the humidity of timber structures samples were controlled using the resistance method. Before measurement and the cutting of short laboratory samples from primary samples, the samples were exposed to air conditioning at a temperature of 20°C for a period of 30 days. The samples were determined and selected so that their fibres ran parallel to the axes of beams, with growth rings parallel to one of the side plains. The results of strength of the timber structure were set based on the relationship (Polish Norm PN-EN 408+ A1 2012)

$$R = \frac{3PL}{2bh^2} \quad (1)$$
