## COMBATING THE EROSION PHENOMENON. THE DECANTING POND FROM FÂNAȚE VILLAGE, BIHOR COUNTY, ROMANIA—CASE STUDY

**Abstract:** *Decanting ponds can have a major impact on the environment, as they often contain heavy metals. In the absence of their monitoring and security, but especially during the greening process, the potential risk of technical accidents occurrence increased significantly. In such events, both the environment and human settlements are affected; sometimes major pollution with cross-border impact may occur. The Fânațe decanting pond is located in Fânațe village, Cîmpani commune, Bihor county, Romania. The arrangement works within the decanting pond aim to establish and consolidate the banks and its base. This paper presents some solutions for combating the erosion phenomenon.*

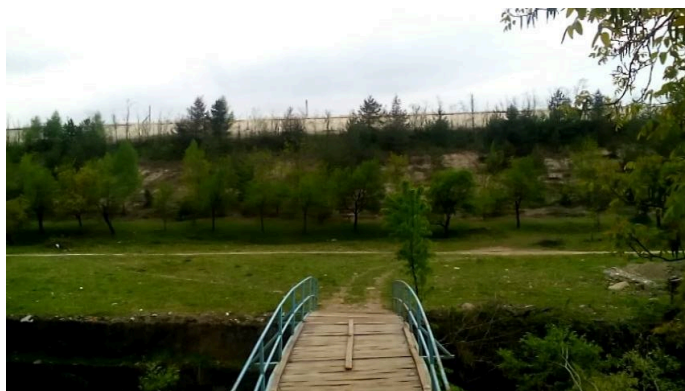
*Figure1: Decanting pond from Fânațe village*

Fânațe pond, occupies an area of 16.2 hectares, and the usefull area is 8.76 ha. The main destination of the land within 1 km of the decanting pond is as follows: forest 6% N; 12.5% NE; 6% E; cultures 12.5% S; 12.5% SW; 12.5% W; pasture 6.5% N; 6.5% E; 12.5% SE; 12.5% NW[27]. The pond has the shape of a pyramid trunk (Figure 1). The height of the deposit is variable depending on the natural ground rate, reaching 28.0 m downstream (to Fânațe village) and 18.2 m upstream. Polymeric ores containing copper, lead, zinc and the ore containing molybdenum, copper extracted from underground are flown in the preparation plant to obtain concentrates. Industrial wastewater from flotation is transported hydrogravitatively to the pond on a 250 mm diameter pipe with a length of 6.2 km. The decanting facility is considered to consist of the decanting pond and the slurry transport pipeline from the Preparation Plant to the pond. The projected capacity of the current Fânațe decanting pond is 4900000 tonnes of tailings.

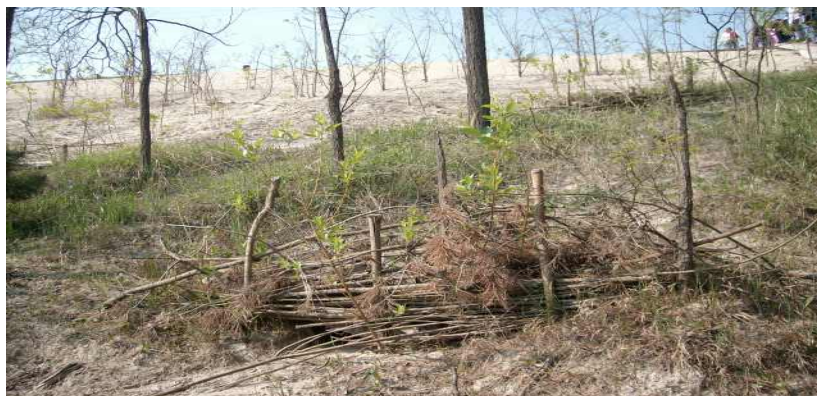
Figure 2: Combating the erosion phenomenon within the decanting pond in Fânațe with the help of silt fences

erosion [30,31]. Figures 1 and 2 show the practical result of such actions.

When silt fences exist (Table 2) it can be seen that the soil loss is much smaller in all variants and the degree of vegetation

coverage of the slope increases up to 78% when the inclination is 15%.

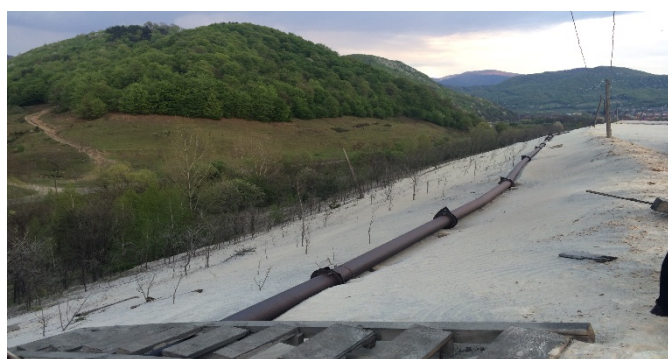
Figure 3: Combating the erosion phenomenon within the decanting pond in Fânațe with the help of forest plantations

The works for the consolidation of the decanting pond base are carried out through: forest plantations and cross-sectional construction works. If the surface of the decanting pond base is dry, it is recommended to plant brier, hawthorn, wild olive. The transversal works include thresholds or dams arranged perpendicularly on the thread of the erosion forms in deep. These can be made of wood, wood with stone, earth, stone, concrete, reinforced concrete. The transverse woodworks include: granisages, fascine works, and silt fences.

In order to reduce the impact of the Fânațe pond on the environment and human health, there is an obligation to include it in the landscape. This can be done by planting a plant protection curtain and by planting species resistant to specific pollutants. The pond consists of very fine particles that can be shattered by the wind; the only protection against this phenomenon remains the afforestation on the terraces of the pond.

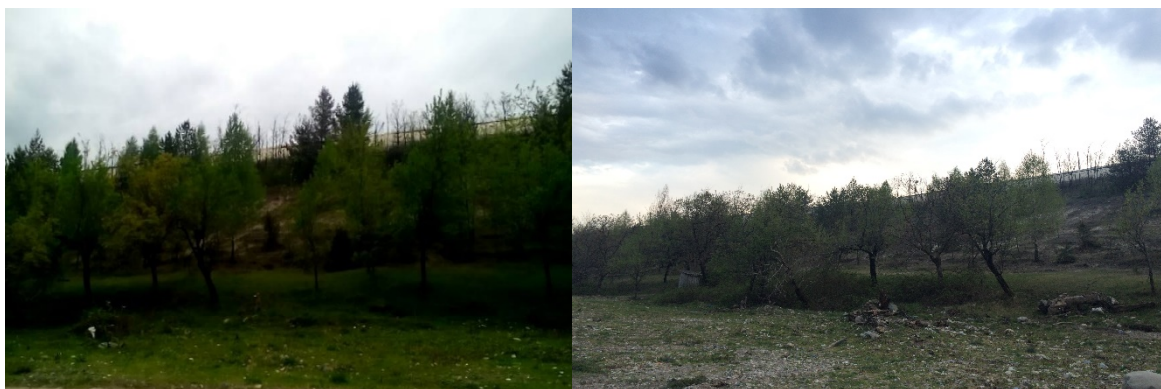
Figure 4: Stabilization works of the slopes of the decanting pond Fânațe

The arrangement of a soil cover on the surface of the decanting pond system of the useful mineral processing plant seeks to achieve the same basic remediation objectives as those described in the case of rock wastes dumps. However, there are certain specific issues to be taken into account, namely: processing tailings usually contain large amounts of cantonated water in pores, often at the saturation limit, at least in certain parts of the decanting pond; sedimentation/consolidation of processing tailings, especially those in the form of slurry, may be significant. This has to be taken into account to determine the optimal profile of the cover and the technology to install it. The settlement of the banks of the decanting pond shall be carried out concomitant with its foundation works and shall be ensured, where appropriate, by grassing, afforestation, covering with various materials and supporting walls. Consolidation is made through forest plantations, both shores and slopes are planted and can be between 10 and 15 meters wide; depending on the degradation of the land, consolidation is also carried out by means grassing and is applied to the sectors that can be plug.
